Tesla, Inc. Service Bulletin		<h2>Reroute Main Front Body Harness</h2>	
SB-20-17-004 March 19, 2020			
Classification Campaign Bulletin		Section/Group 17 - Electrical	Mobile Service Cannot Perform
Model Year 2017 - 2019	Model Model X	Country/Region All	Version All
<small>The model(s) and model year(s) listed are a general approximation of the affected VIN list. Refer to the VIN/Bulletin Tracker or Customer/Vehicle profile to determine applicability of this bulletin for a particular vehicle.</small>

On certain Model X vehicles, the main front body harness might contact the RH front upper control arm.

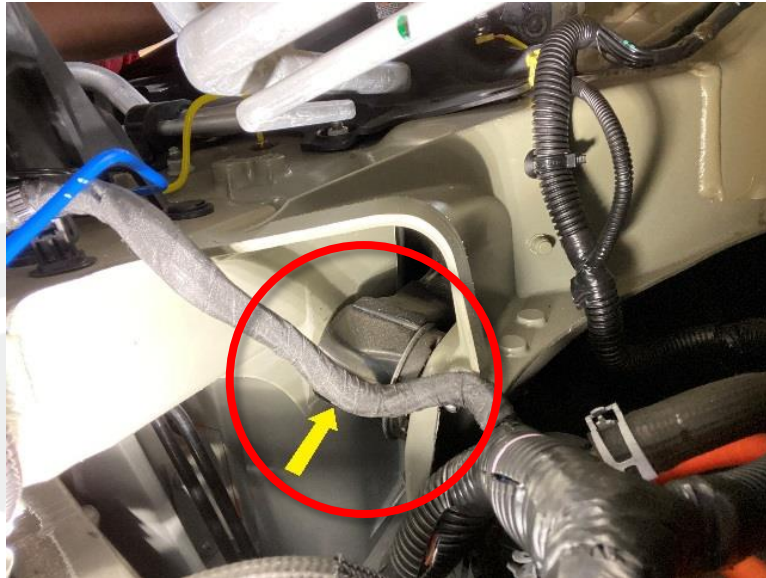
Figure 1

3. Inspect the fuse box harness branch at the main front body harness near the RH front upper control arm for damage (Figure 1):
 - If there is no sign of the harness contacting the RH front upper control arm, or if the harness is contacting the RH front upper control arm but the insulation of the wires is still intact, continue to the next step.
 - If any of the harness wires are damaged or exposed, repair the harness. Refer to [SI-17-17-002](#), “Electrical Harness Repair” for further instructions on how to repair the wire(s), and then continue to the next step.
