DC/DC Converter Overheat

19.5MY Onwards Range Rover, RR Sport, RR Evoque MHEV variant

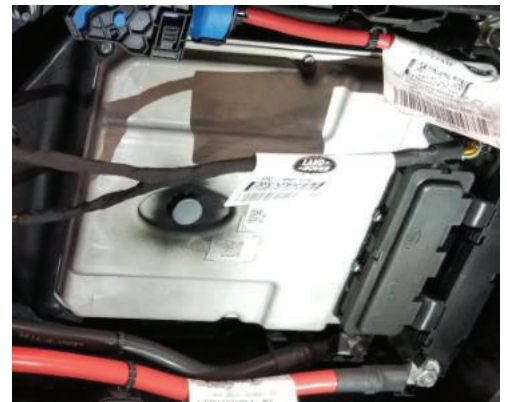
- The 12V system is identified to not be charging.
- The DC/DC converter is found to have evidence of overheating.

- Perform a thorough inspection of the charging circuits.
- Replace the DC/DC Converter if it is identified as having failed.
- If evidence is present of an overheat condition in the DC/DC Converter, raise an EPQR and hold the part for return.
- Include contact information (name, email address, and phone number) in the EPQR for someone at the retailer who can serve as the point of contact for the shipping company.
