L560 Check Engine MIL

2018 Onward RR Velar

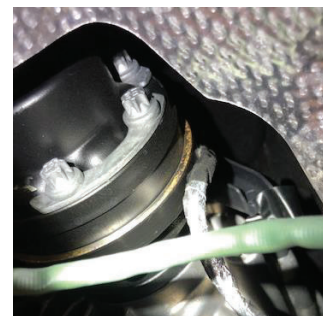
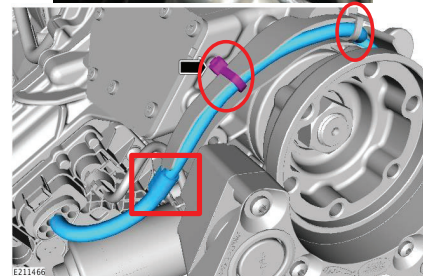
- Various DTCs for oxygen sensors may be present depending on the damage to the harness.
- Visual inspection finds the harness is damaged due to contact with the driveshaft.

- Make repairs to the harness as necessary.
- Make sure the harness is secured into the bracket with two cable ties in the locations denoted by the ovals and tape in the location noted by the square in the image to the right.
