FEAD Tensioner

17MY onward Range Rover, RR Sport, RR Velar, Discovery, F TYPE, F PACE, XE, XF, XJ equipped with AJ126

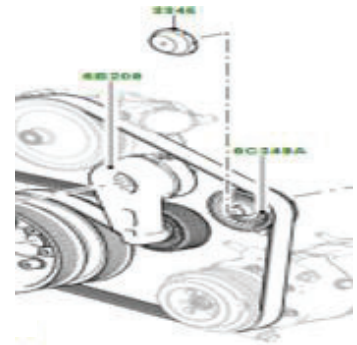
- There is a noise from the engine.
- The charge warning lamp is on.

- Analysis of returned parts has identified the tensioner failure is attributed to oil intrusion into the bearing.

- Inspect for evidence of an oil leak in the area of the FEAD tensioner.
- Perform diagnosis of the root cause of the oil leak and document findings with pictures. Repair the leak as necessary.
- Raise an EPQR which includes detailed information about the source of the oil leak and pictures.
