**\*\* SOLUTION \*\***

| Title | Volvo Chassis - <b>Model VNX</b> - One Piece Propeller Shaft (Drive Shaft) Contacts Crossmember - <b>Vehicles Built Between 4 November 2018 And 1 February 2020</b> |

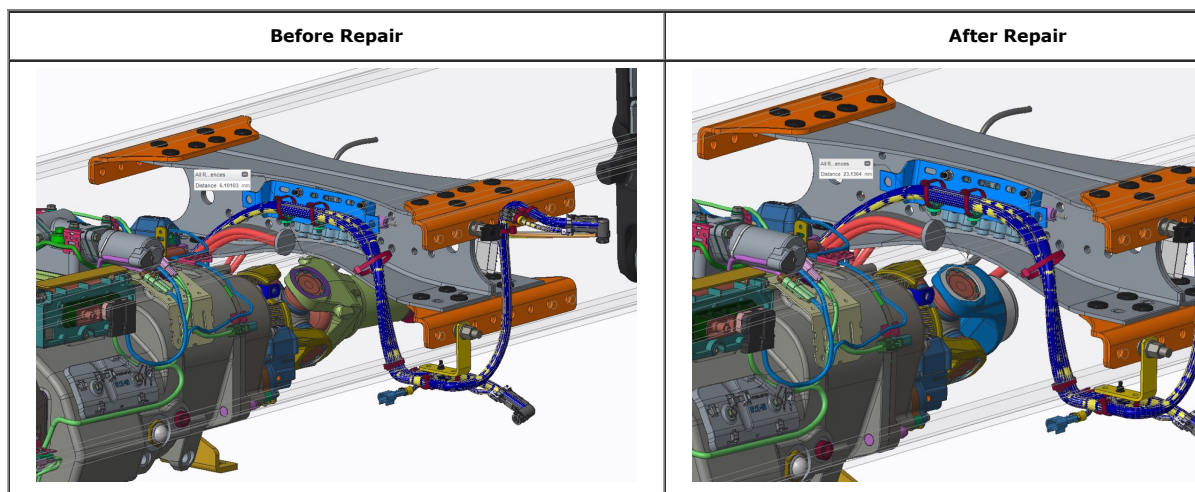
| <b>Cause</b> | Due to close tolerances between the cross member and the propeller shaft on vehicles equipped with a one-piece shaft, the yoke of the drive shaft may contact the back to back "C" channel cross member under acceleration and/or suspension articulation. |

| <b>Solution</b> | <p><b>For applicable vehicles with the symptom described above:</b></p> <ol style="list-style-type: none"> <li>1. Remove the drive shaft.</li> <li>2. Flip the shaft end-to-end (rear to the front, front to the rear).</li> <li>3. Reinstall the flipped driveshaft.</li> </ol> |

**Refer to the images below for proper appearance:**
