GROUP ELE	MODEL 2021MY Seltos (SP2)
	NUMBER 197	DATE March 2020

TECHNICAL SERVICE BULLETIN

**SUBJECT: SERVICE ACTION: SELTOS AVN 5 WIDE
SOFTWARE UPDATE (SA417)**

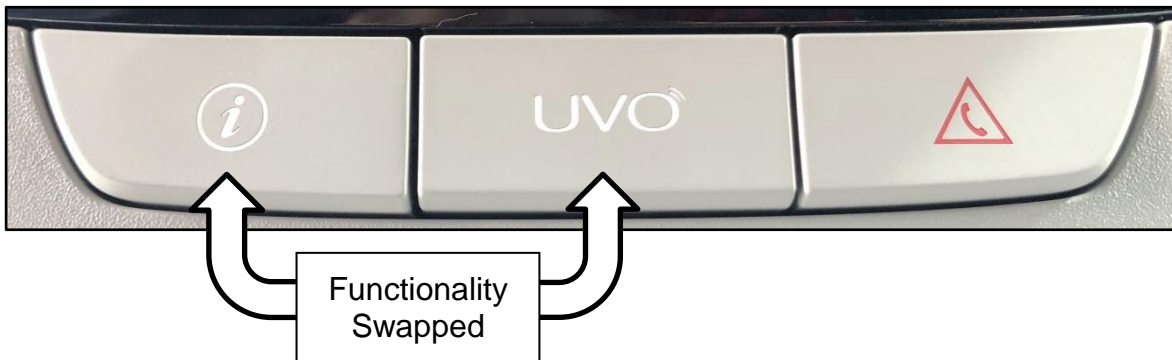
This bulletin provides the procedure for updating the AVN 5 WIDE head unit software on some 2021MY Seltos (SP2) vehicles produced from November 26, 2019 through February 18, 2020, which may exhibit “UVO” and “INFO” buttons with reversed functionality relative to published customer education materials. To correct this concern, perform the head unit software update procedure outlined in this bulletin. Before conducting the procedure, verify that the vehicle is included in the list of affected VINs.
