| Title | <a href="#">Volvo Chassis</a> - Vehicles Equipped With AMT-C, AMT-D, And AMT-F (I-Shift) Transmissions - Hill Start Assist (HSA) Engaging On Flat Ground, Inclination Sensor Calibration |

| <b>Volvo Model</b> | VN , VNL , VNM , VNR , VNX , VAH , VHD , VT |

| Transmission | AMT-C , AMT-D , AMT-F With Crawler Gears , AMT-F Without Crawler Gears |

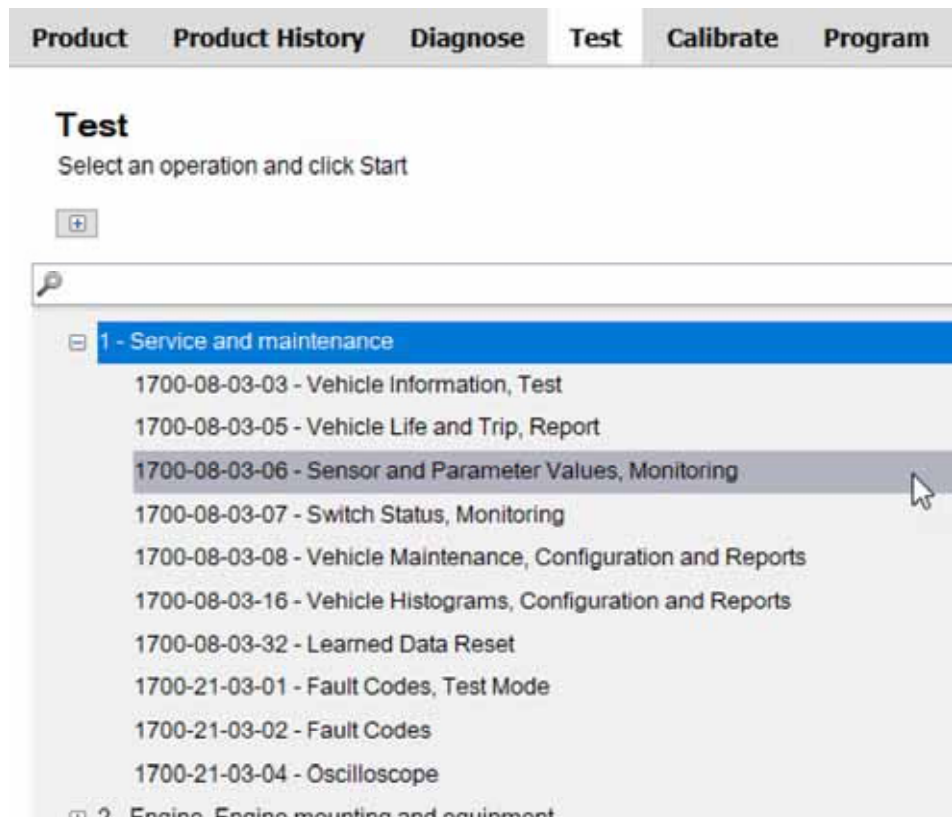
5. With the driving portion completed, connect to the vehicle with PTT.
6. Under the Test tab, select Operation [1700-008-03-06 Sensor and Parameter Values, Monitoring](#).

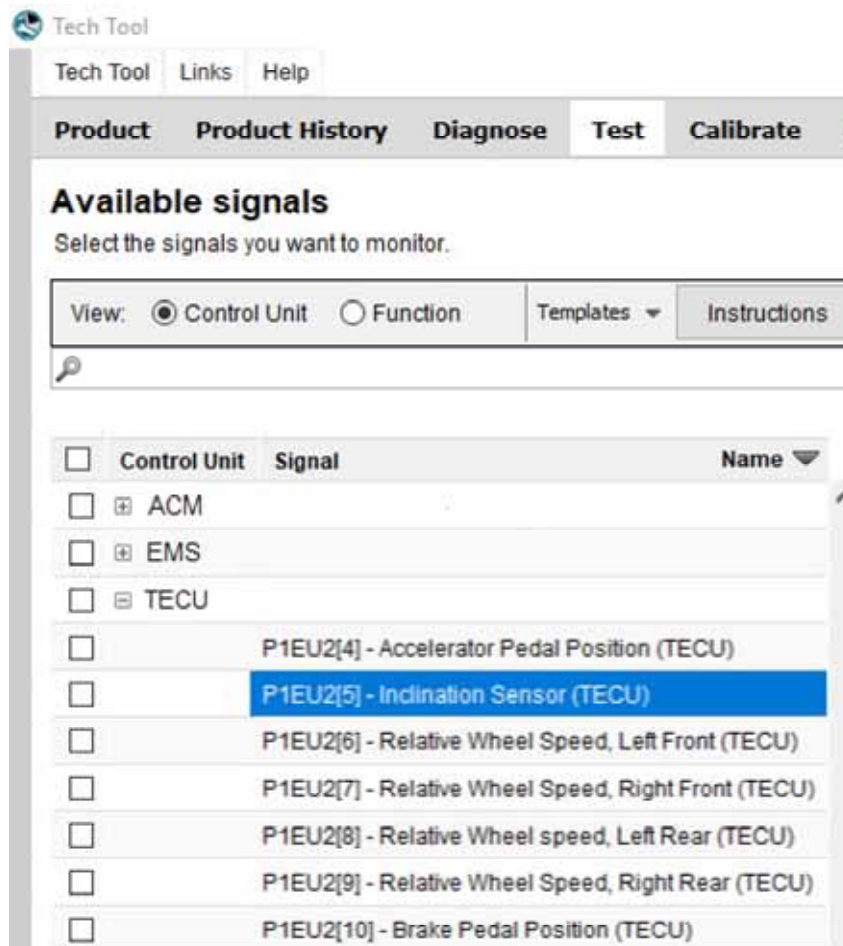
7. Locate and select parameter [P1EU2\[5\] - Inclination Sensor \(TECU\)](#).

8. Verify the inclination sensor is reading between -1.5° and 1.5°.
