## **Service Campaign**

### **ABS ECU Part Number Verification**

ABS ECU Part Number Verification. Replace if necessary.

**UCHP SCC CODE:** S7469

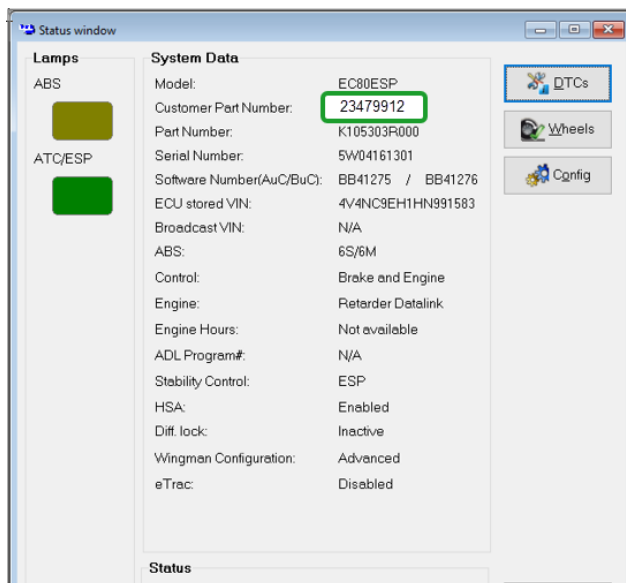
- When finished reading ECU, ACOM will display the Status Window with Customer Part Number. This should read 23479912 as seen below.

- 
- 
- 
- 
- If part number matches 23479912, verification is complete, no replacement needed.
- If part number is anything other than 23479912, please proceed with replacement using service operation 5931.03.02.01 - ABS ECU, Replacement.
