JLRTB02012NAS2

TECHNICAL BULLETIN

'Gearbox Fault Detected' Displayed On The Instrument Panel Cluster (IPC)

MODEL:	MODEL YEAR:	VIN:	ASSEMBLY PLANT:
I-PACE (X590)	2019-2020	F60094-F80069	Graz (Austria)

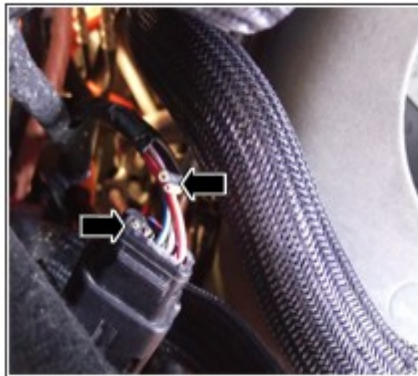
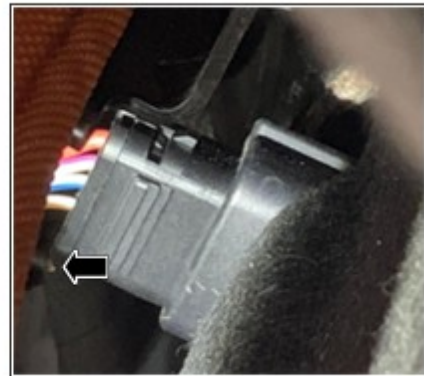
E256857

No retention to the front Electric Drive Unit (EDU) causing strain on wiring going to the park lock actuator connector (C1YE113A).

- ■ If the park lock actuator connector (C1YE113A) wiring is found to be damaged, as per the illustration, **continue to step 2**.

Renew the front compartment wiring harness (see TOPIx Workshop Manual section 418-02: Wiring Harnesses - Removal and Installation - Front Compartment Wiring Harness).
