<b>HYUNDAI</b> <b>Technical Service Bulletin</b>	GROUP <b>CAMPAIGN</b>	NUMBER <b>20-01-014H</b>
	DATE <b>MARCH, 2020</b>	MODEL(S) <b>PALISADE (LX2)</b>
<b>SUBJECT:</b> BLIND-SPOT COLLISION WARNING (BCW) RADAR UPDATE (SERVICE CAMPAIGN T4K)

**BLIND-SPOT COLLISION WARNING (BCW) RADAR UPDATE  
(SERVICE CAMPAIGN TK4)**

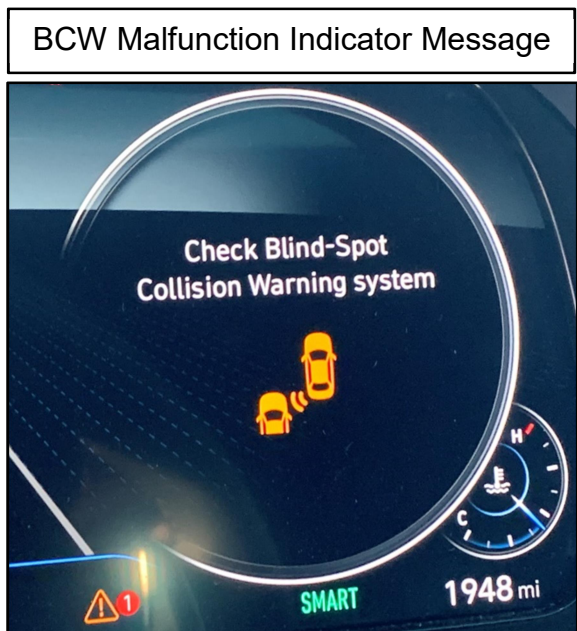
**Description:** Some Palisade (LX2) vehicles may intermittently experience the BCW Malfunction Indicator Light ON with a message "Check Blind-Spot Collision Warning System" displayed on the instrument cluster. This bulletin provides the service procedure to update the BCW system software to correct the intermittent BCW Malfunction Indicator Light.

**NOTE:** When the BCW Malfunction Indicator Message turns ON, the diagnostic code C270354 (Control Module Slave Calibration) will be triggered.
