Technical Service Bulletin

GROUP BODY ELECTRICAL	NUMBER 20-BE-002H-1
DATE MARCH, 2020	MODEL(S) PALISADE (LX2)

SUBJECT: BLIND-SPOT COLLISION WARNING (BCW) RADAR UPDATE

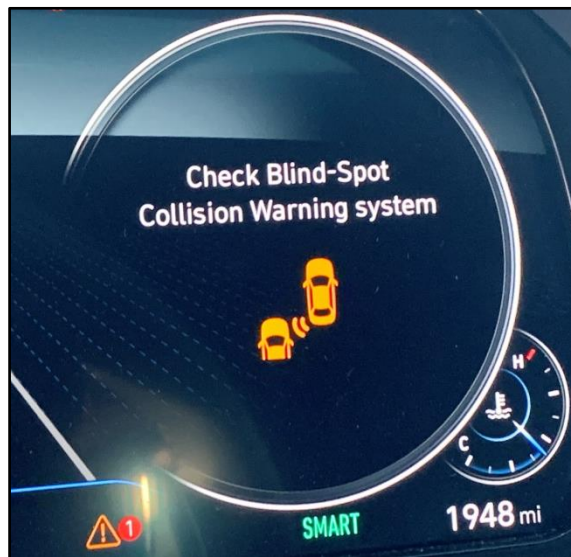
Description: Some Palisade (LX2) vehicles may intermittently experience the BCW Malfunction Indicator Light ON with a message “Check Blind-Spot Collision Warning System” displayed on the instrument cluster. This bulletin provides the service procedure to update the BCW system software to correct the intermittent BCW Malfunction Indicator Light.

NOTE: When the BCW Malfunction Indicator Message turns ON, the diagnostic code C270354 (Control Module Slave Calibration) will be triggered.

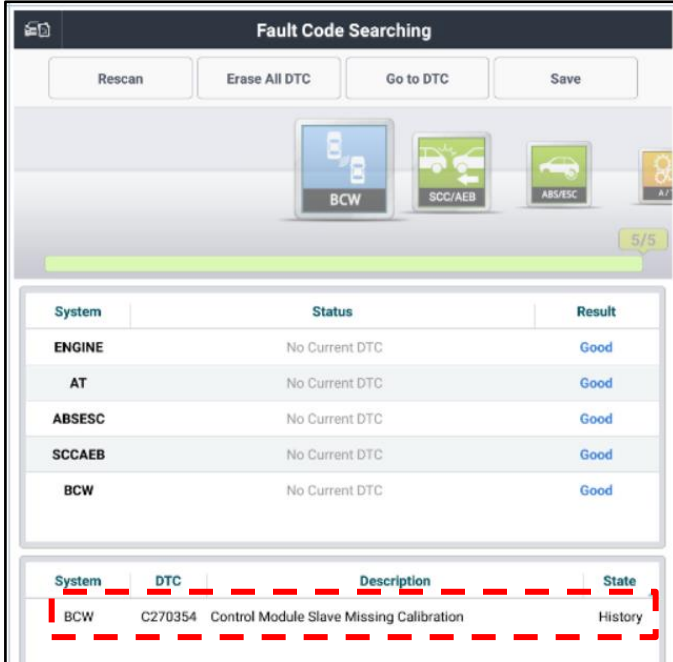
1. Perform the BCW system DTC scan.
If the DTC code C270354 is shown in history code, then proceed with updating the BCW.
2. Take a picture or screenshot of the GDS displaying DTC C270354 in history for warranty claim image upload.

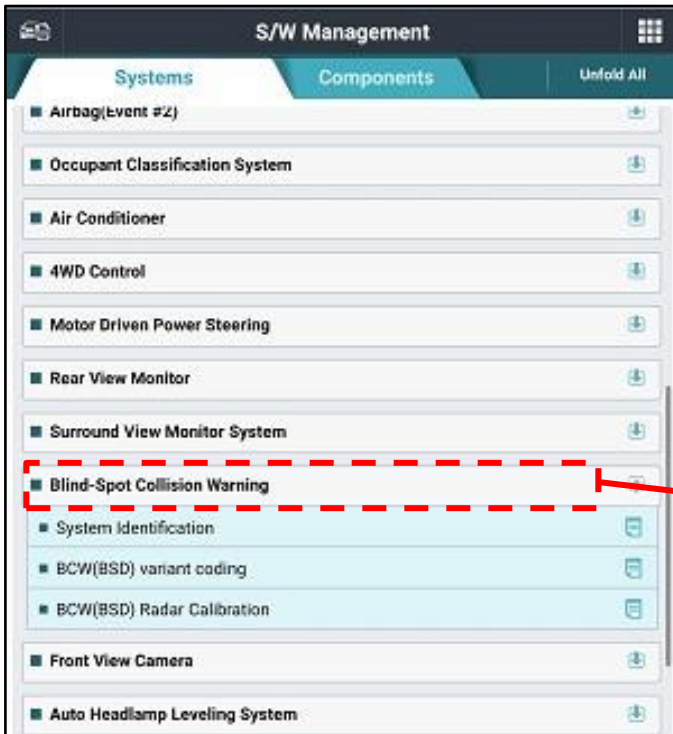
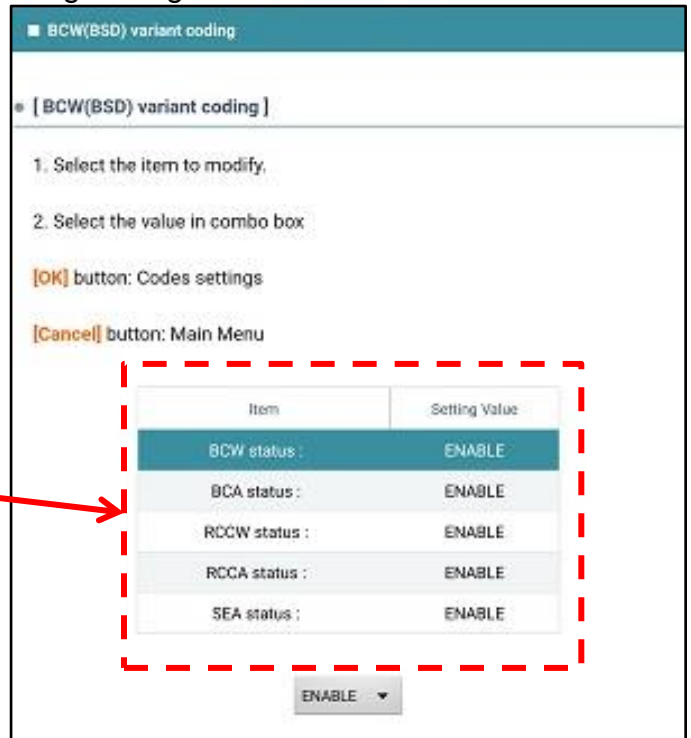
3. Write down or take a picture of the BCW variant coding setting.

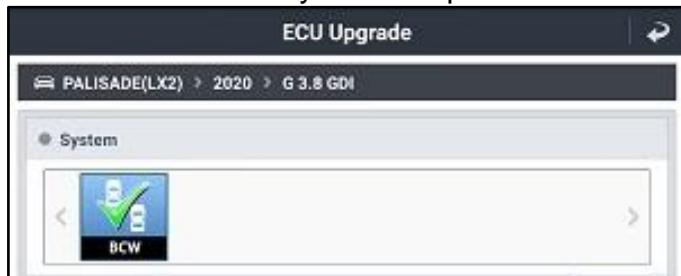
4. Select BCW as the system to update.
