Technical Service Bulletin

GROUP Interior	NUMBER 20-BD-005H
DATE March, 2020	MODEL(S) Sonata (DN8a)

SUBJECT: INSIDE DOOR HANDLE REPAIR

Description: This bulletin describes the procedure to repair an inside door handle exhibiting noise when opening the door.

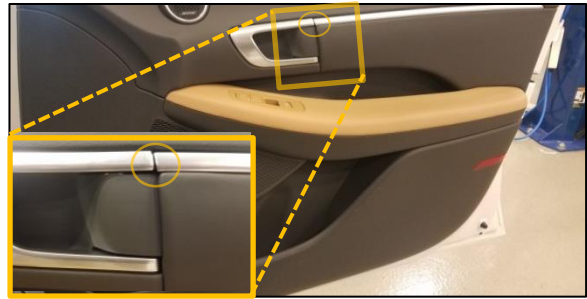
1. Inspect the area where the inside door handle meets the chrome accent. If the inside door handle is slightly raised above the door trim, repair is required.

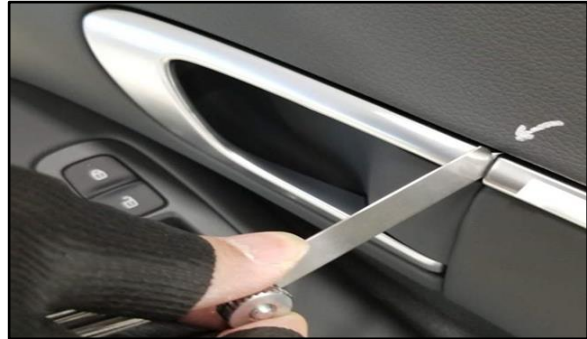
2. Insert a **0.3mm feeler gage** into the gap between the door handle and the chrome accent for inspection.

If the inside handle is flush or slightly lower than the door trim, the gap should have a measurement of 0.3mm (or more). If the measurement is below 0.3mm, repair is required.

If the door handle is higher than the chrome accent, repair the door trim even if the gap measures at or larger than **0.3mm**.
