SERVICE BULLETIN

EL20-008

March 9, 2020

RADIO INTERMITTENTLY REBOOTS DURING AUDIO PLAYBACK VIA BLUETOOTH CONNECTED IPHONE

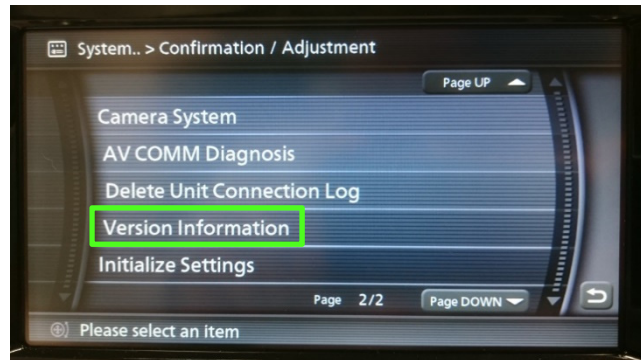
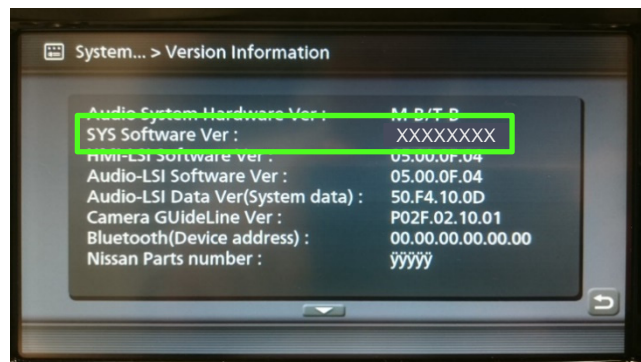
Figure 6

- If the **SYS Software Version #** is less than the numbers shown below, turn the ignition OFF and continue to step 7 on page 4.
- If the **SYS Software Version #** is equal to or greater than the numbers shown below, no software update is needed. Go to ASIST for further diagnostic and repair information.

- For 2018-2019 Sentra, Versa Note and Versa Sedan: 80856035
- For 2020 Versa Sedan and 2018- 2020 Kicks: 80851035

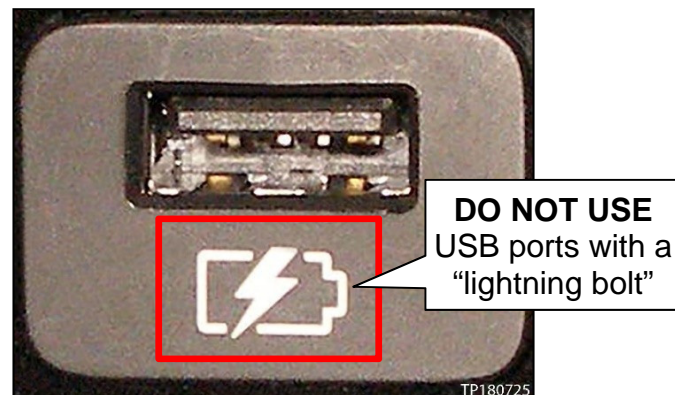
Figure 12

NOTICE Do not insert the USB drive into a charging port (Figure 12). If used, the update software and/or USB drive may become damaged. Only insert the USB drive in a USB media port.
