<b>Subject:</b> Replacing Throttle Pedal Jumper Harness			
<b>Field Change Program:</b> Field Campaign	<b>FCP Number:</b> 475	<b>Revision:</b> A	<b>Date:</b> 03/24/2020
<b>Coach Section:</b> 07- Electrical	<b>P/N:</b> 04-15-1282		<b>Type:</b> Product Integrity

## 1.0 Description

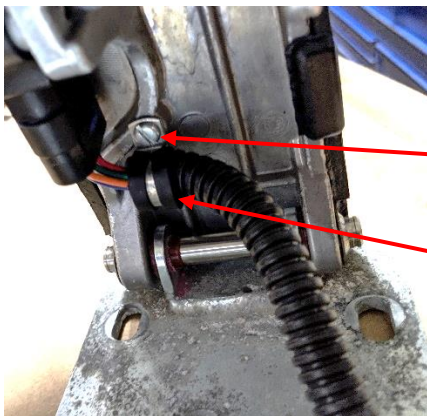
William Controls, the supplier of the throttle pedal, removed a p-clamp that holds the harness in place while the pedal is in operation. Due to the absence of the p-clamp the wires are put under stress during operation of the pedal and are breaking internally in the harness, creating an intermittent, erratic data signal being sent to the engine ECM.

Using self-tapping screw, part of kit T07-3774, install p-clamp, part of kit T07-3774, to the throttle pedal as shown below.
