SERVICE BULLETIN

Classification: AT18-003e	Reference: NTB18-058e	Date: March 5, 2020
------------------------------	--------------------------	------------------------

2013-2017 SENTRA AND VERSA SEDAN, AND 2014-2017 VERSA NOTE; ENHANCED DIAGNOSTIC LOGIC FOR CVT

APPLIED VEHICLES: 2013-2017 Sentra (B17)
2013-2017 Versa Sedan (N17)
2014-2017 Versa Note (E12)

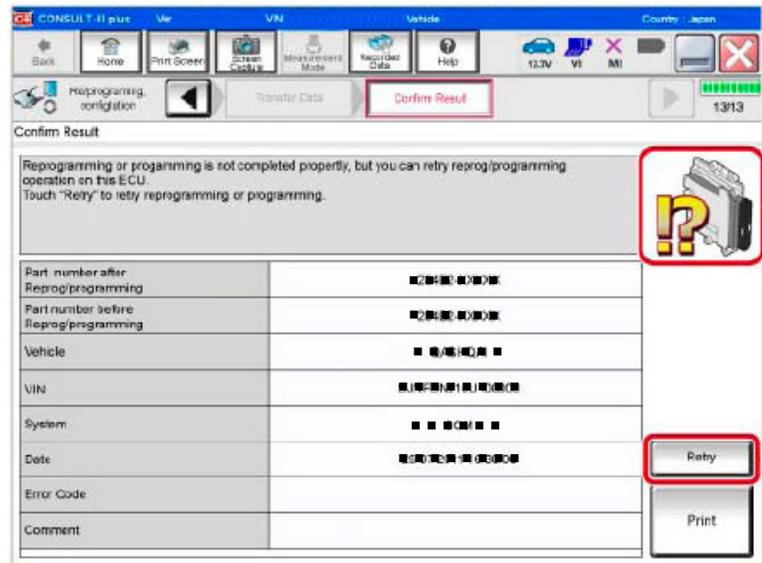
Figure 6

If reprogramming does not complete and the “!?” icon displays as shown in Figure 6:

- Check battery voltage (12.0–15.5 V).
- Ignition is ON, engine OFF.
- External Bluetooth® devices are OFF.
- All electrical loads are OFF.
- **Select retry and follow the on screen instructions.**
- “Retry” may not go through on first attempt and can be selected more than once.

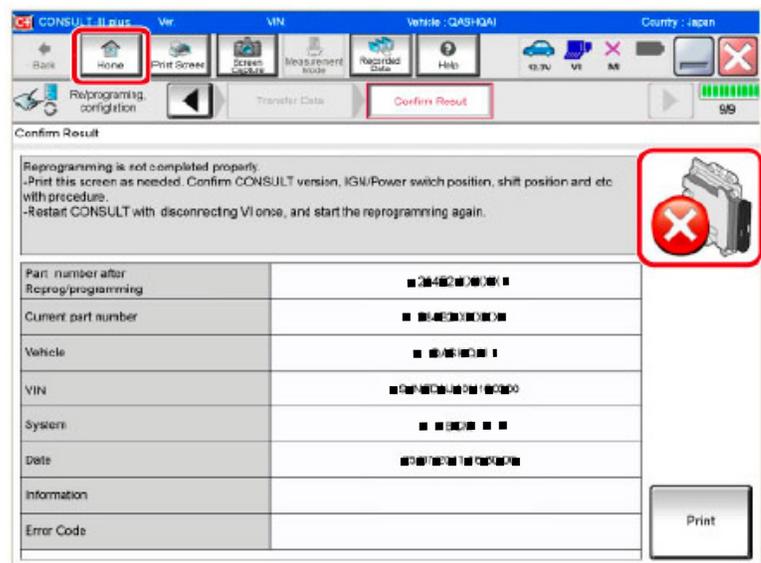
Figure 7

If reprogramming does not complete and the “X” icon displays as shown in Figure 7:

- Check battery voltage (12.0 – 15.5 V).
- CONSULT A/C adapter is plugged in.
- Ignition is ON, engine OFF.
- Transmission is in Park.
- All C-III plus / plus VI cables are securely connected.
- All C-III plus updates are installed.
- **Select Home, and restart the reprogram procedure from the beginning.**
