Published date: 03/2/2020

PIT5287F Diagnostic Tip - Front Shock Terminal Removal

With Magnetic Ride Suspension Package (RPO Z95)

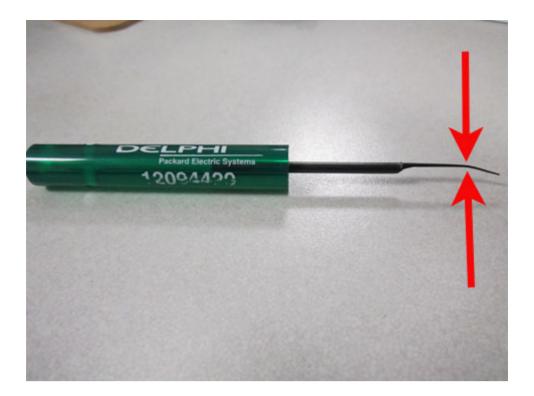
Certain repairs to the front suspension require the removal of the front shock electrical connector terminals. Because the terminals are positioned deep into the connector body, it may be difficult to remove the terminals.

The use of terminal release tool J-38125-12A (Delphi # 12094429), with a small modification, has been found to make removal of the terminal(s) much easier.

Slightly bend the end of the J-38125-12A release tool, as shown in the photo below.

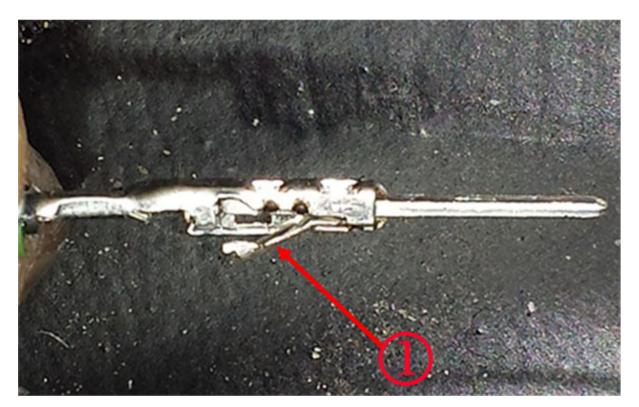
While looking down into the connector body at the terminals, there is a purple TPA that will align itself in the release position when the release tool is inserted into the release hole. Shown below is a shock terminal, that is already removed from the connector body, to show the metal locking tab (1) that will need to be pushed in with the terminal release tool before the terminal will pull out of the connector body.
