Transmission Control Module (TCM) Reprogram Dealer Inventory

Reference: PM942
Date: March 31, 2020

PM942 - 2020 SENTRA TRANSMISSION CONTROL UNIT REPROGRAMMING

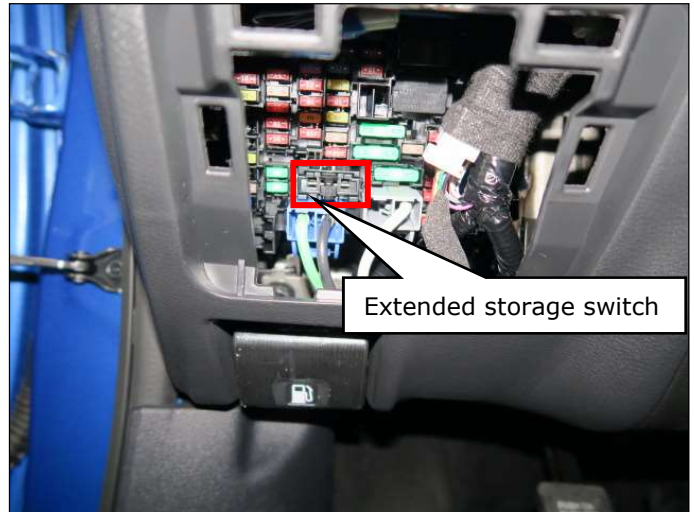
1. Verify vehicle is not in "Shipping Mode".
 - Remove Fuse J/B cover
 - Verify the Extended Storage Switch is pressed in as shown in Figure 1

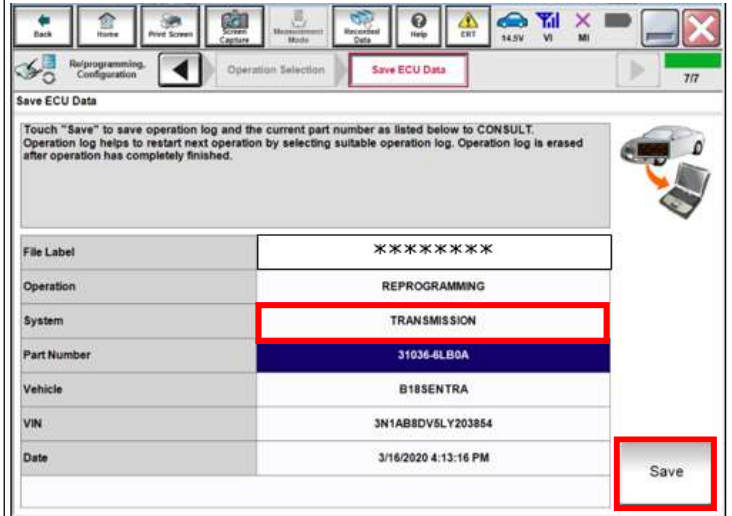
Figure 9

11. Check TCM part number. (Figure 9)

Is the TCM part number 31036-6LW0A?

- If **NO** Select "Save" to continue TCM reprogramming procedure on **Step 12.**
- If **YES**, Reprogramming is **NOT** needed. Continue to claims information and claim operation code PM9421 "Reprogram Not Needed".
