SS 1034684 P4 New Cascadia Road Lamp Strain Relief and Water Protection For Electrical Connection

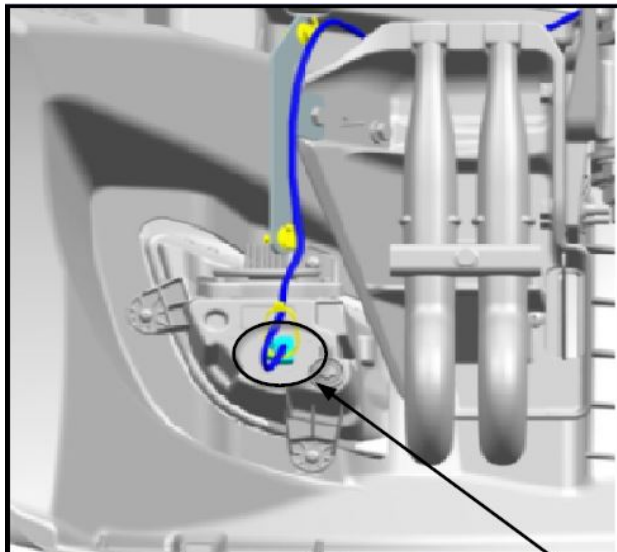
The connector that attaches to the road lamp is exposed to water spray from the vehicles front tires. Even though the connector is sealed, water spray, in conjunction with wiring that may be pulled sideways, can attribute to water intrusion into the connector.

A backshell P/N AI 1326459 1 (same as 23-13304-622) can be added to the connector providing shielding from direct water spray, while also to indexing the wiring and providing strain relief for the wires enter the connector. See image below for the connector location and backshell image.

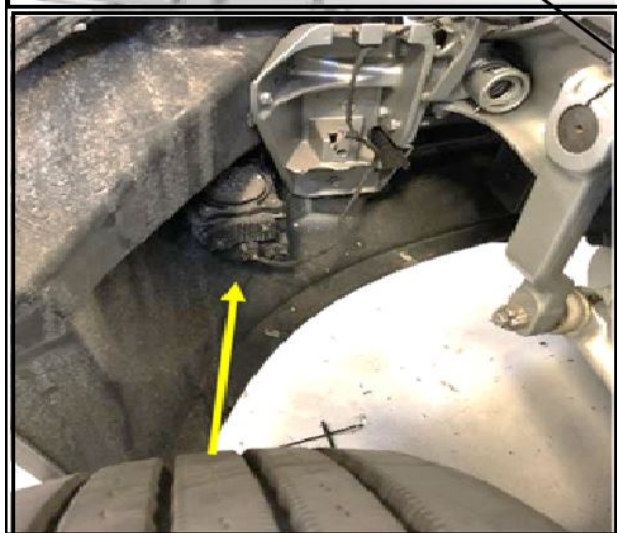
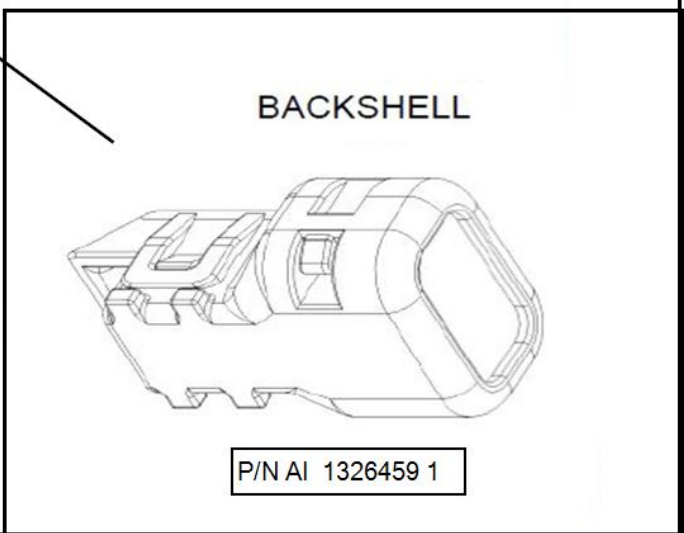
The P/N AI 1326459 1 backshell will install on the connector at each of the road lights (total quantity required 2). This extra protection and strain relief will provide better protection from water intrusion. The picture at the bottom left shows the direction of road spray from the front tire.
