Preliminary Information

PIP5712 Diagnostic Tip - Crankshaft Balancer Removal

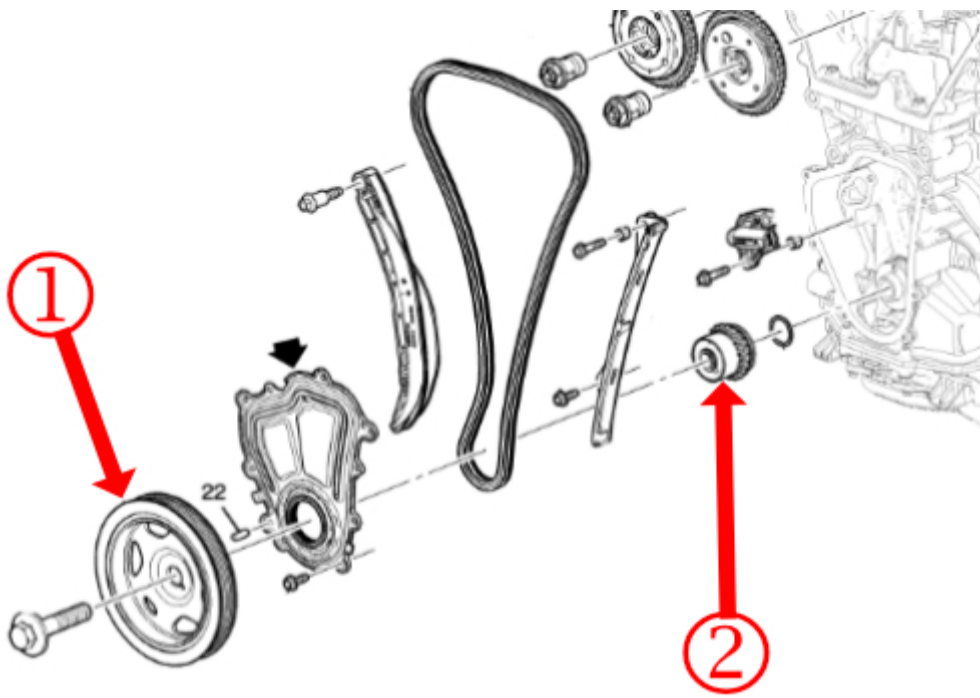
Involved Region or Country	North America
Condition	Crankshaft sprocket may disengage from crankshaft during Crankshaft Balancer removal.
Cause	Crankshaft sprocket may stick to the Crankshaft balancer during removal.

Anytime that the crankshaft balancer (1) is removed for service, be careful not to pull the crankshaft sprocket (2) off of the end of the crankshaft due to the balancer sticking to the sprocket.

Loosen the crankshaft balancer bolt a few turns and then strike the crankshaft balancer with a rubber mallet to separate the crankshaft balancer from the Crankshaft sprocket.

Caution: Do not rotate the crankshaft on these engines with the crankshaft balancer removed. The crankshaft balancer and bolt must be reinstalled to avoid damage to the crankshaft sprocket, crankshaft and valvetrain.

Once the two components are separated, proceed with repair / diagnosis.
