Preliminary Information

PIT4261F Tire Sidewall Irregularities

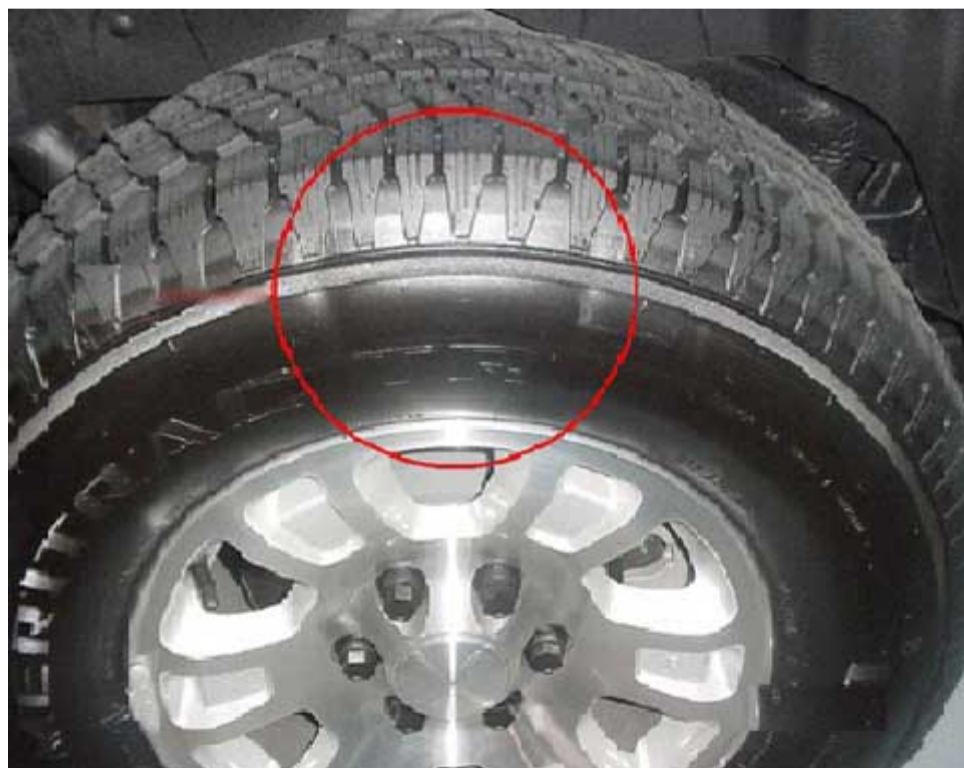
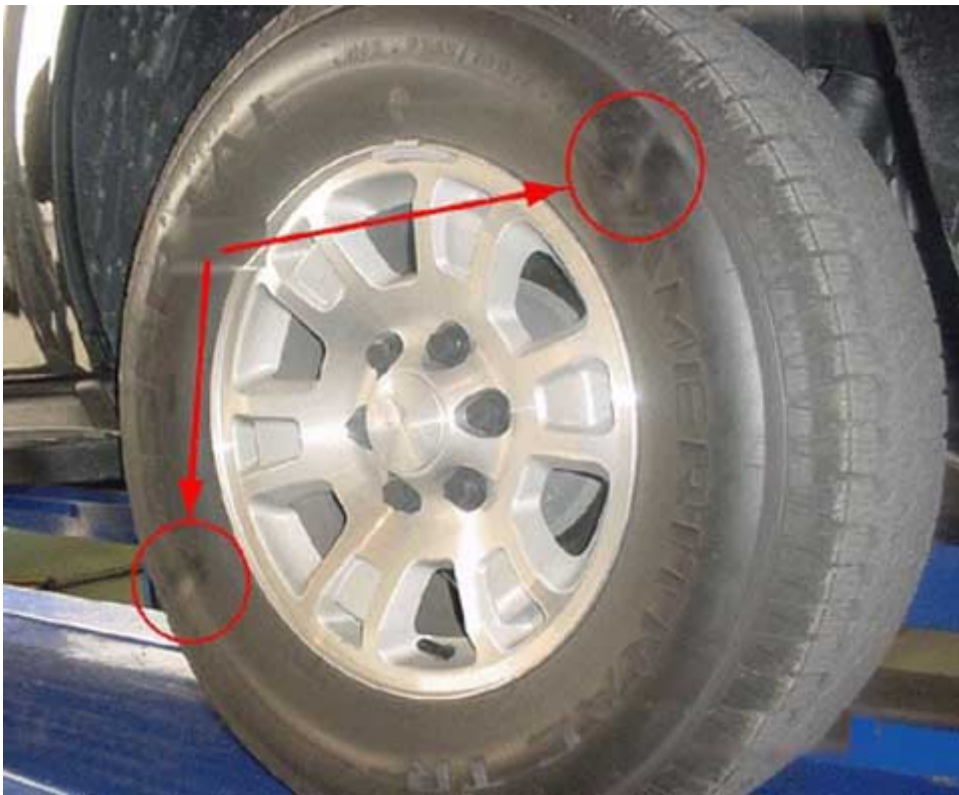
Slight sidewall indentations are a common characteristic of radial tire construction. These indentations are more noticeable on larger size tires having a larger side wall height. Radial tire body construction includes individual cords that run parallel to each other from bead to bead (down the sidewall, across the tread and up the other sidewall). These cords will overlap at points on the circumference of the tire. When the tire is mounted and inflated, it is free to naturally expand. The overlapped areas may create slight indentations, undulations, or protrusions since the stretching capacity of the overlapped area is slightly different than the rest of tire sidewall area.

The following two photo's show examples of tires with a sidewall indentation.

This is a visual condition that will not affect durability, reliability or performance of the tires. Tire replacement to address this condition is not recommended and will lead to customer dissatisfaction as the replacement tires will likely have the same or similar condition.
