PIT5657C Loose Shifter Lever / Poor Shift Actuation from Shift Lever / Shift to Park Message / Dead Battery

Product Investigation Review Required

Brand:	Model:	Model Years:	VIN:		Engine:	Transmissions:
			from	to		
Chevrolet	Silverado 1500 (New Model)	2019	All	All	All	All
GMC	Sierra 1500 (New Model)	2019	All	All	All	All

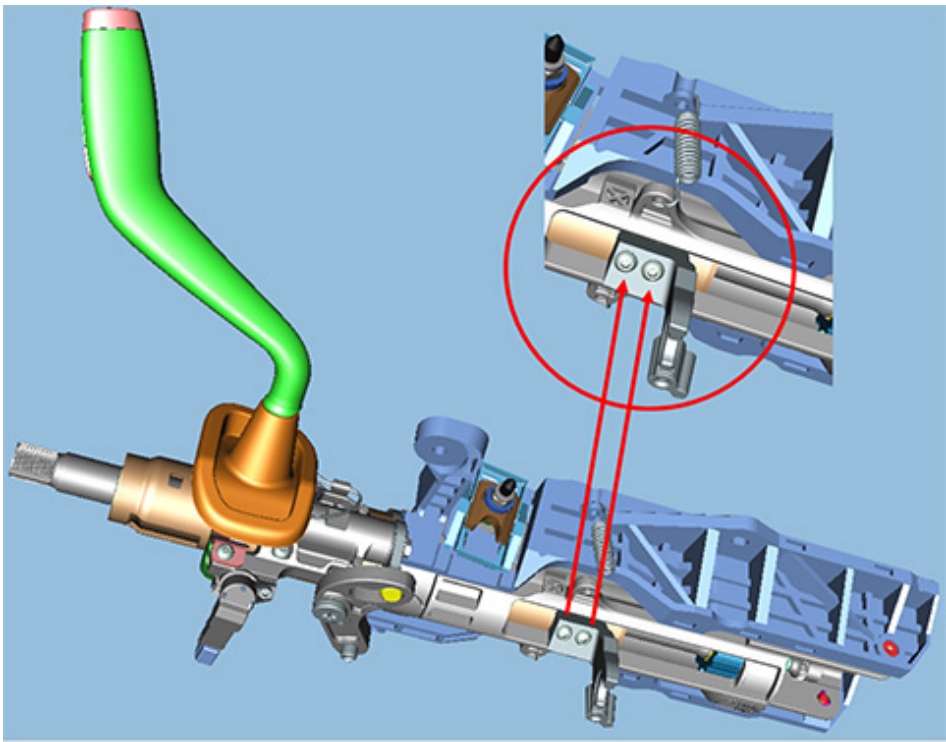
Involved Region or Country	North America
Condition	Some customers may comment of a loose shifter lever, poor shift actuation from the shift handle, and/or unable to shift to park. If the shifter will not go into park, the ignition will not turn off completely, which could cause a dead battery. Also, a "Shift to Park" message will be displayed on the DIC.
Cause	This concern could be caused by the shift cable bracket attaching bolts being loose, see picture below.

Note: Do NOT tighten these bolts, they are not serviceable.

Inspect the shift cable bracket attaching bolts for being loose. If the bolts are found to be loose, replace the steering column assembly. Do NOT tighten or replace these bolts, they are not serviceable.
