Preliminary Information

PIT5426C Second Row Seat Belt Wet And/Or Carpet Wet from the C-Pillar Area Rearward

Models

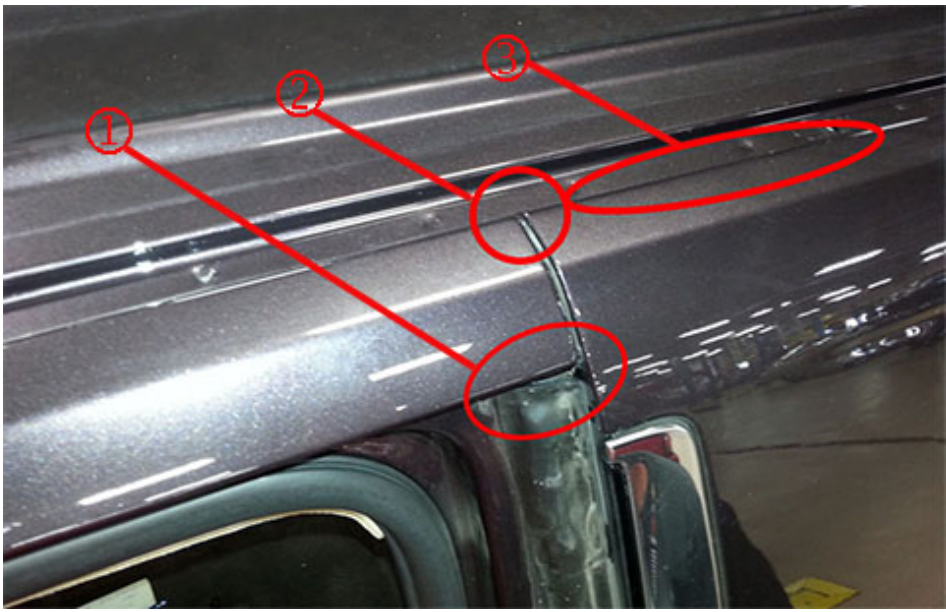
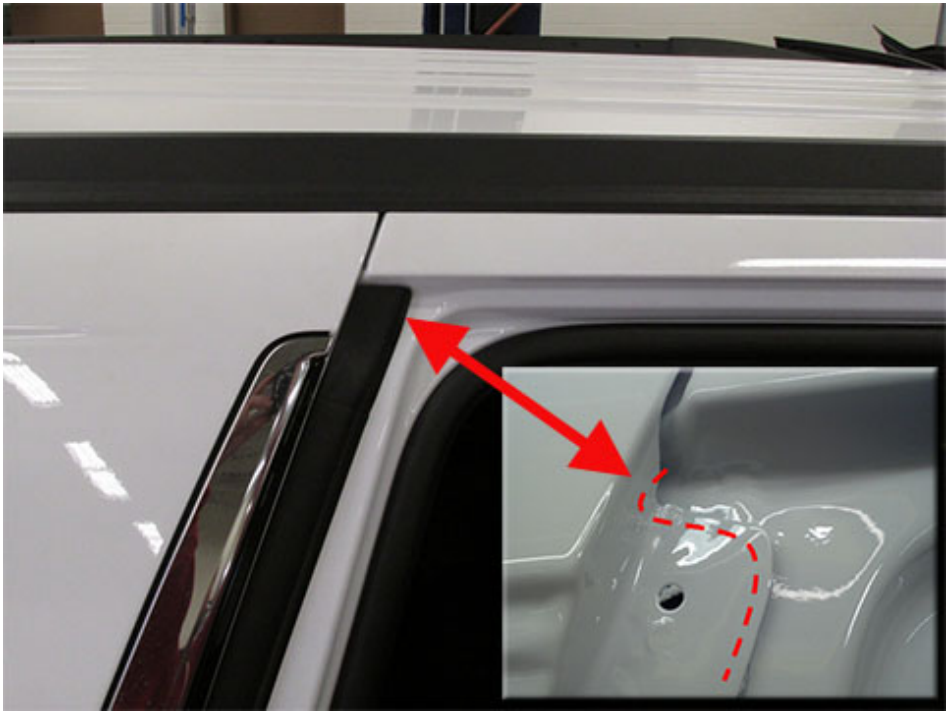
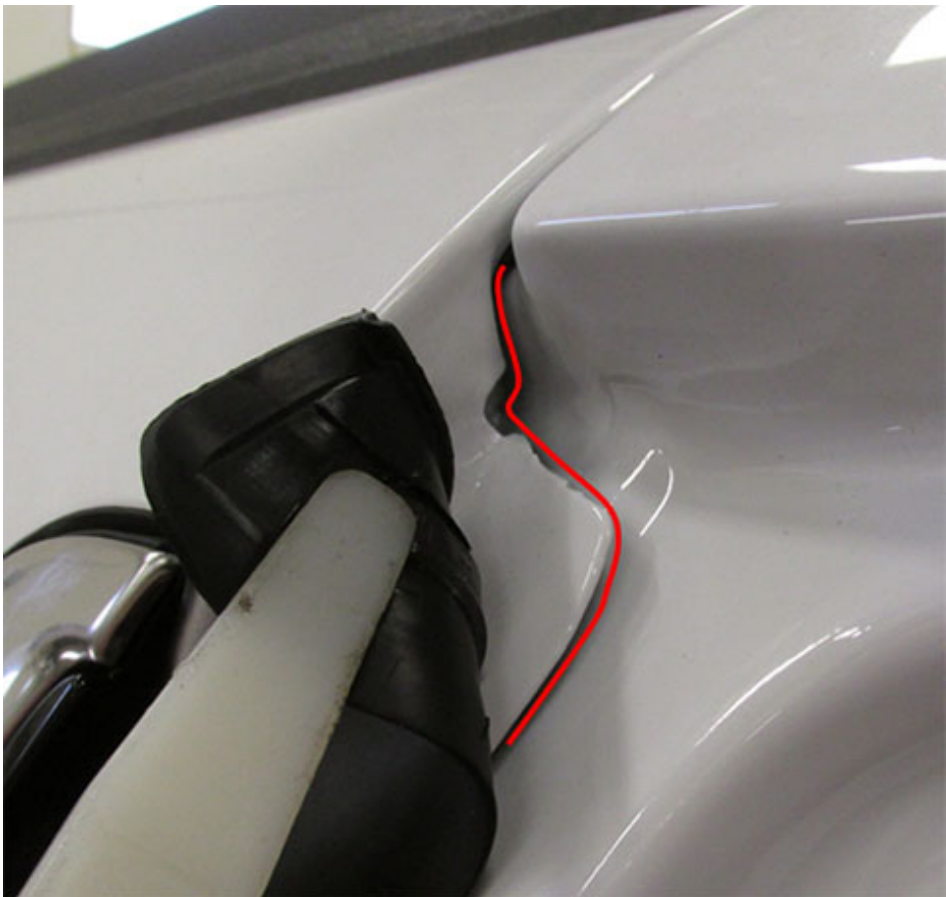
To correct the condition there are 3 areas of body seam sealer that needs to be addressed. Clear flowable seam sealer can be applied to the areas as shown in the pictures below. To allow for proper repair, the luggage carrier roof side rail on the affected side will need to be removed, (with pillar trim being repositioned and the headliner partially lowered for rail access), see SI for removal instructions.

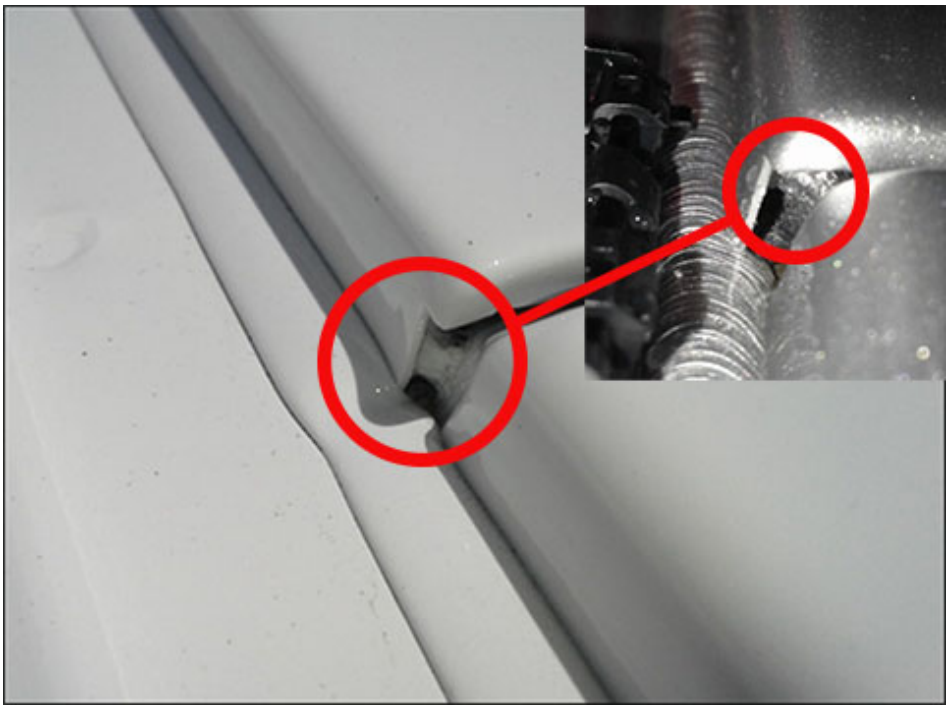
4 - With the quarter panel weather strip removed, inspect for clear seam sealer between the c-pillar and rear quarter panel (Area 1 as seen above).

5 - If seam sealer is not present, or if any gaps are found in the sealer, apply clear flowable seam sealer between the c-pillar and rear quarter panel sheet metal as shown per red line in picture.

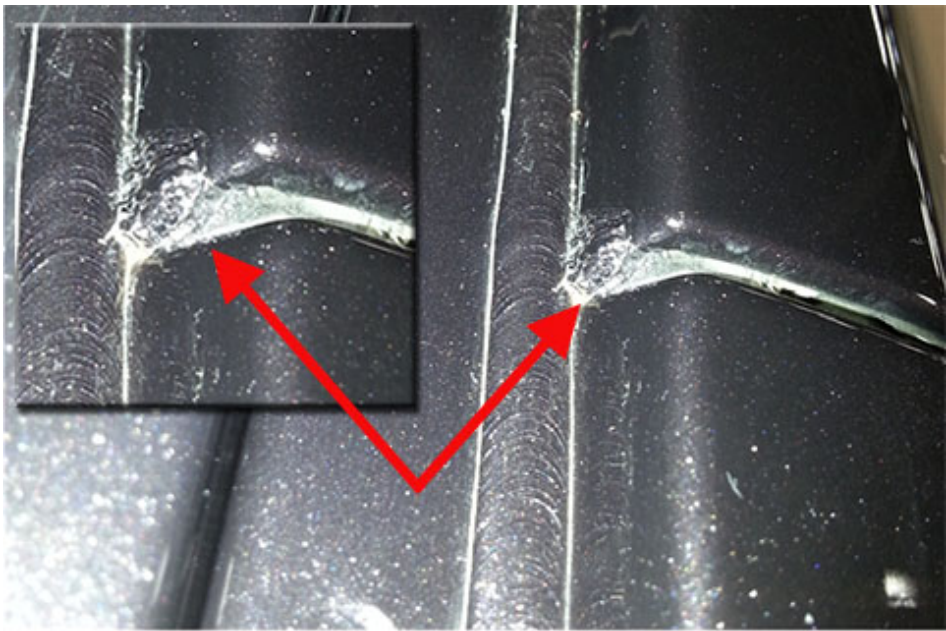
6 - With the roof rail removed on the affected side, inspect existing seam sealer in the area shown; door surround to quarter panel and roof panel (Area 2 as seen above) for skips or pin holes in the sealer.

7 - Fill any voids or pins holes found in the existing seam sealer with clear flowable seam sealer.

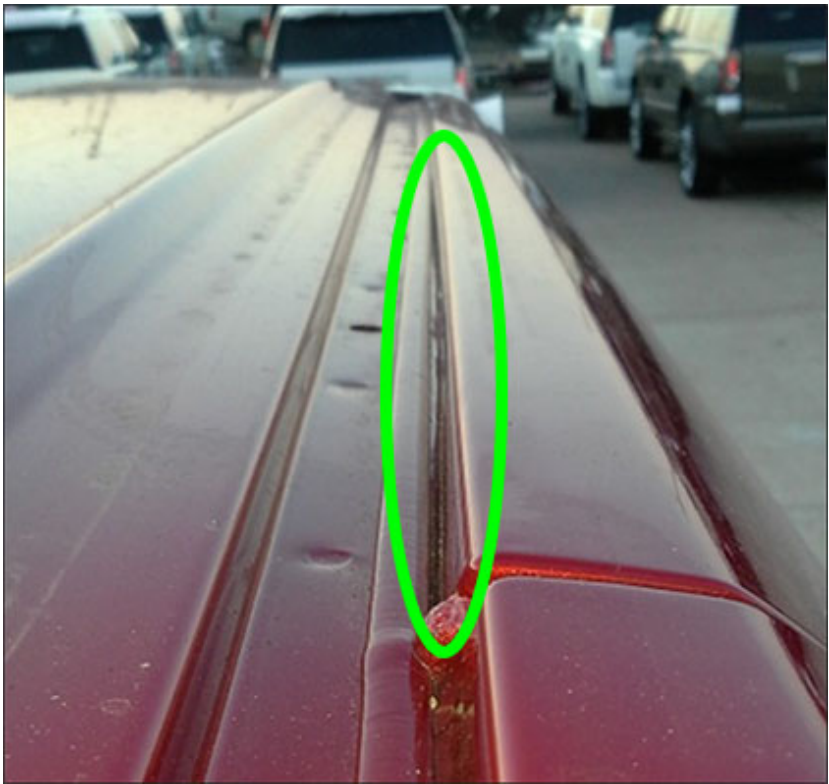
8 - With the roof rail removed on the affected side, inspect existing seam sealer in the area shown; quarter panel to roof panel (Area 3 as seen above) for skips or pull-away along the outboard edge.

9 - Apply clear flowable seam sealer along the rear quarter panel to roof seam as illustrated in picture above.
