Preliminary Information

PIT5700B Service Front Camera Message

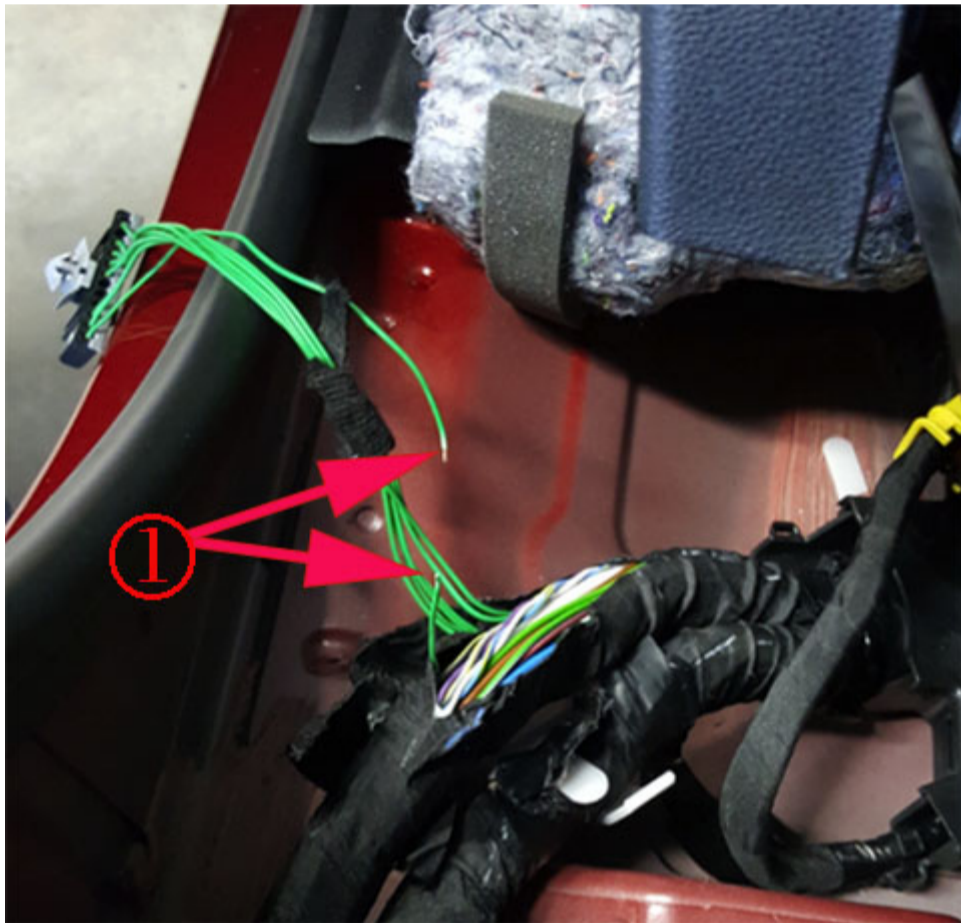
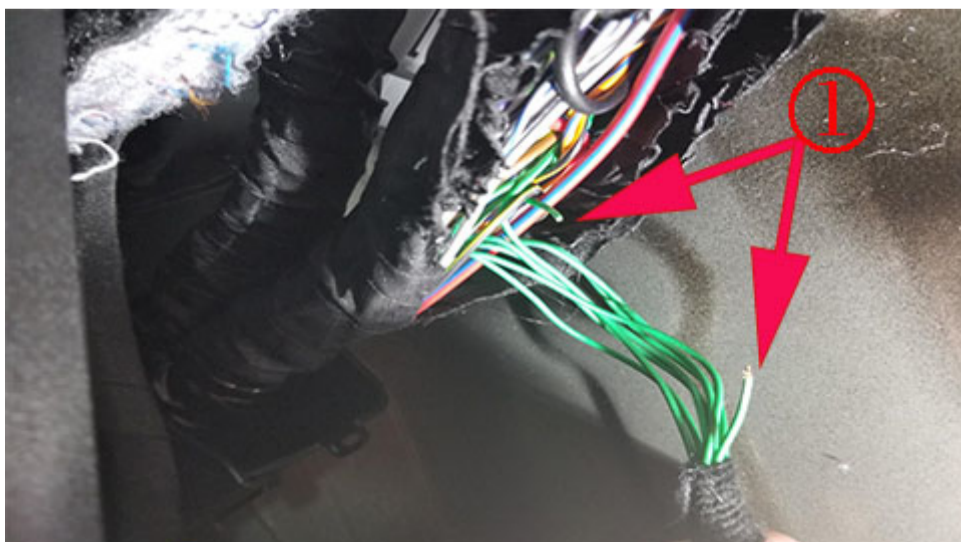
See # 1 below:

If it is found that the K124 ASCM is not communicating on low speed (with UGN) inspect circuit 5060 for an open in the harness near JX300.

On Blazer JX300 is located at the base of the B pillar.

On Acadia JX300 is located on the floor near the driver seat.

If an open is found repair the circuit following SI Serial Data Circuit Wiring Repairs.
