Preliminary Information

PIT5622B Diagnostic Tip Side Object Detection System Unavailable Message at Startup

Models

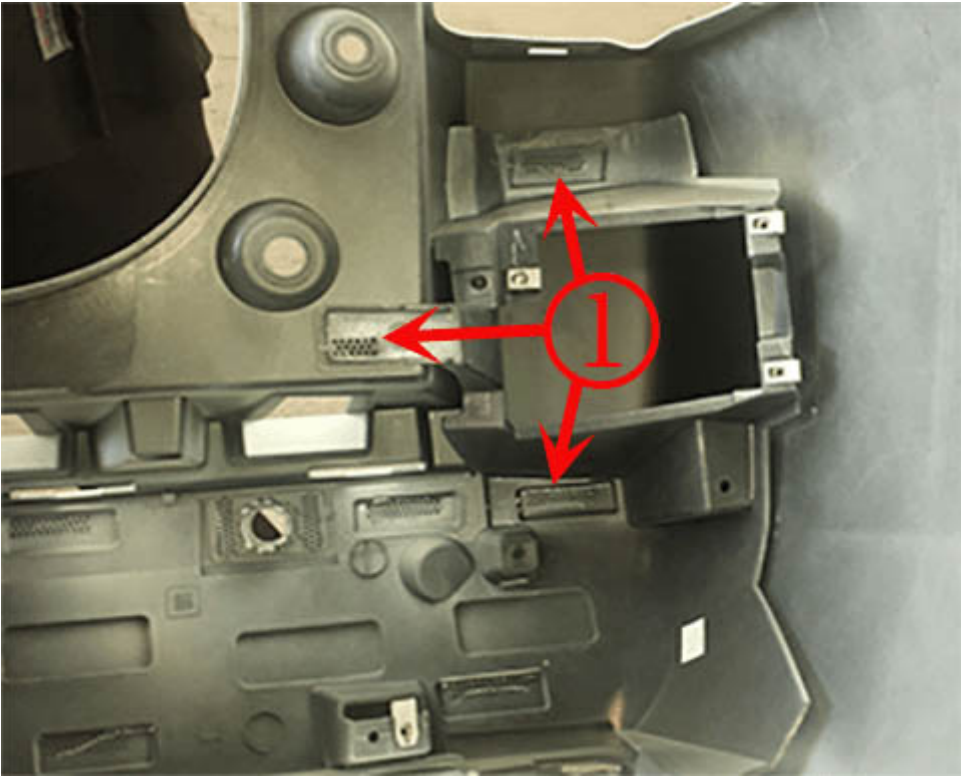
Perform a visual inspection of the Side Detection Modules, wiring, connectors and mounting brackets. The modules may need to be removed to inspect the mounting and brackets thoroughly. Look for anything broken/damaged/cracked, etc. Most importantly, inspect the heat staked areas (1) for becoming detached by lightly pulling on the bracket near the heat staked areas to make sure they are still attached. In the photo below is an example of a right hand Side Detection Module bracket, which has broken away at the top heat staked area (2). Also, inspect the brackets for being repaired or rebonded to the rear fascia (3) during a previous repair.

If any issues are found with the module mounting, mounting brackets, or rear fascia, replace as necessary.

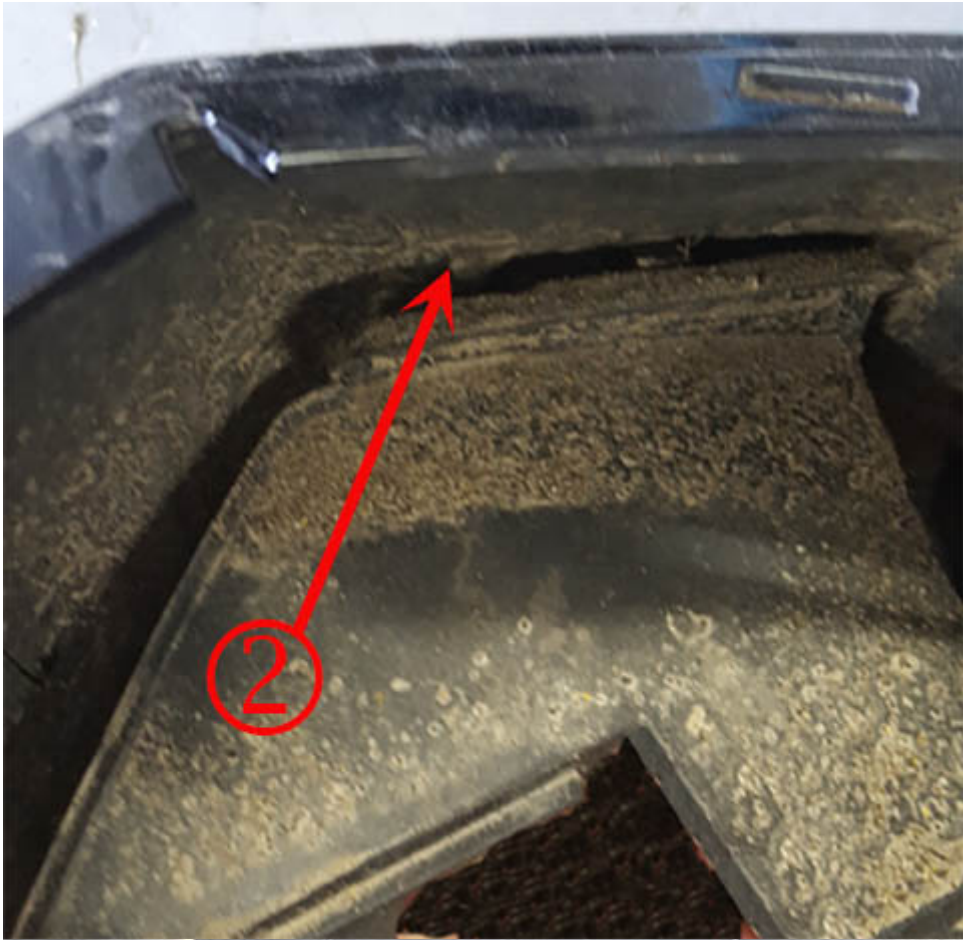
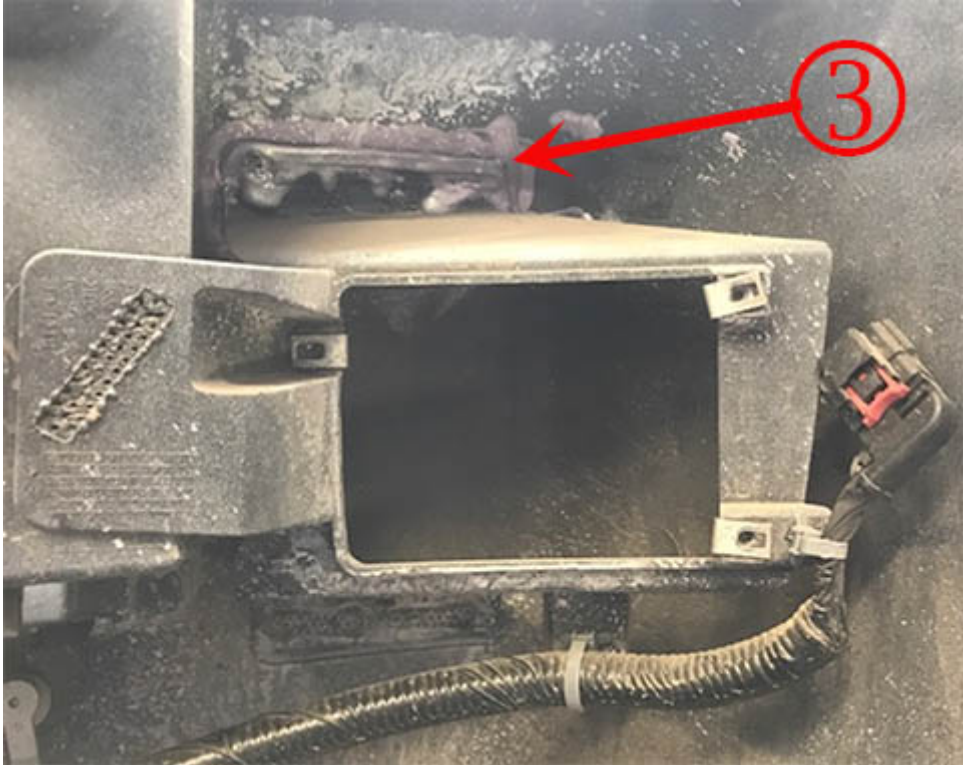
On later built models with lower mileage, if no issues are found with the fascia or mounting brackets, inspect the positioning of the mounting brackets where they are heat staked to the fascia. In some cases, the mounting brackets were heat staked to the fascia, in the incorrect position by the supplier. To inspect for this issue, remove the fascia from the truck and do a comparison between the left sensor mounting bracket position and the right sensor mounting bracket position. Also, the fascia will have alignment marks that can be used as a reference when inspecting the mounting bracket positioning to the fascia.

Even after the Side Detection Module mounting issue has been repaired, the module will not immediately know that it is now mounted correctly. This will still result in a "Side Detection System Unavailable" message at start up. Because it takes time for the Side Detection Module to learn that it is now mounted correctly, the only way to immediately clear the "Side Detection System Unavailable" message at start up is to replace and program the Side Detection Module on the side that originally had the mounting issue.
