Abnormal Buzz/Groan Noise at 20 - 30 mph From Front Transfer Case

YEAR(S)	MODEL(S)	ADDITIONAL INFORMATION
2019	RAV4

Some 2019 model year RAV4 Adventure and Limited grade AWD vehicles may exhibit an abnormal buzz/groan noise from the front transfer case at 20 – 30 mph when accelerating from a stop and/or at 20 – 13 mph on deceleration after driving the vehicle for 15 – 20 minutes or more. This condition occurs with Normal drive mode selected during disconnect/connect timing of the AWD system. Follow the Repair Procedure in this bulletin to address this condition.

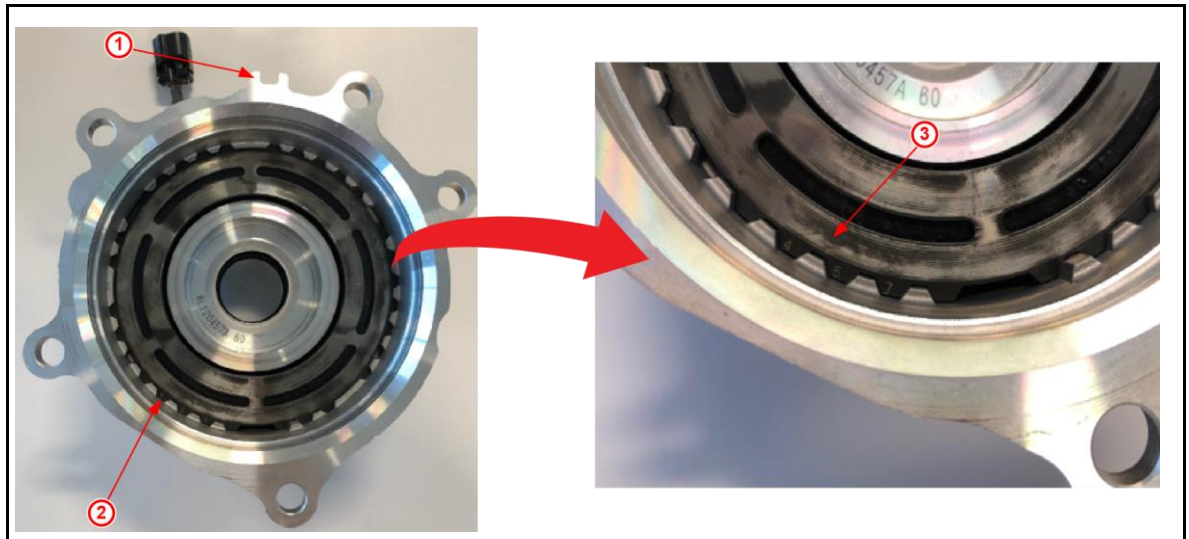
Figure 6.

- Engraved markings **MUST** be visible.
When installed, engraved markings (numbers) will face inward toward the front transfer case/transaxle.
- Outer plate is clocked correctly out of the box as NEW part (it is important to NOT remove the outer plate from the EMC cover).
The reason for NOT removing the outer plate is because it can be easily bent/damaged (there is no reason to handle outside of the cover).

1. Install the NEW front transfer case electro-magnetic clutch.
 - A. Make sure the outer plate is securely installed to the NEW front transfer case electro-magnetic clutch cover.

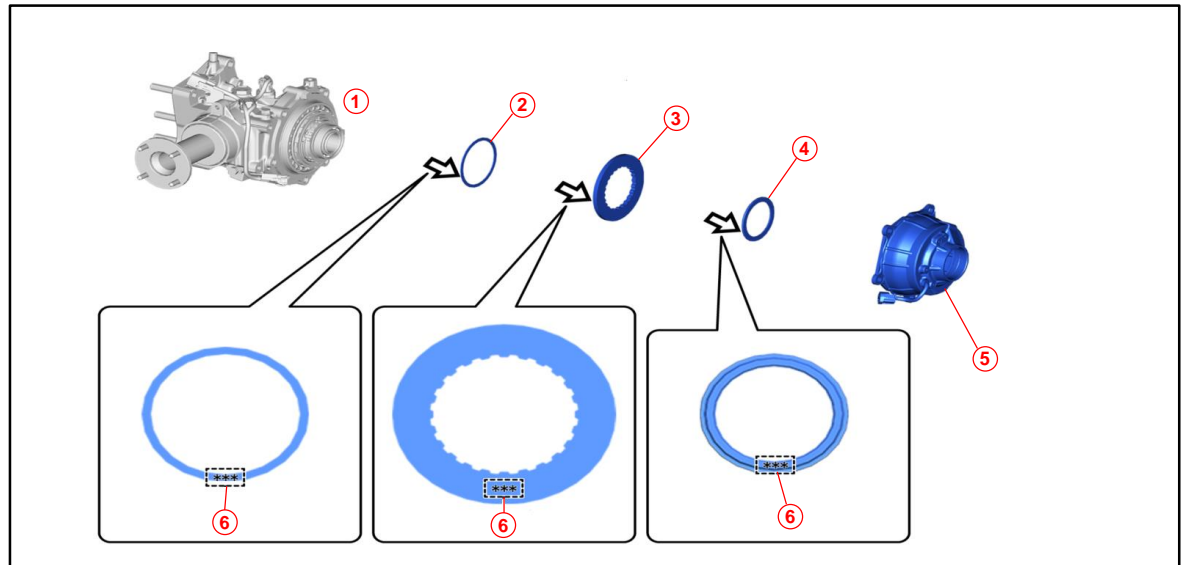
Figure 8.

A NEW shim, armature plate, and thrust roller bearing MUST be installed to the front transfer case with the engraved mark surfaces facing the vehicle inner side (automatic transaxle side). If engraved markings are visible AFTER installation of either shim, armature, and/or needle bearing, the customer may experience the same buzz/groan noise concern AFTER the repair. Ensure the engraved markings are NOT visible when installing these three components.

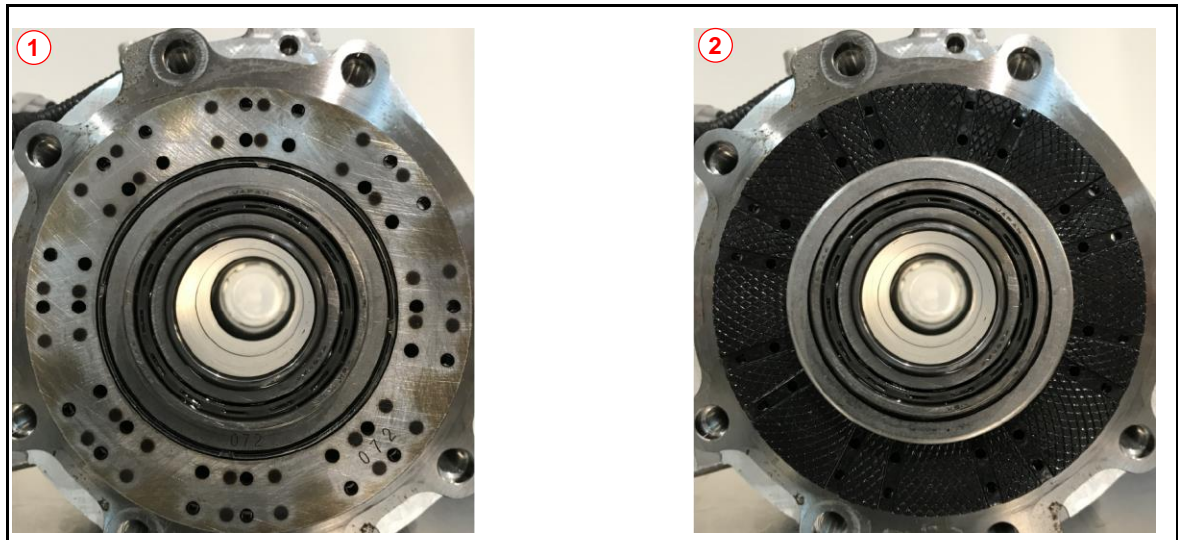
Figure 12. No Good vs OK Condition

AFTER proper installation, the engraved mark should NOT be visible.

1	No Good Condition
2	OK Condition

- E. Install the NEW thrust roller bearing to the front transfer case with its engraved mark surface facing the vehicle inner side (automatic transaxle side).
