# TIGER 900 BATTERY COVER FITTING - EXTRA PDI CARE POINT

**TOL NOTICE (US&CAN) – March 5, 2020**

**TOL Ref. # 13967-SVC**

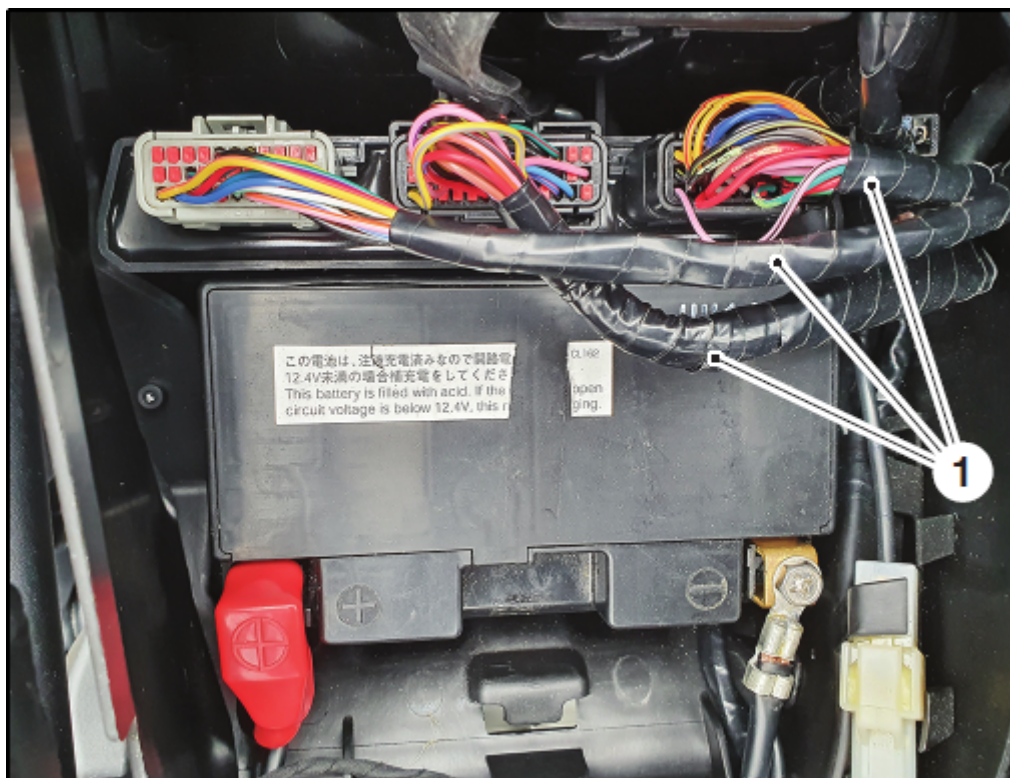
Examine the routing of the harness for the engine ECM. The image below shows the harness **loosely** routed. This can become trapped when you install the battery cover:
