GST Blackout Package Wheel Bumper/Fender Interference

Service Category: Suspension**Section:** Tire/Wheel**Market:** USA

Introduction

Some 2020 model year 4Runner vehicles equipped with GST installed wheels that are part of its Blackout Package (BA) may exhibit an abnormal noise when in Reverse with the wheels at or near full lock due to interference between the tire and bumper and/or fender liner. Follow the Repair Procedure in this bulletin to address this condition.

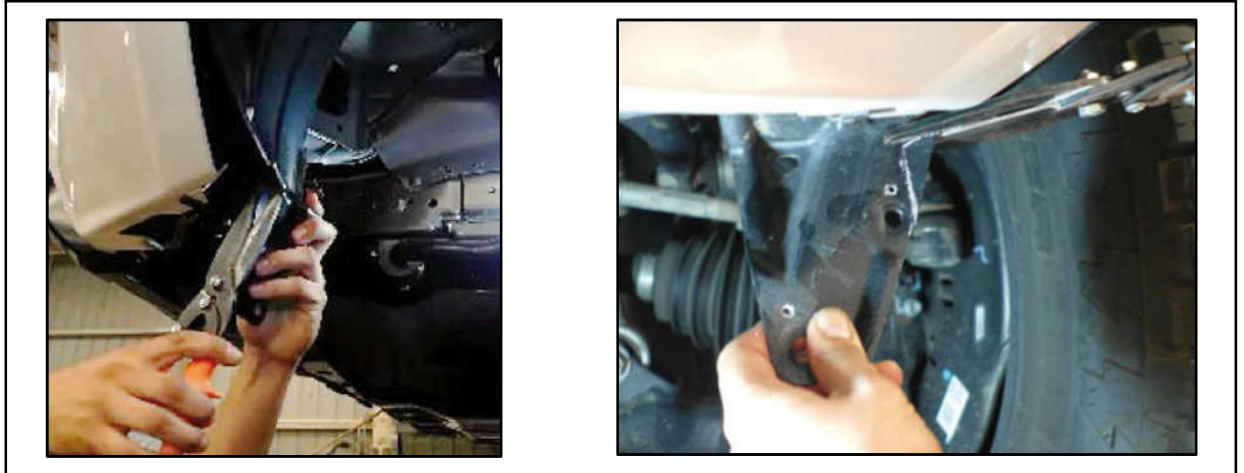
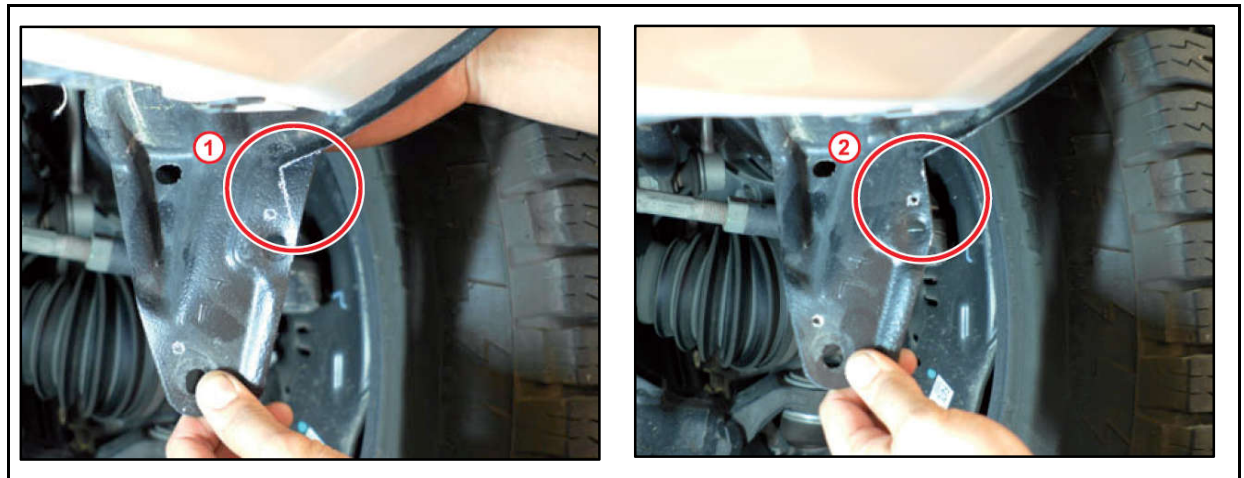
1	Before Cut
2	After Cut

- Using cutters, remove the marked plastic area as shown.
