MIL ON With DTC(s) P1C5F19 and/or P1C5D19 Causing Over-current Condition

Service Category Vehicle Interior

Section Meter/Gauge/Display

Market USA

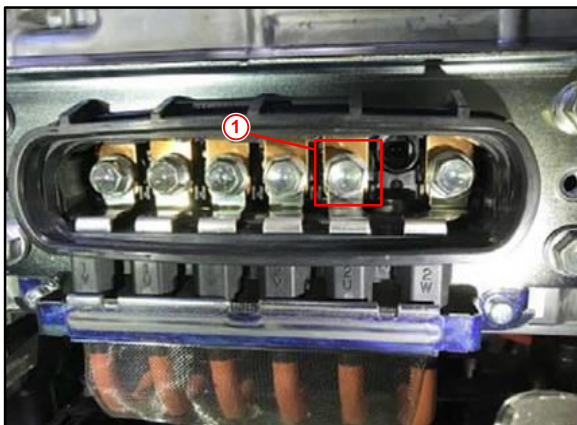
Figure 1. View of Terminals at the Inverter

1 Close-Up View of Terminal (See Figure 2)

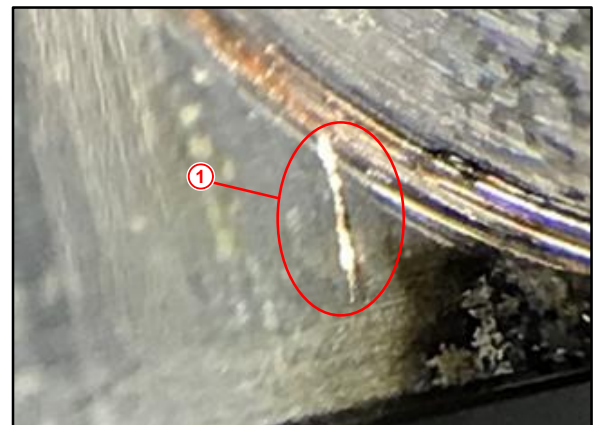
Figure 2. Close-Up View of Terminal

1 Debris Created From Bolt Tightening

Ensure correct fastening tools and torque are used when installing the MG cable. Over tightening can create additional debris.

3. Using compressed air, blow out ALL potential debris on the terminals and connections area of the inverter and transaxle. Visually confirm there is no debris present on terminals and connections area.

4. Reinstall the MG cable with NEW bolts into the transaxle assembly. Inverter bolts can be reused. Refer to TIS, applicable model and model year Repair Manual:
