Technical Service Bulletin

90 Instrument cluster: clinking or whirring noise during notification sounds

90 20 43 2059071/1 April 3, 2020.

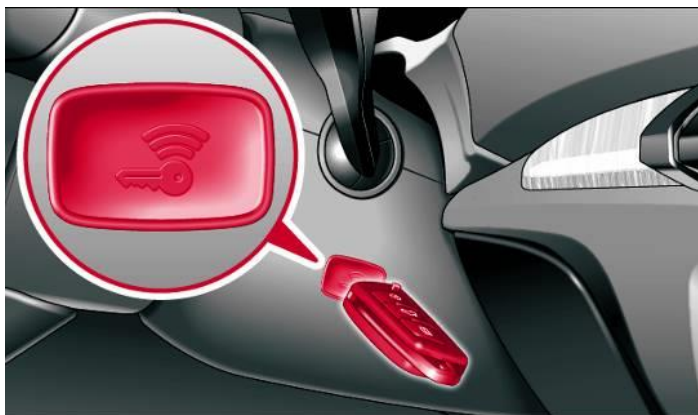
Figure 1. Key reader coil location.

2. Make sure that the vehicle's key is held or taped to the key reader coil (Figure 1) during the update process.
