#### 91 Sound system: A-pillar speaker rattle, vibration or poor audio reproduction

91 20 55 2059143/1 April 8, 2020.

Model(s)	Year	VIN Range	Vehicle-Specific Equipment
A6, A7	2019	All	Not Applicable

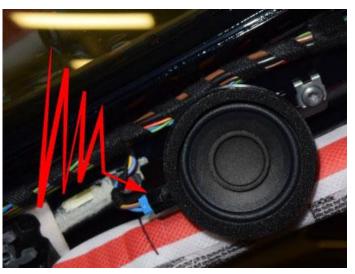
Tolerance between the speaker and harness connector is too high, creating unwanted vibration.

Verify that the noise is coming from the electrical connector at the A-pillar speaker (R276 or R277) (Figure 1).

**Figure 1.** Unwanted noise at the A-pillar speaker's electrical connection.

- 2. Ensure fasteners are properly torqued to 3.0Nm.
- 3. Update connector at speaker with improved connector 4B0 971 832 A.
