Technical Service Bulletin

91 MIB1 Audi connect and Online Services are inoperative with the SIM not recognized

91 20 56 2045723/4 April 9, 2020. Supersedes Technical Service Bulletin Group 91 number 17-52 dated September 25, 2017 for reasons listed below.

Model(s)	Year	VIN Range	Vehicle-Specific Equipment
A3	2015 - 2016	All	MIB High with Audi connect

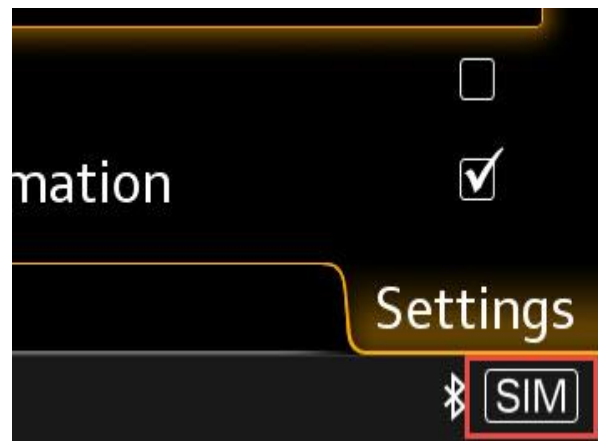
The customer states that there are no online services available via the inserted SIM card. The inserted SIM card cannot be recognized by the MMI (Figure 1).

Figure 1. SIM is not recognized.

The internal USB port for the phone module does not initialize. Therefore the phone module is not recognized in the information electronics control module 1, J794 (address word 005F), and as a result, any SIM inserted into the MMI cannot be utilized.

If it is determined the customer's SIM card and Audi connect subscription are okay, and the SIM cannot be recognized in the customer's MMI, then the telephone module must be replaced in the MMI.

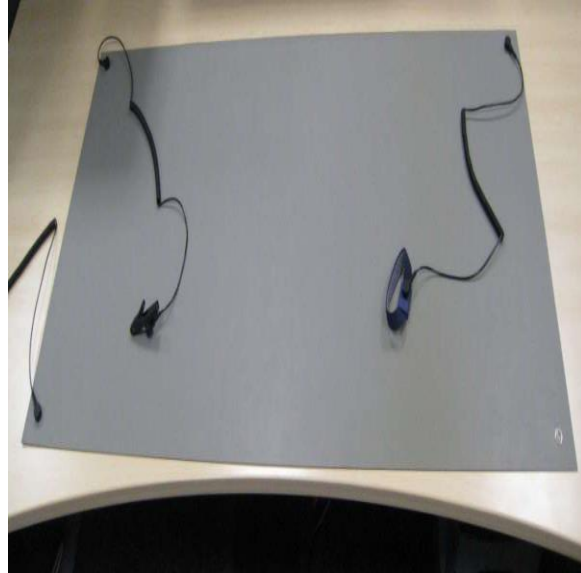
Figure 3. ESD work surface.

2. Remove the information electronics control module 1, J794 (address word 005F) from the vehicle according to the Elsa repair manual.
3. Place the ESD work-bay VAS 6613 in an area free of dirt and dust (Figure 3).

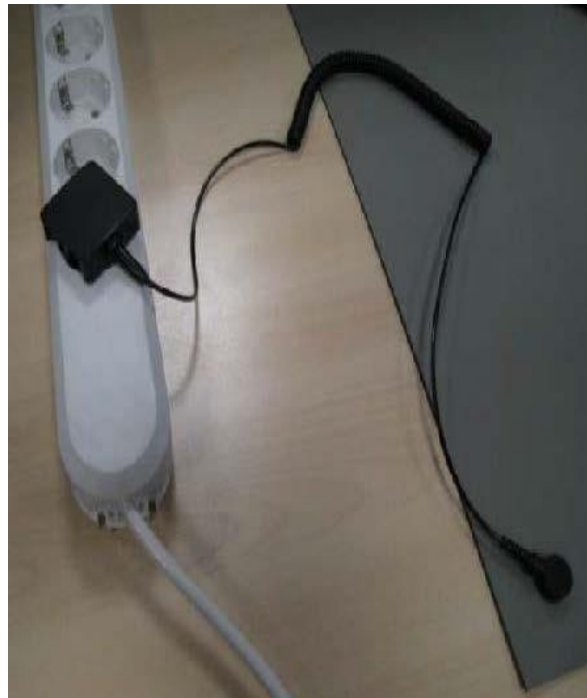
Figure 4. Grounded ESD work surface.

4. Connect the plug of the ESD work-bay to the grounding outlet (Figure 4). If necessary, observe the work-bay instructions provided in the VAS 6613 kit.

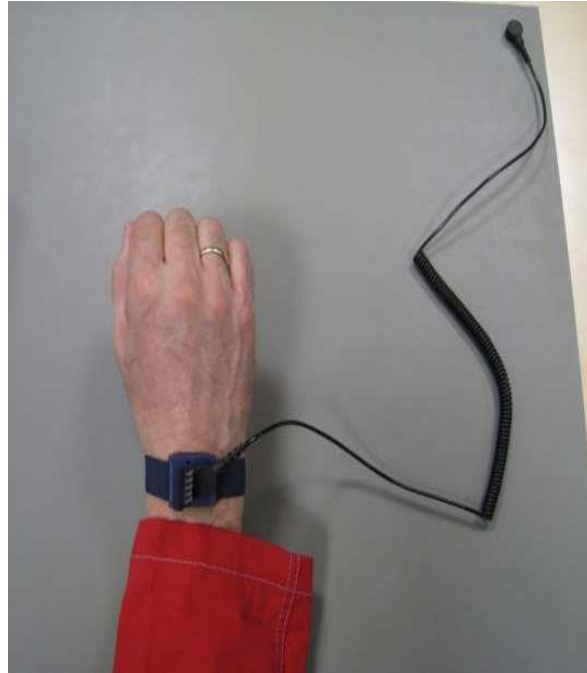
Figure 5. Human ground strap.

5. Attach the grounding strap (loop) of the ESD work-bay to your wrist (Figure 5).

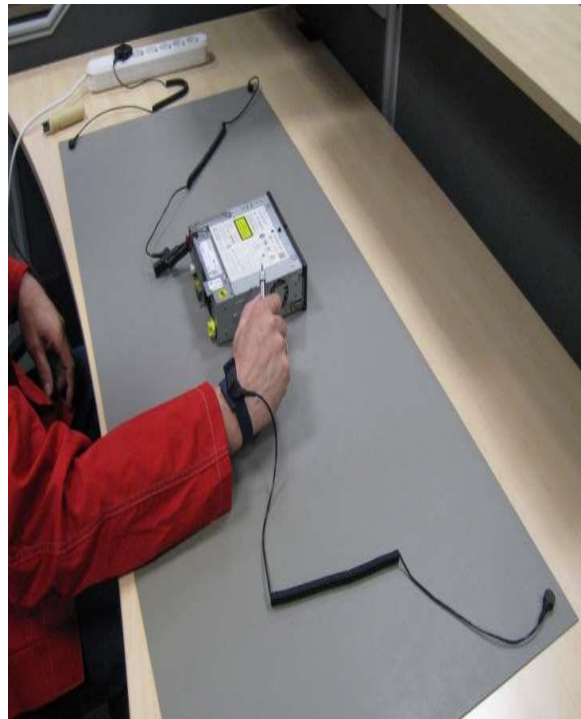
Figure 6. ESD complete setup.

6. Place the removed information electronics control module 1, J794 (address word 005F) on the ESD work-bay (Figure 6).

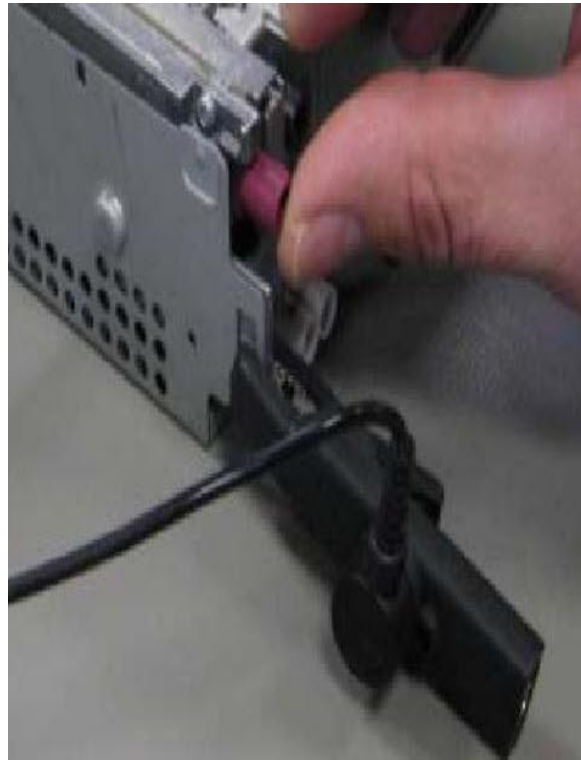
Figure 7. Alligator clip on the MMI housing.

7. The housing must also be grounded with the alligator clip (Figure 7).

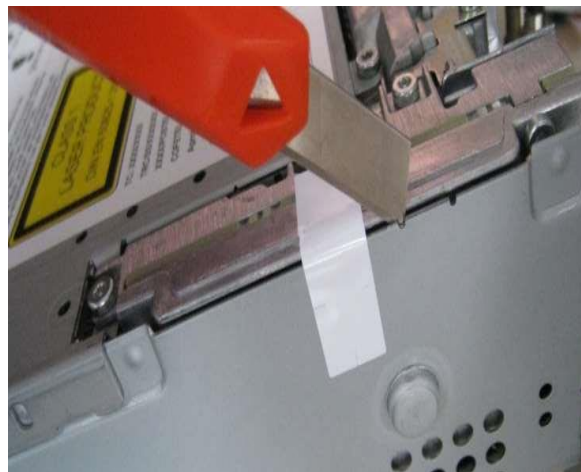
Figure 8. Warranty seal.

8. Cut through the seal of the unit using the utility knife (Figure 8).

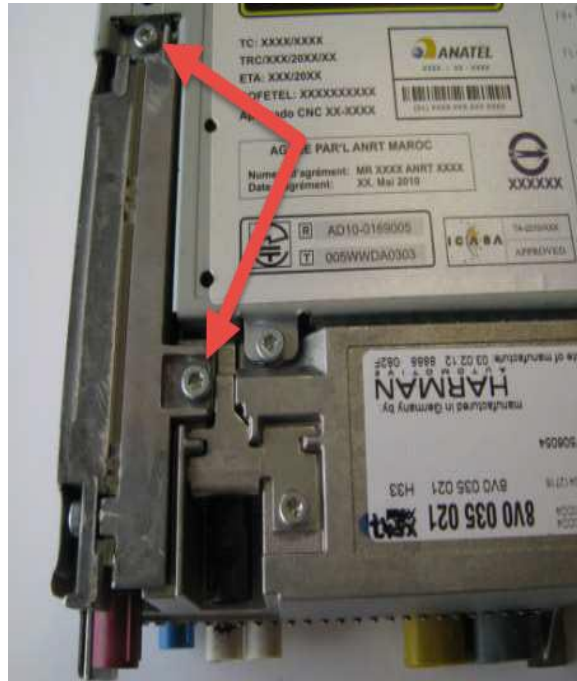
Figure 9. Telephone module screws.

9. Remove the two screws holding the telephone module (arrows in Figure 9).

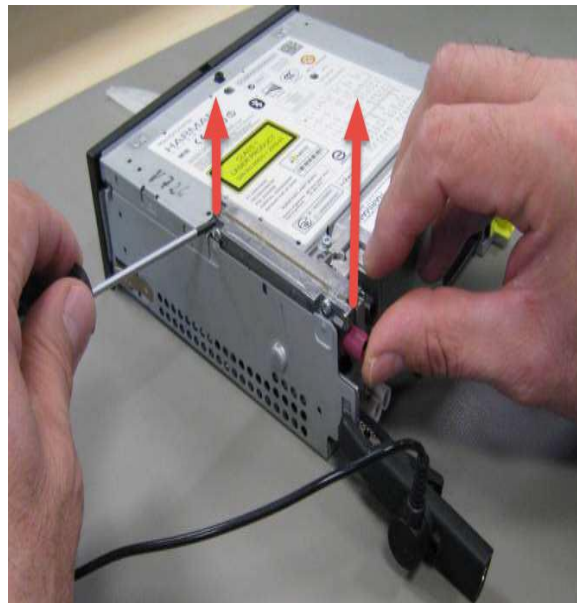
Figure 10. Lift up on both ends.

10. Lift the phone module on the inner end in the direction of the arrow and at the same time on the outer end (Figure 10).

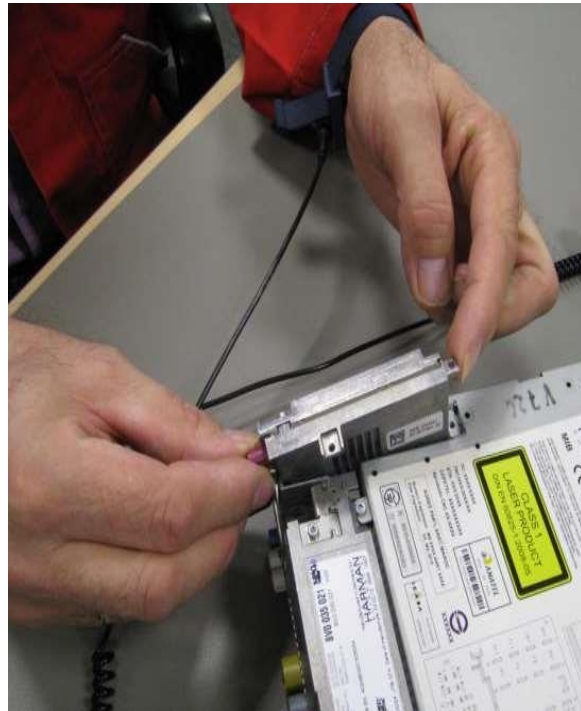
Figure 11. Remove the top out first.

11. Completely take out the phone module towards the top (Figure 11).

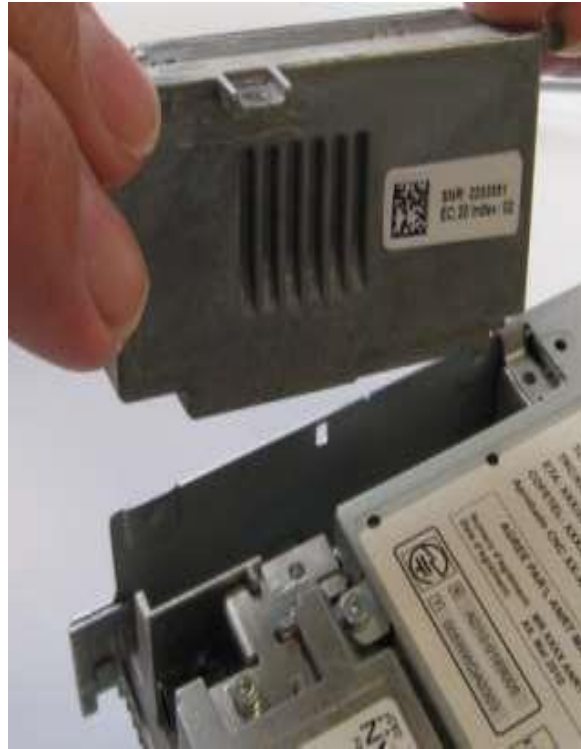
Figure 12. Insert the new telephone module.

12. Place the new phone module downwards into the channel and carefully press in the contacts (Figure 12).

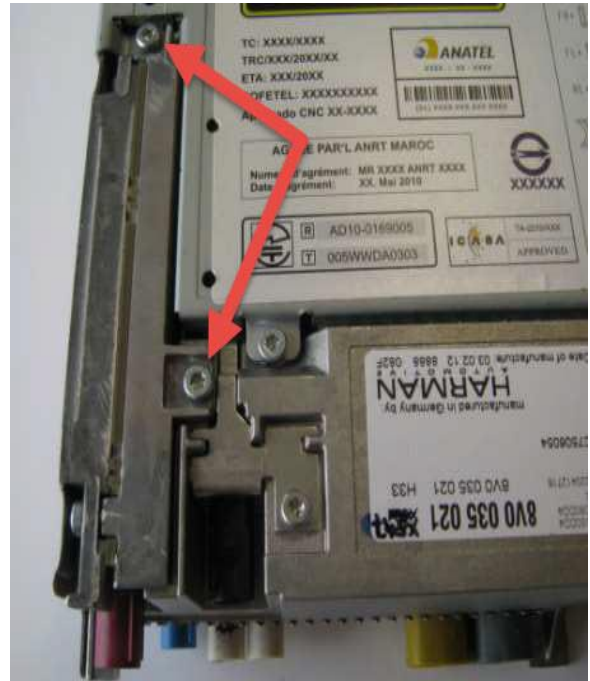
Figure 13. Do not over-torque screws.

13. Slightly tighten the module with the supplied screws (arrows in Figure 13).

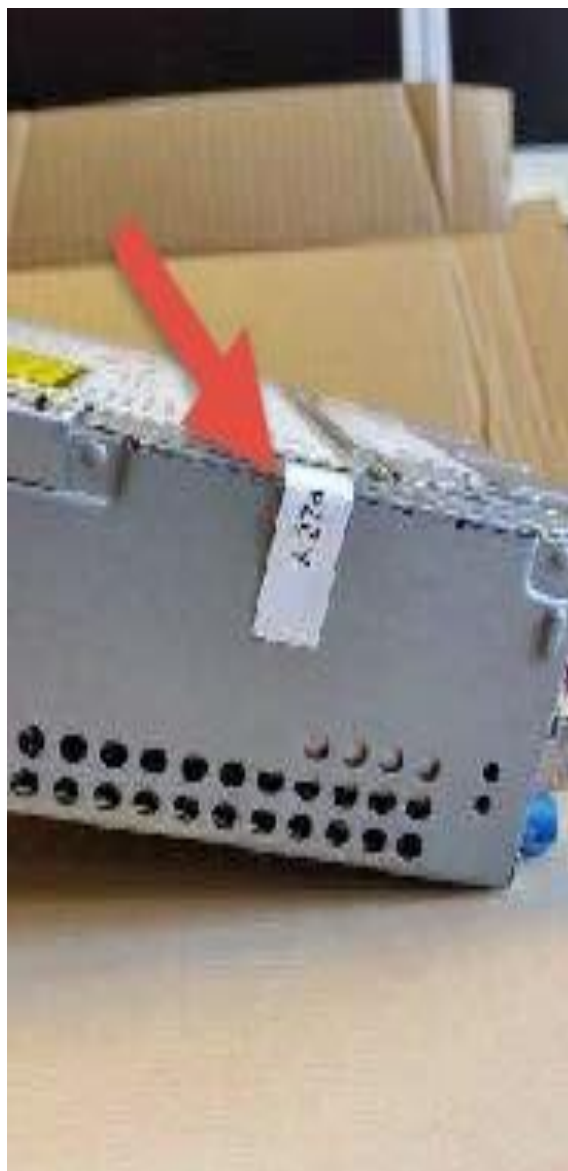
Figure 14. Apply a new warranty label.

14. Stick the supplied repair sticker with the label - A 274 - on the information electronics control module 1, J794 (address word 005F) (Figure 14).
