Technical Service Bulletin

92 Rear view camera washer operates with difficulty

92 20 26 2059228/1 April 10, 2020.

Model(s)	Year	VIN Range	Vehicle-Specific Equipment
Audi e-tron quattro	2019 - 2021	All	Not Applicable

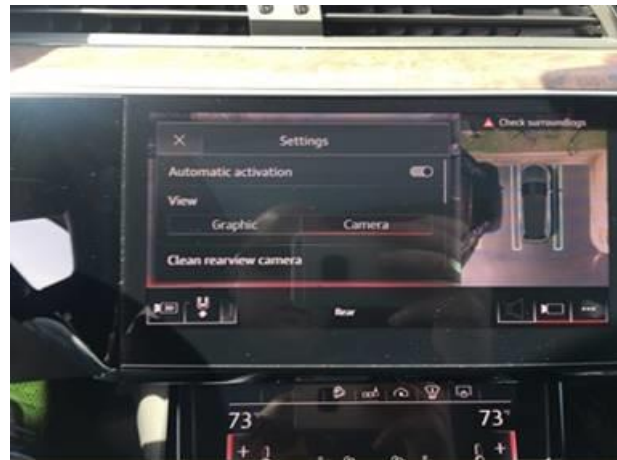
- When the 'clean rearview camera' function is activated, the washer fails to spray solvent (Figure 1).
- The function must be activated several times before the solvent is sprayed.

Figure 1. Clean rearview camera function being displayed.

Because of the absence of a check valve in the washer solvent circuit to the rearview camera washer jet, the delivery tube for the solvent loses its prime during driving or the opening of the rear lid. The rearview camera washer system is designed to cancel additional wash cycles after 4 activations to conserve washer solvent and prevent unnecessary solvent use. Because 4 activations are insufficient to fill and pressurize the washer solvent circuit the rearview camera cannot be cleaned until the KL15 circuit is cycled (ignition key cycle).

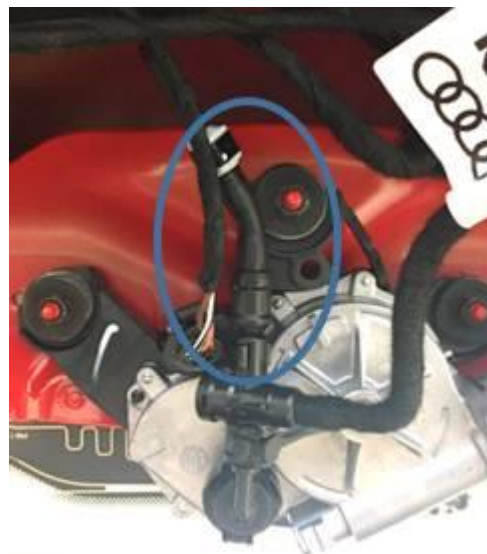
Figure 3. Check valve assembly installed.

2. Fit the 4N0 955 481 A valve end of the assembly to the 'T' section of the manifold and the 5M0 955 875 coupling piece end to the removed washer line as shown in the illustration. It should now be installed in-line with the original assembly (Figure 3).

4. Activate the rearview camera washer several times to purge the air in the washer solvent circuit and fill the line.
