Technical Service Bulletin

97 Car jerks/bucks or hesitates while driving DTCs P023400, P023500, P023600, P023700, and P023800 are stored in the ECM

97 20 73 2058976/2 April 10, 2020. Supersedes Technical Service Bulletin Group 97 number 20-71 dated March 19, 2020 for reasons listed below.

Model(s)	Year	VIN Range	Vehicle-Specific Equipment
Q5	2018 - 2020	All	2.0 liter

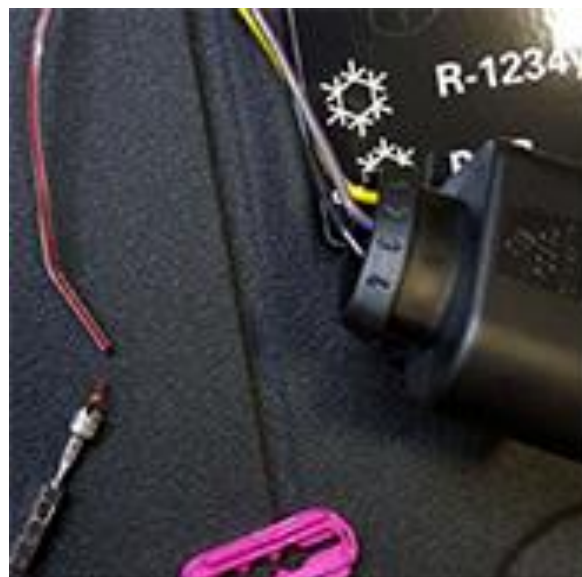
One of the pins or wires at the boost pressure sensor (G31) connector T4e may be backed out or broken due to the routing concept of the engine harness. When inspected, the harness is found to be too tight in the area of the sensor.

Figure 1. T4e with damaged wire.

If there is damage to the pins or wire, repair the harness as needed (Figure 1). Ensure there is sufficient slack in the harness to prevent future issues.
