FLA COE
 FLB COE
 FLD Conventional
 Business Class
 FLC 112 Conventional

General Information

Freightliner
Service Bulletin

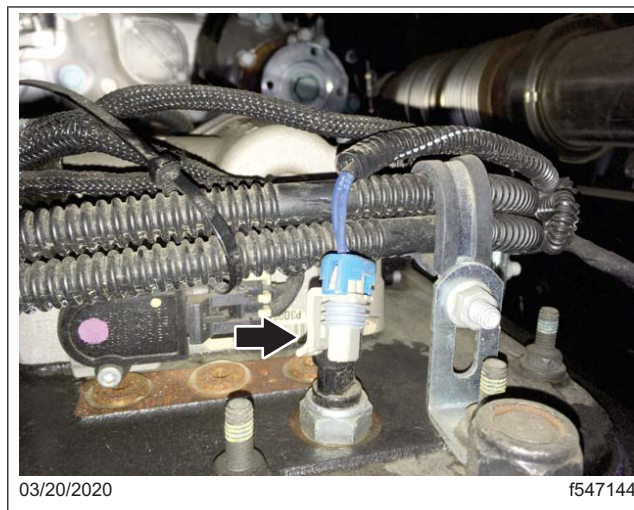
Fig. 1, Connector Unplugged

Though the backup light harness is long enough to connect to the backup light switch, it may be short enough that the wire seals in the connector can be stressed. Moisture entering through the seals can cause corrosion, resulting in a bad connection and/or failure of the switch.

As a result, backup lights and, if equipped, the backup alarm, may not function when the vehicle is shifted into reverse.

1. Park the vehicle on a level surface, apply the parking brakes, and shut down the engine. Chock the tires.
2. Disconnect the batteries.
3. Locate the backup light switch on the transmission and, as needed, remove the clipping points for access. Unplug the connector from the backup switch. See [Fig. 1](#).

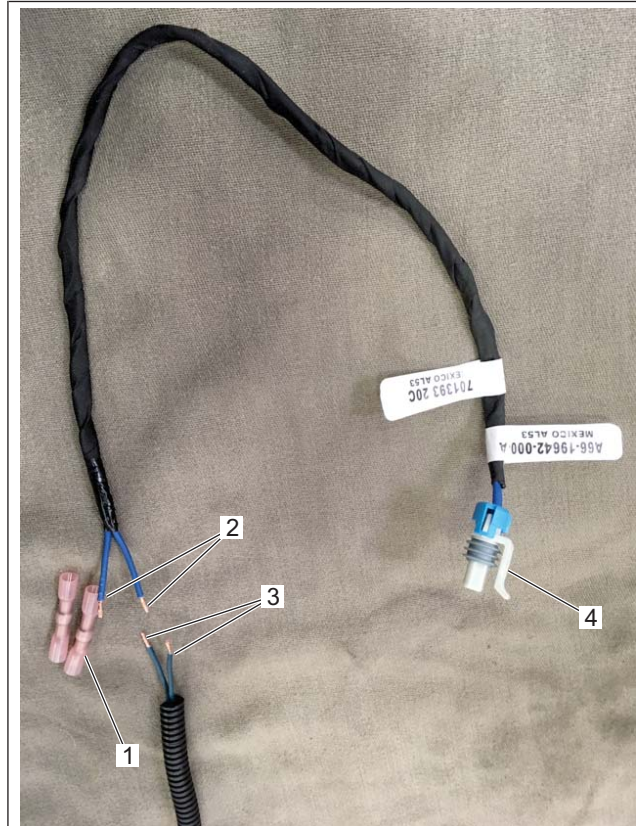
Fig. 2, New Light Switch Jumper Harness

1. STA-DRY Butt Connectors
2. Stripped Wires on Light Switch Jumper Harness (A66-19642-000)
3. Stripped Wires on Old Harness
4. Light Switch Jumper Harness (A66-19642-000)

4. Cut off the backup harness connector where the wires enter the connector. See [Fig. 2](#).
