Business Class M2  
Cascadia  
108SD/114SD  
> New Cascadia

**Freightliner  
Service Bulletin**

## General Information

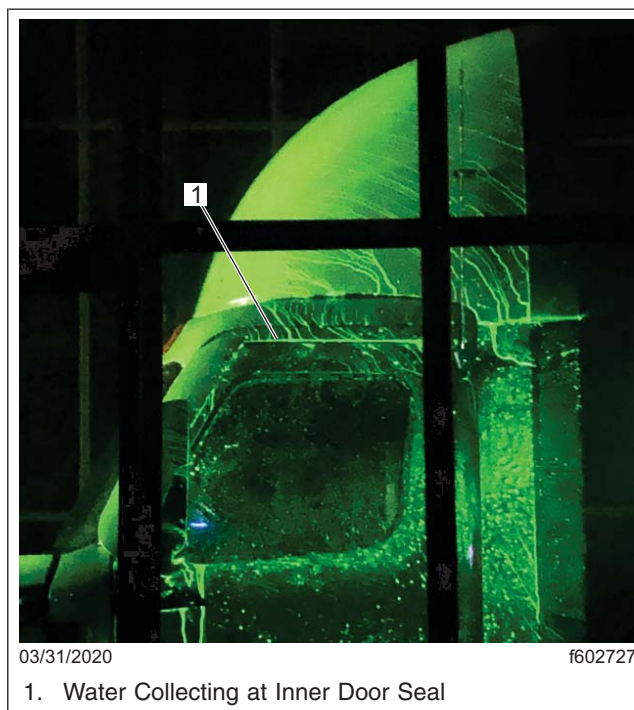
**Fig. 1, Wind Tunnel Water Pattern**

New Cascadia day cab vehicles with roof fairings may experience minor water leaks through the upper door seals. See [Fig. 1](#).

This issue can be minimized by regularly wiping down the door seals to keep them free of road grime. See [Fig. 2](#) for an example of road grime collection from water leaking through the upper door seals.

A rain gutter seal can also be installed above each door using a Cascadia tertiary seal (part number 18-63286-002).
