Business Class M2
 > Cascadia
 108SD/114SD
 > New Cascadia

**Freightliner
 Service Bulletin**

60-167

Draining Water Trapped in the Upper A-Pillar

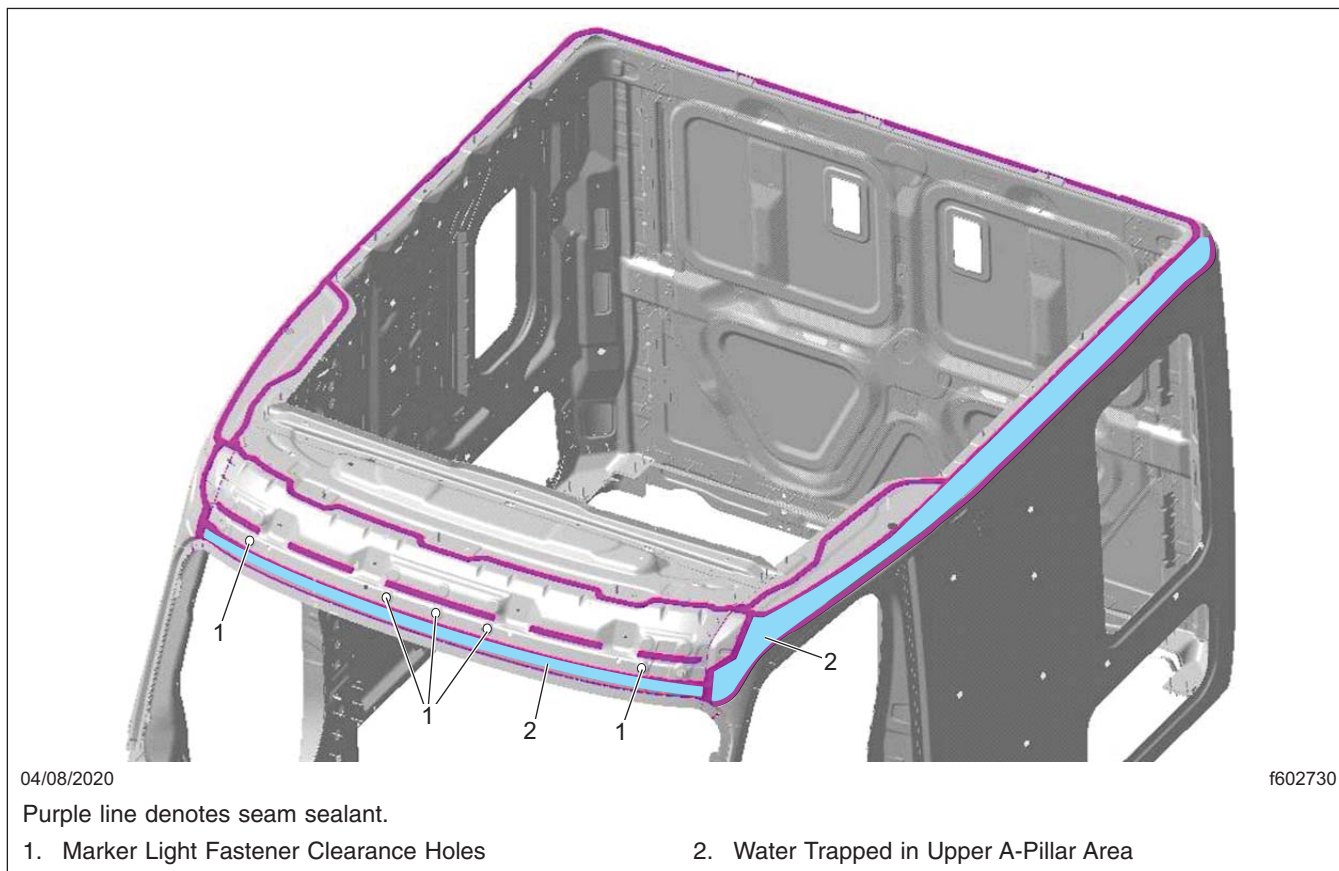
Fig. 1, Water Collection Areas and Paths Into Cab

A water leak in the seams between the cab roof and cab side wall or back wall can result in water becoming trapped in the upper A-pillar area in some Cascadia and New Cascadia vehicles. This water may migrate inside the cab and eventually spill through the marker light fastener clearance holes and drip on the dash. See [Fig. 1](#).

If water is dripping on the dash and no other leaks can be found, follow these instructions to check for and drain the collected water and create a path to drain any future water intrusion.
