Technical Service Bulletin: TSB200054

Released Date: 27-Mar-2020

**New Exhaust Gas Recirculation (EGR) Temperature Sensor Connector Back Shell:
Fault Codes 2375, 2376, and 1867**

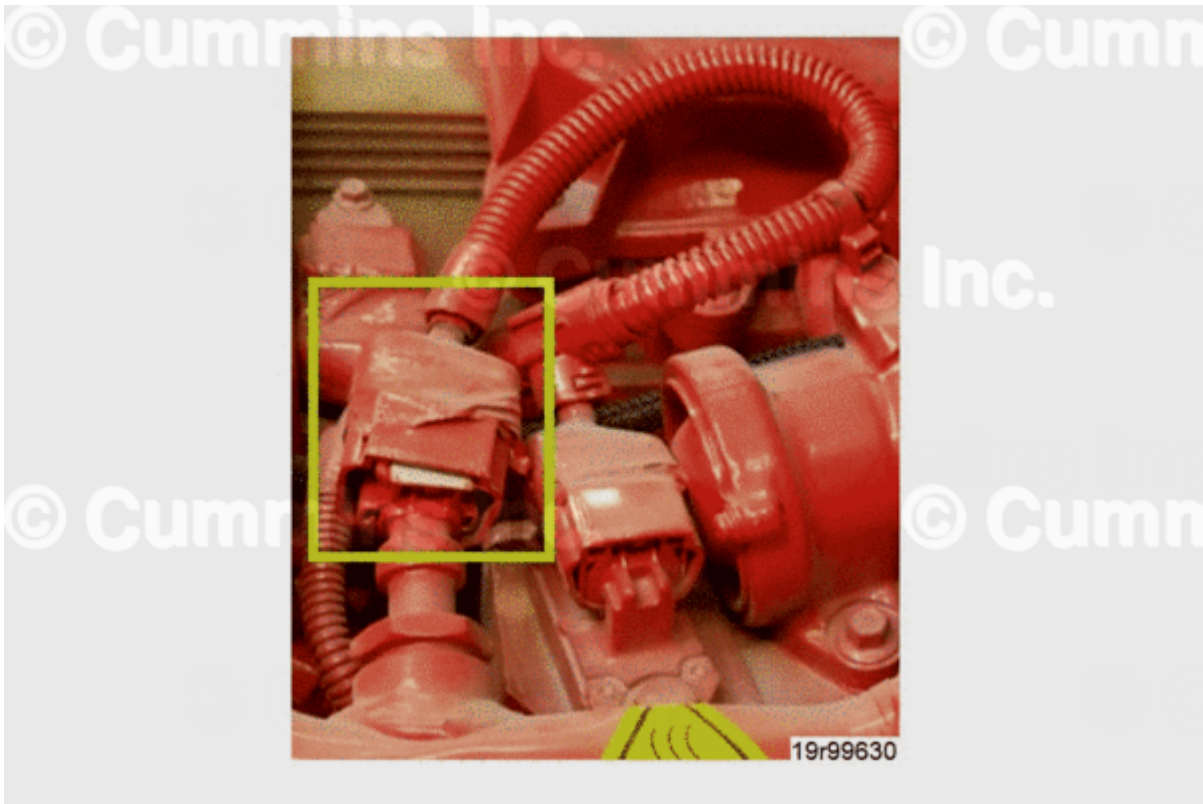
Figure 1, EGR Temperature Sensor Boot Location.

Verify non-transit bus engine which has a rubber boot over the EGR temperature sensor. See Figure 1 below.

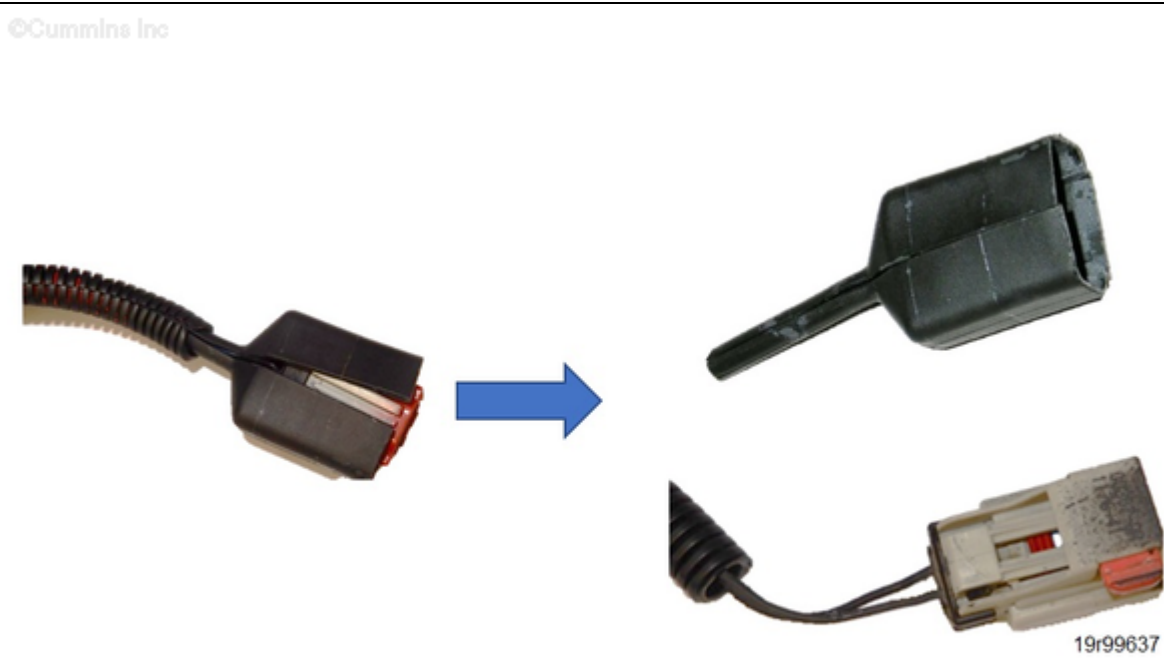
Figure 2, EGR Temperature Sensor Tape and Boot Removal.

1. Remove the EGR temperature sensor tape and rubber boot. See Figure 2 below.

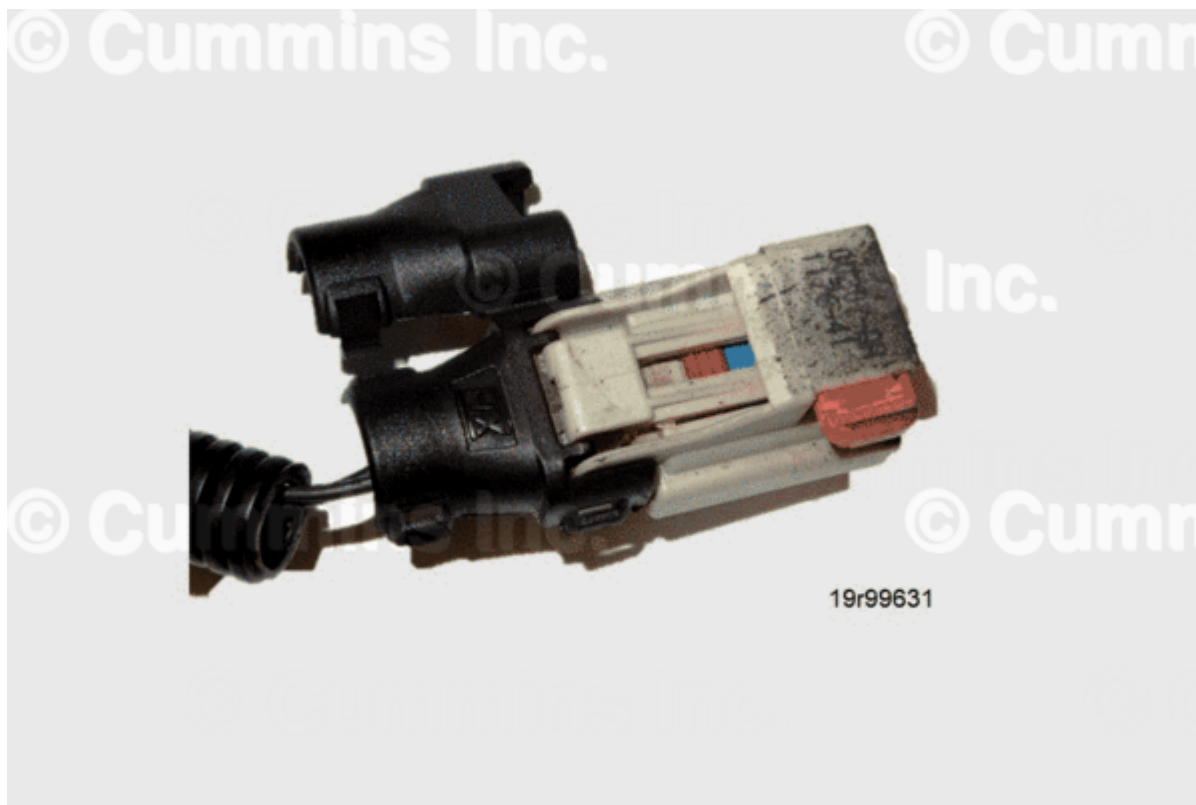
Figure 3, New EGR Temperature Sensor Back Shell Installation on Connector.

2. Replace the EGR temperature sensor connector using service kit, Part Number 5394319, if the wires are found to be damaged, or if connection appears to be intermittent.
3. Wrap the wires at the EGR Temperature Sensor Connector with electrical tape starting 13 mm [½ in]. behind the connector and extending for 75 mm [3 in] down the length of the wires (to protect the wires)
4. Reference the Figures below and snap the EGR temperature sensor connector back shell, Part Number 4402567, onto the EGR temperature sensor connector and over the conduit. Verify wires are **not** pinched and conduit is fully inserted into the EGR temperature sensor connector back shell. See Figures below for more examples.

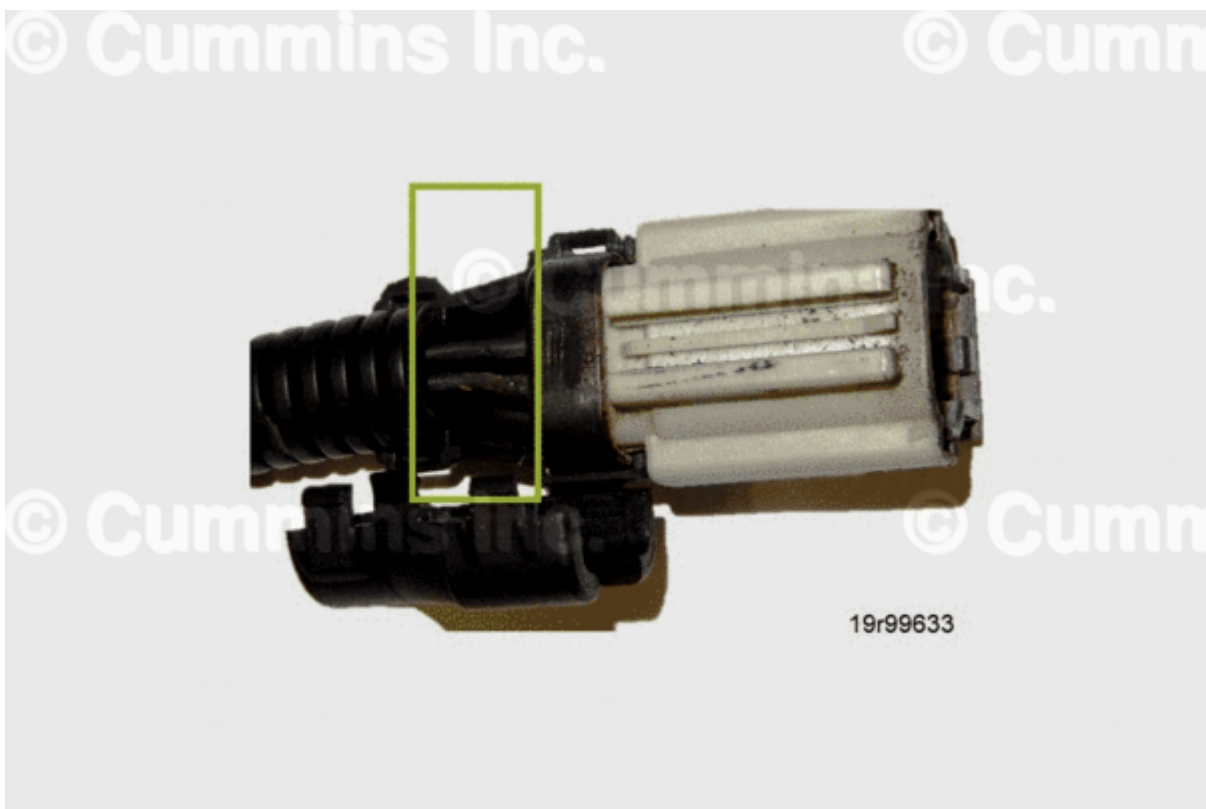
Figure 4, New EGR Temperature Sensor Back Shell Correctly Installed Showing Correct Conduit Depth.

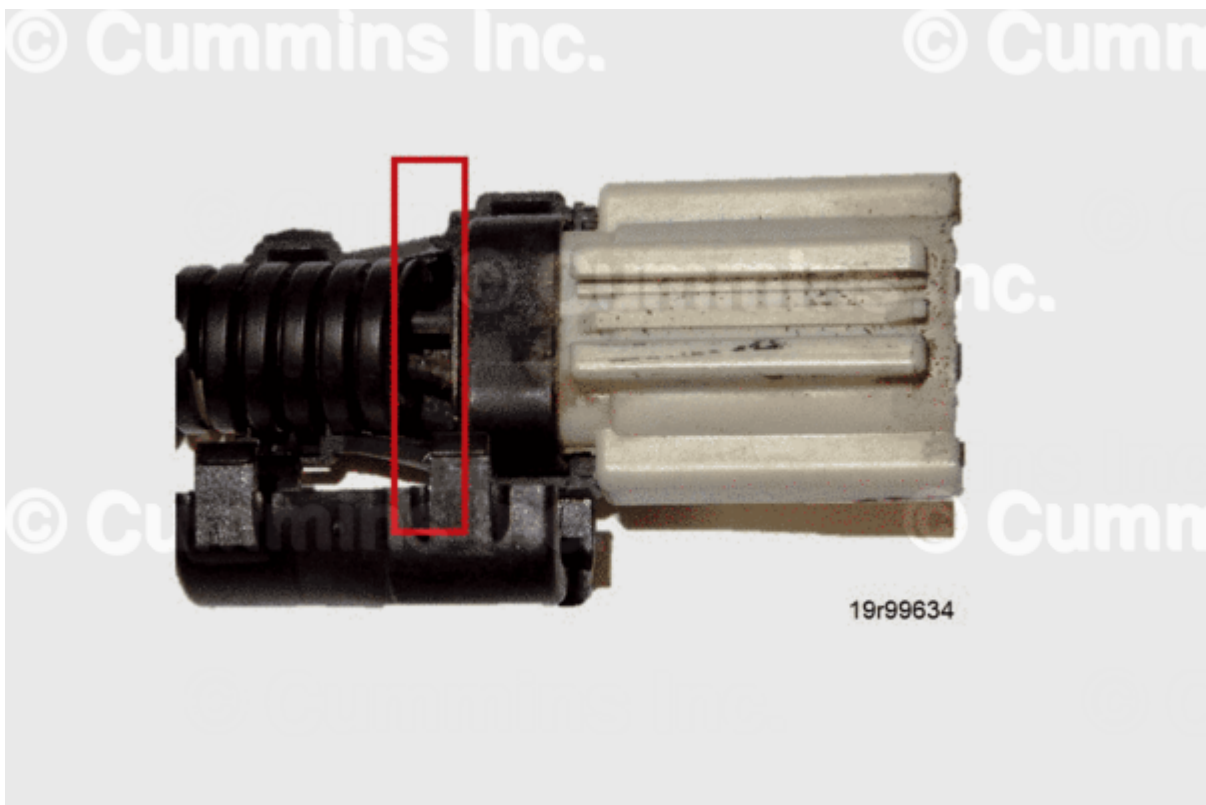
Figure 5, New EGR Temperature Sensor Back Shell Connector Installed Showing Incorrect Conduit Depth (Too High).

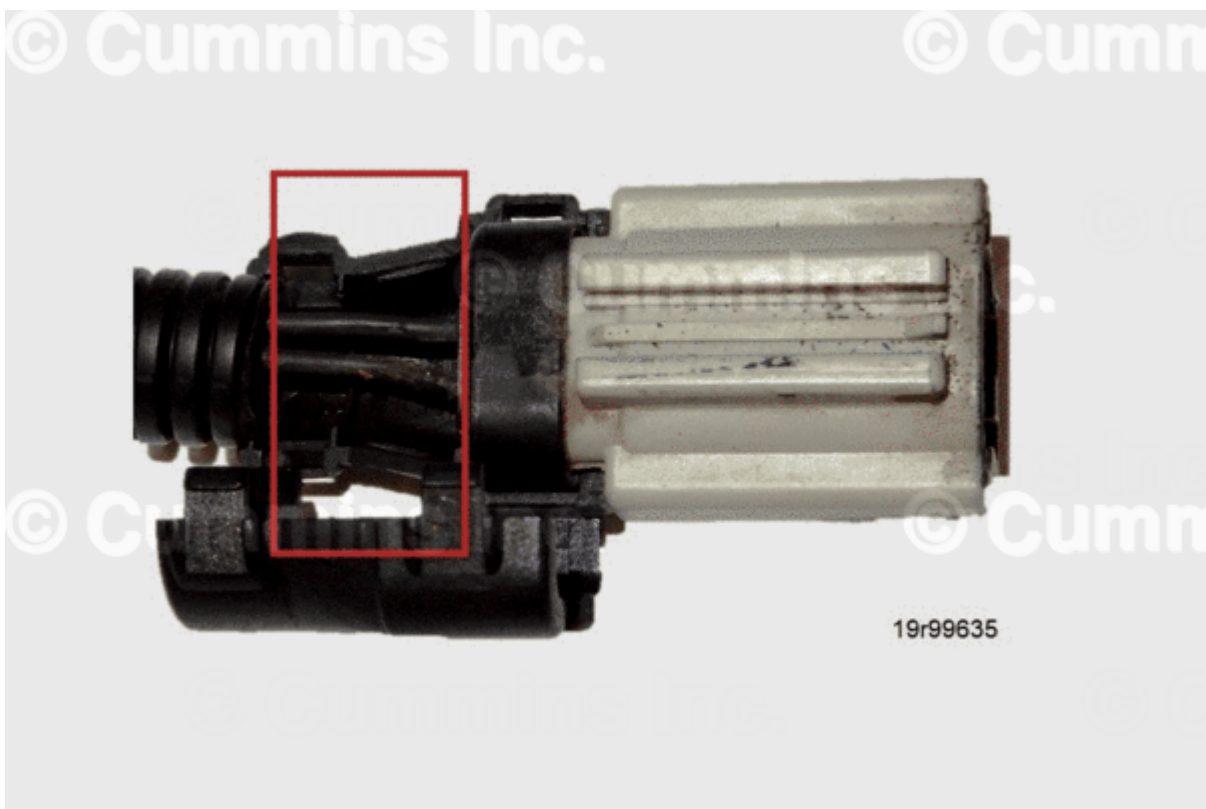
Figure 6, New EGR Temperature Sensor Connector Back Shell Installed Showing Incorrect Conduit Depth (Too Low).

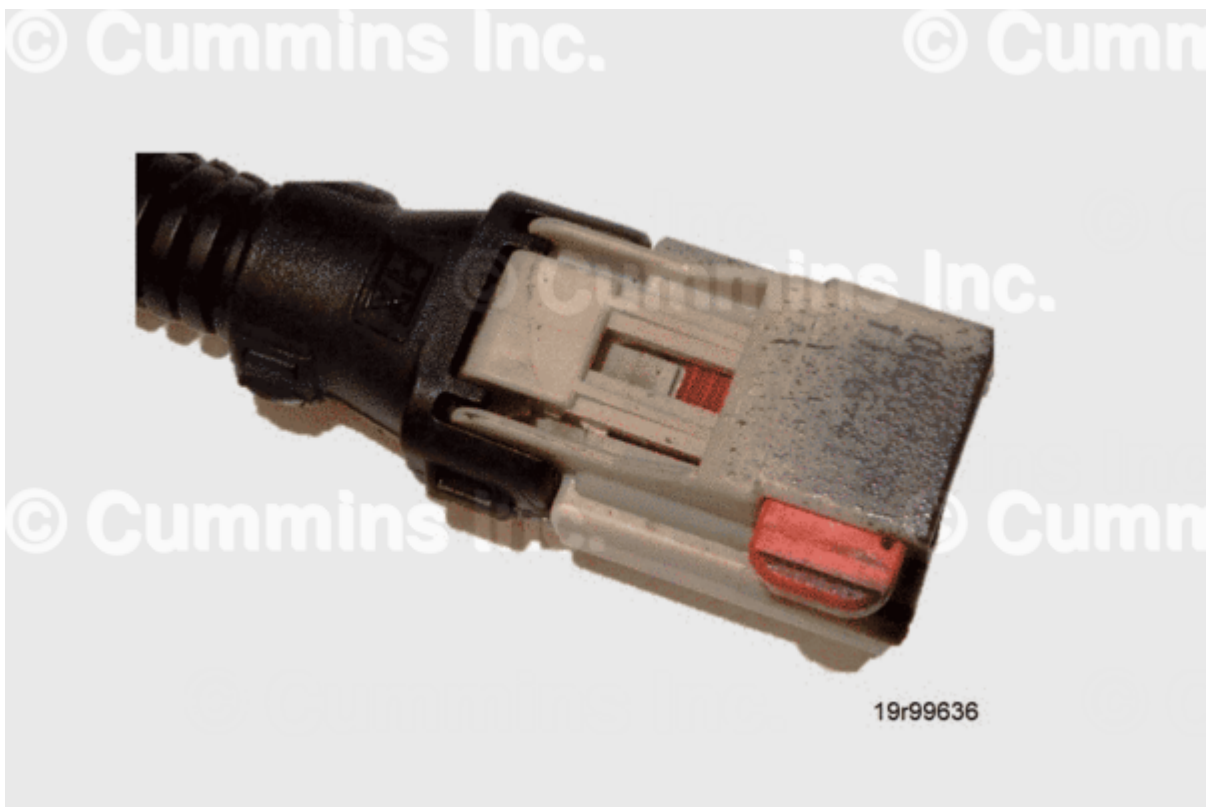
Figure 7, New EGR Temperature Sensor Connector Back Shell Connector Installed (Complete).
