GLOBAL SAFETY FIELD INVESTIGATIONS
DCS5345
URGENT - DISTRIBUTE IMMEDIATELY

Subject: N202295800 - Service Update
Exhaust Cam Position Sensor Fault

Models: 2020 Chevrolet Malibu equipped with 1.5L DOHC Turbo Engine
(RPO LFV)

N202295800 Exhaust Cam Position Sensor Fault

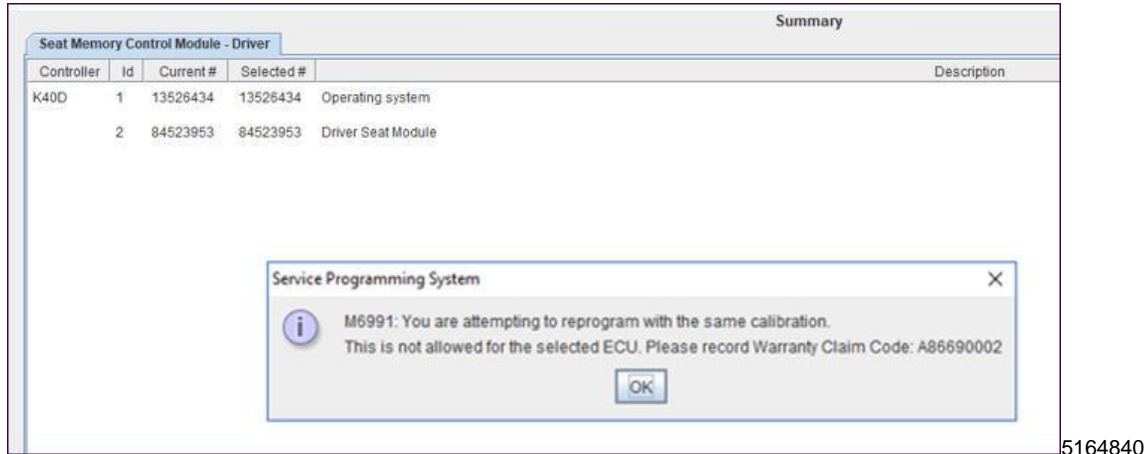
Note: If the Same Calibration/Software Warning is noted on the SPS Summary screen, record the warranty claim code (WCC) and select OK and follow screen instructions. After a successful programming event, the WCC is located in the Service Programming System dialogue box of the SPS Summary screen. No further action is required. Refer to the Warranty section of the bulletin.

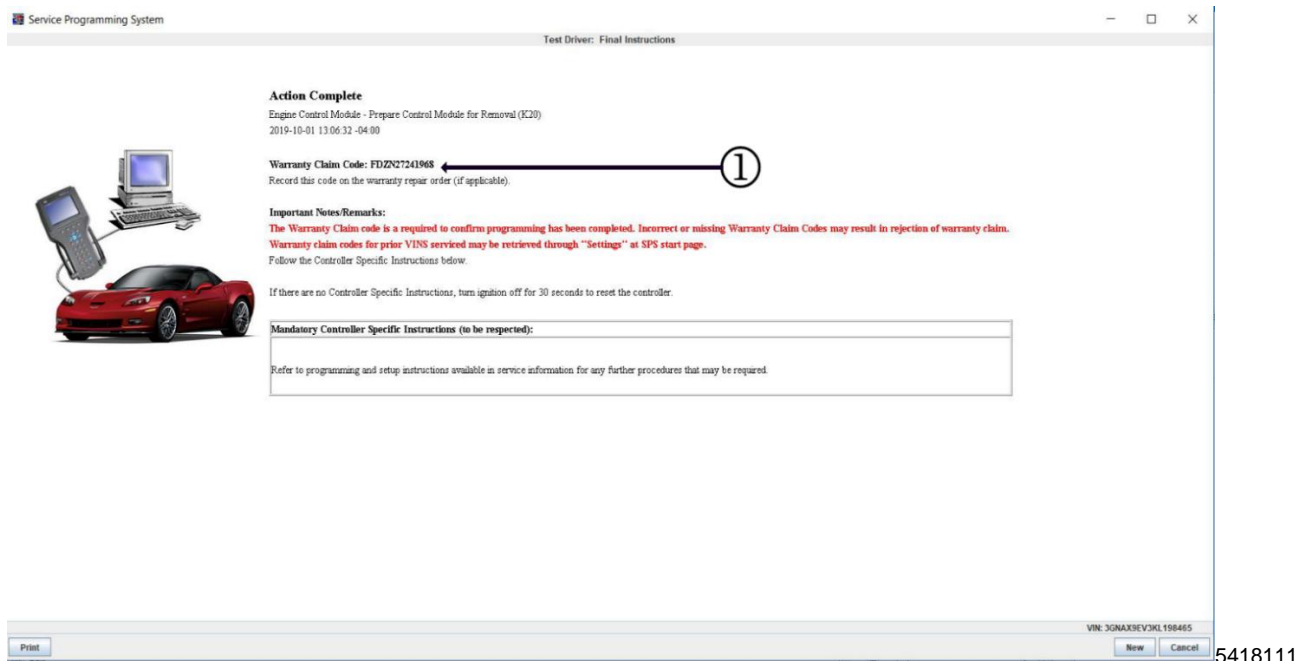
Note: To avoid warranty transaction rejections, you **MUST** record the warranty claim code provided on the SPS Warranty Claim Code (WCC) screen on the job card. Refer to callout 1 for the location of the WCC on the SPS screen.

2. Record SPS Warranty Claim Code on job card for warranty transaction submission.
