**Air Conditioning System - Improved Component Inspection**

Toyota

In certain cases of leaking air conditioning systems, the root cause of the leak is inadvertently overlooked, causing a repeat repair. To improve customer satisfaction and repair A/C system leaks in one dealer visit, Toyota has developed a set of guidelines for evaluating A/C system components.

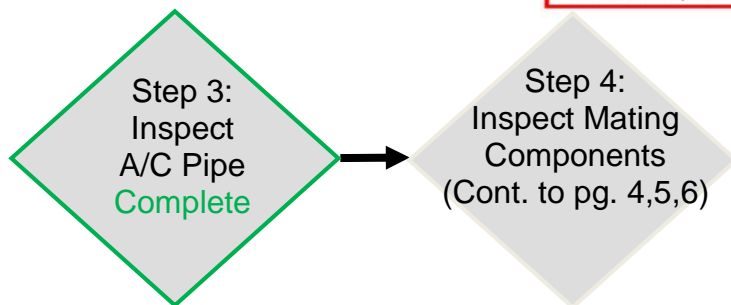
**Corrosion – No Good Part**  
Pipe is damaged due to corrosion of base material. Pipe replacement is recommended to prevent repeat repair.
