Subject		Market
Air Conditioning System – Improved Component Inspection		USA
Service Category	Section	
Vehicle Interior	Heating/Air Conditioning	
Applicability		
Lexus

In certain cases of leaking air conditioning systems, the root cause of the leak is inadvertently overlooked, causing a repeat repair. To improve customer satisfaction and repair A/C system leaks in one dealer visit, Toyota has developed a set of guidelines for evaluating A/C system components.

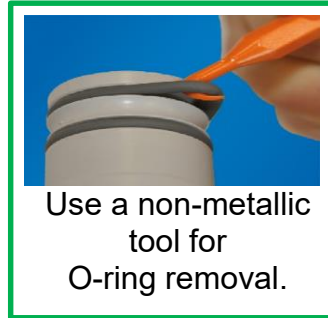
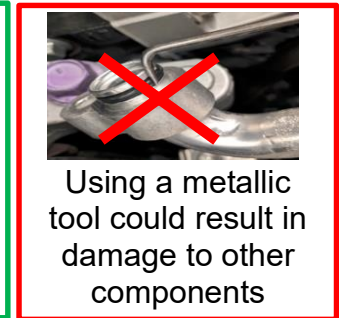
OK Part* - Line at middle of O-ring is straight with no deformation. No tears, or crushed areas.
 *O-rings should be replaced anytime they are removed from a pipe/component to prevent leaks and foreign material.

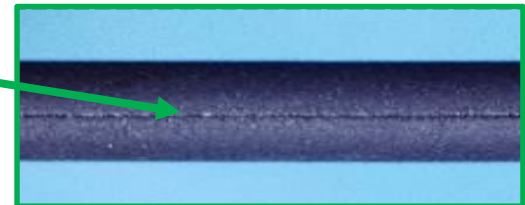
Twisted O-Ring – No Good Part
 Line at middle of O-ring is not straight.

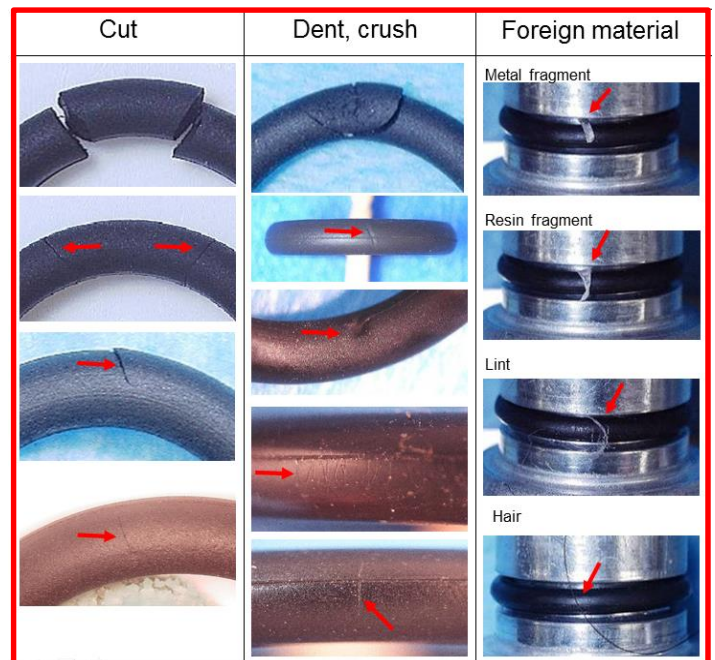
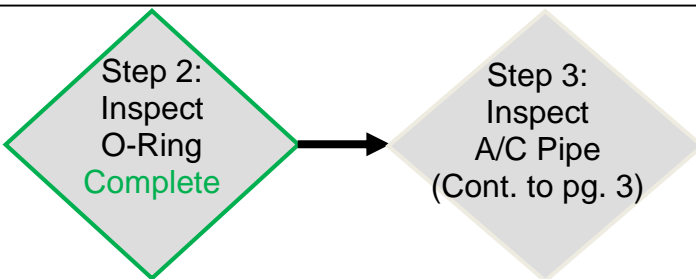
Foreign Material– No Good Part
 O-ring contaminated by material outside A/C system. Replace O-ring, proceed with A/C Pipe inspection.

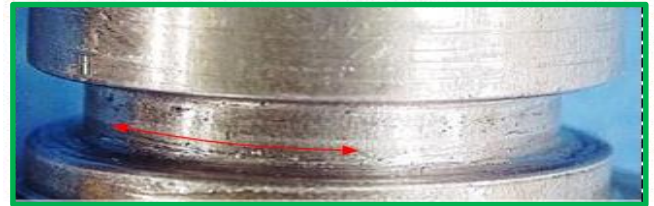
OK Part - Light scratching parallel with O-ring groove. This is caused by normal part processing. Pipe is ok to reuse.

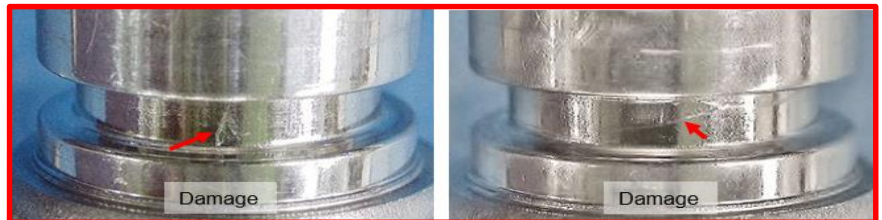
Damage – No Good Part
Pipe is damaged due to deep scratching or gouge of base metal. Pipe replacement is recommended to prevent repeat repair.

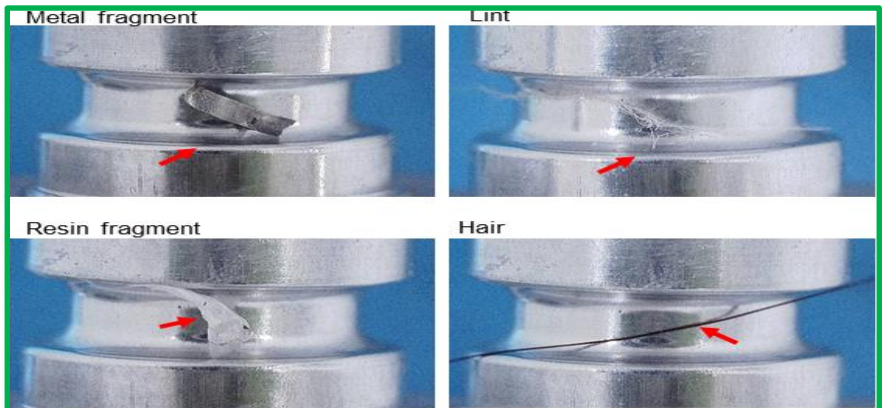
Foreign Material – OK Part
Pipe has foreign material stuck to it. Material can be cleaned off using a non-metallic tool and the pipe is ok to be reused.

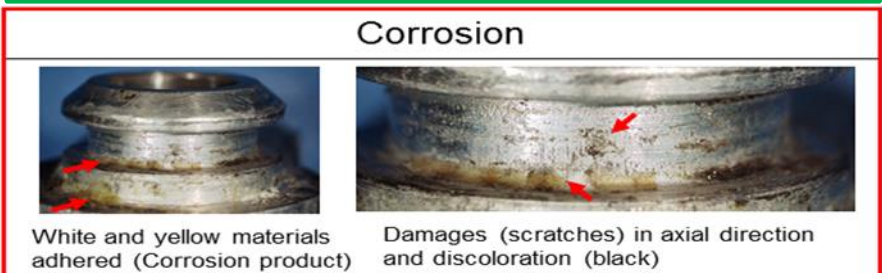
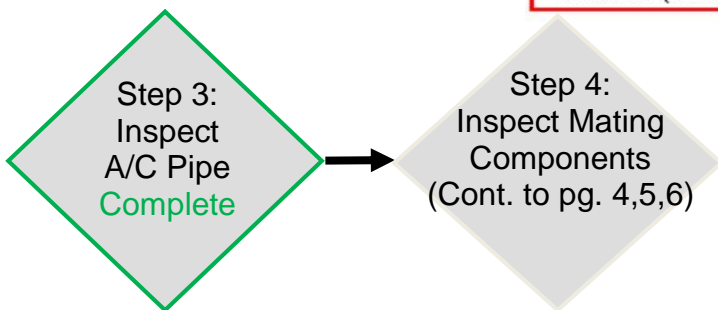
Corrosion – No Good Part
Pipe is damaged due to corrosion of base material. Pipe replacement is recommended to prevent repeat repair.

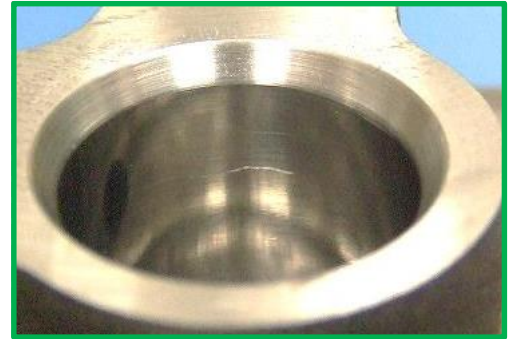
OK Part - Light scratching parallel with O-ring groove. This is caused by normal part processing. Compressor is ok to reuse.

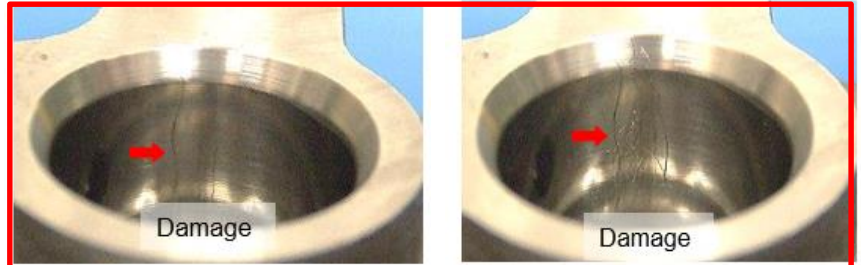
Damage – No Good Part
Compressor seal bore is damaged due to deep scratching perpendicular to O-ring groove.

Compressor replacement is recommended to prevent repeat repair.

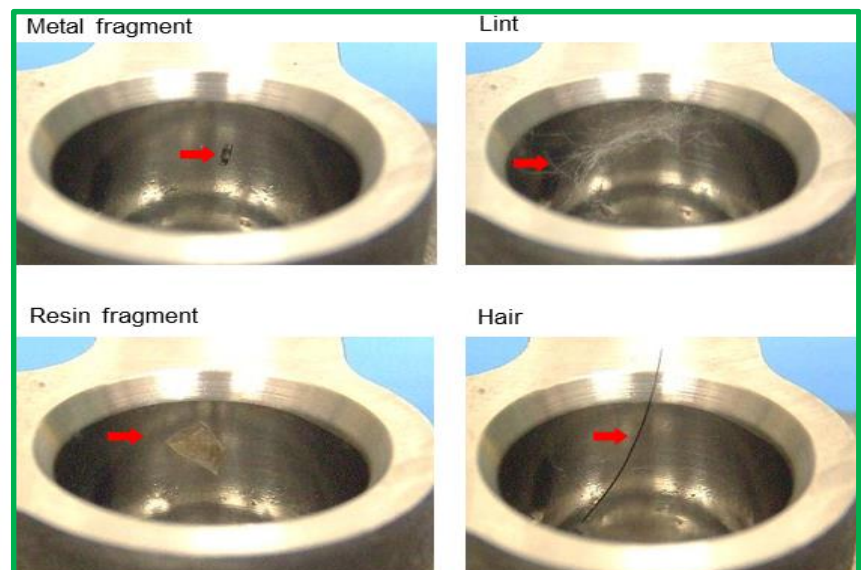
Foreign Material – OK Part
Compressor has foreign material stuck to seal bore.

Material can be **carefully** cleaned off using a non-metallic tool and the compressor is ok to be reused.

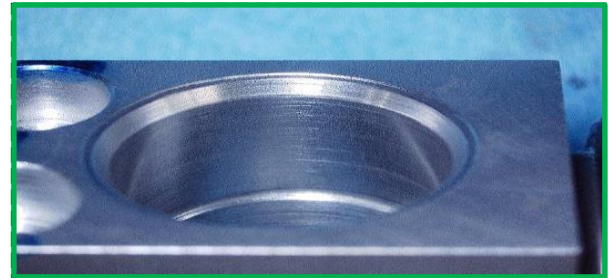
OK Part - Light scratching parallel with O-ring groove. This is caused by normal part processing. Expansion valve is ok to reuse.

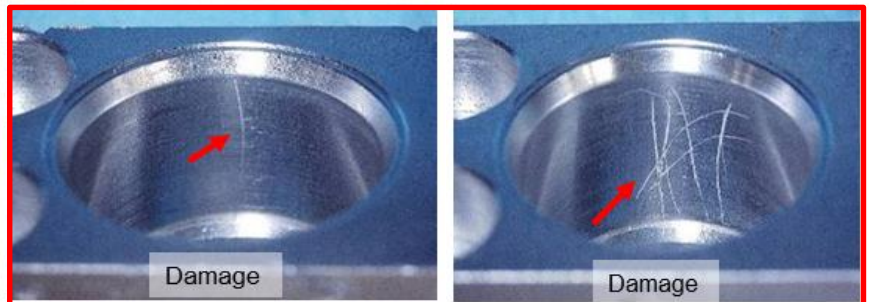
Damage – No Good Part
 Expansion valve seal bore is damaged due to deep scratching perpendicular to O-ring groove.

Expansion valve replacement is recommended to prevent repeat repair.

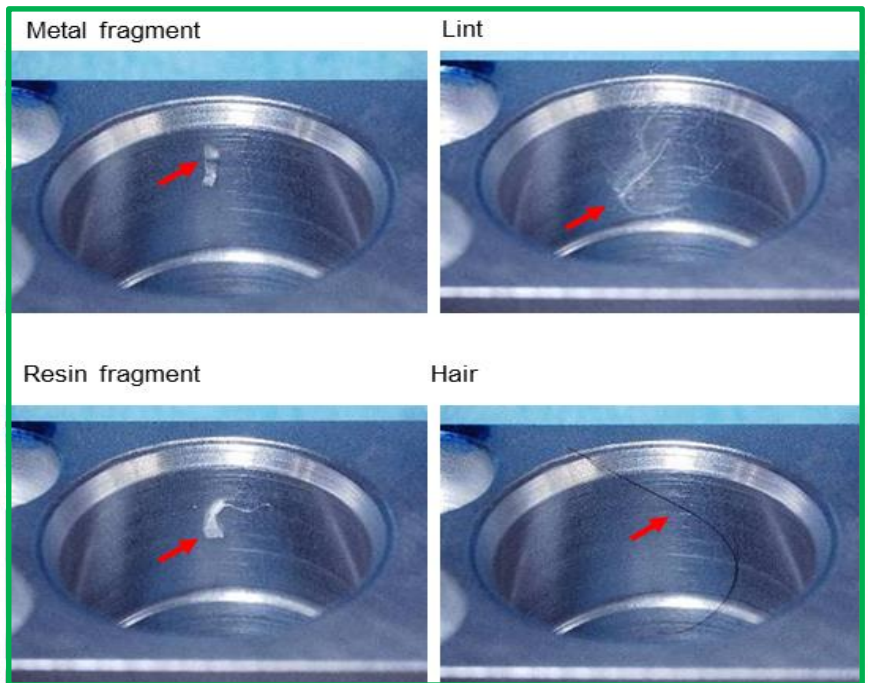
Foreign Material – OK Part
 Expansion Valve has foreign material stuck to seal bore.

Material can be **carefully** cleaned off using a non-metallic tool and the expansion valve is ok to be reused.

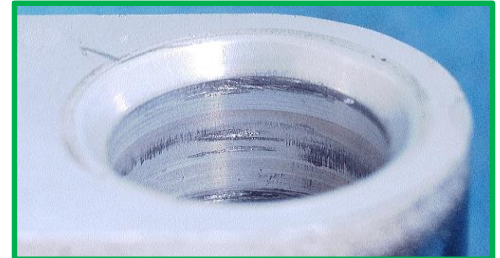
OK Part - Light scratching parallel with O-ring groove. This is caused by normal part processing. Condenser is ok to reuse.

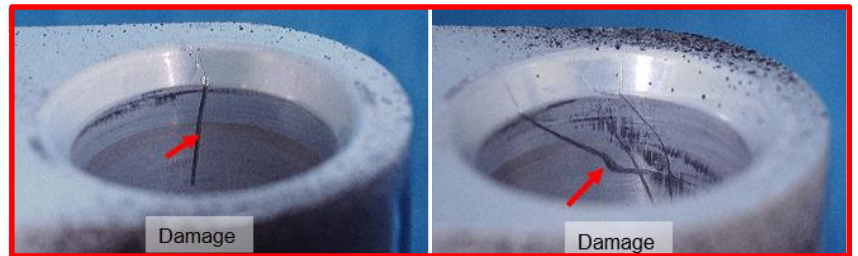
Damage – No Good Part
Condenser seal bore is damaged due to deep scratching perpendicular to O-ring groove.

Condenser replacement is recommended to prevent repeat repair.

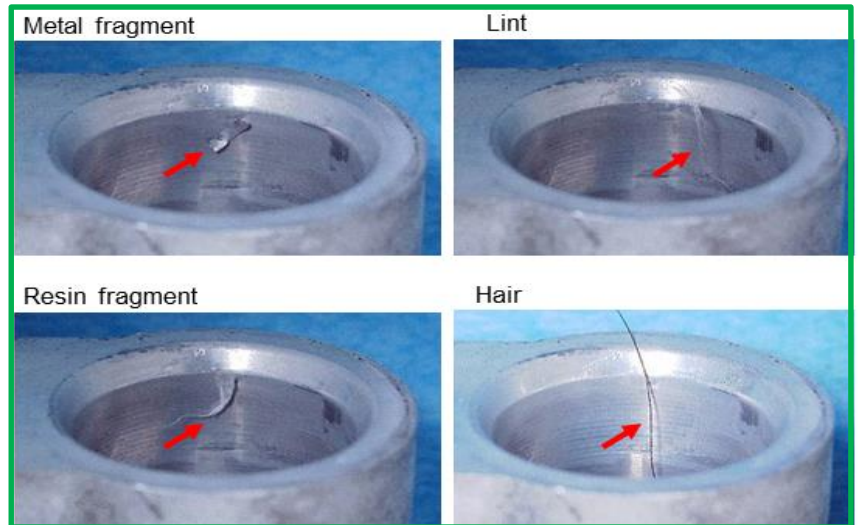
Foreign Material – OK Part
Condenser has foreign material stuck to seal bore.

Material can be **carefully** cleaned off using a non-metallic tool and the condenser is ok to be reused.

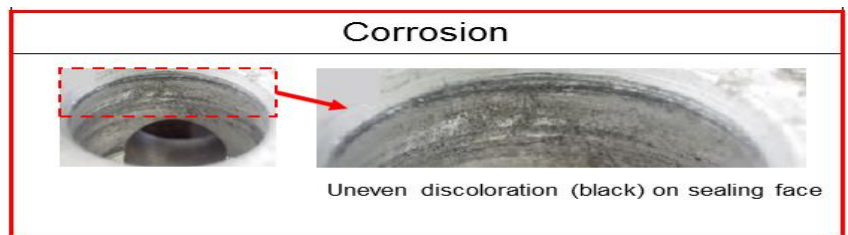
Corrosion – No Good Part
Seal bore is damaged due to corrosion of base material.

Condenser replacement is recommended to prevent repeat repair.
