SIB 12 03 20

SERVICE ACTION: INSPECT AND SECURE THE ENGINE ELECTRICAL HARNESS

E-Series	Model Description	Production Date	Affected Engine
F95	X5 M Sports Activity Vehicle	July 27, 2019 thru January 14 2020	S63M
F96	X6 M Sports Activity Coupe	April 24, 2019 thru January 15 2020	S63M

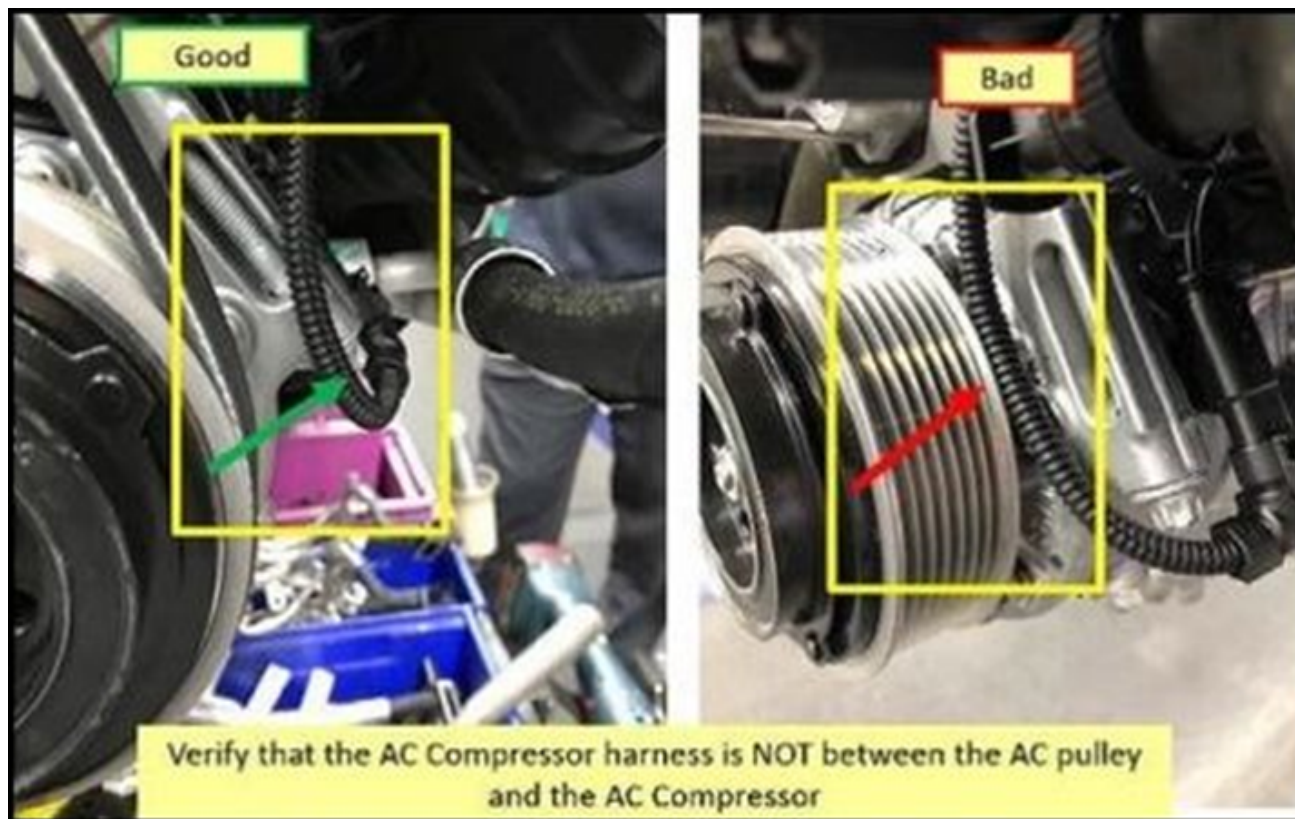
2. Check the wiring harness for damage in the area of the air conditioning compressor

a. If the wiring harness is damaged or abraded:

- o The wiring harness must be replaced. Ensure the replacement wiring harness is properly routed as shown to the left. The heat-resistant cable tie is not needed if the engine harness is replaced and properly routed.

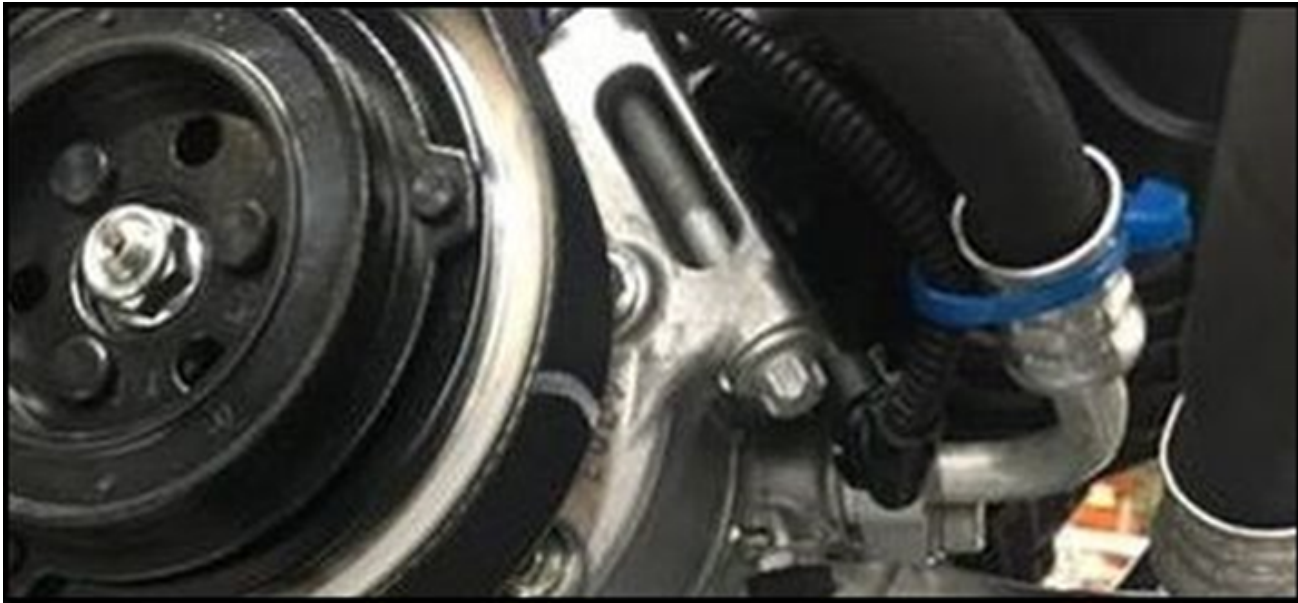
3. If the wiring harness has not been damaged:

Secure the wiring harness to the air conditioning refrigerant line as shown below.

Note: Only the heat-resistant cable tie must be used to secure the wiring harness to the metal crimp of the air conditioning refrigerant line as shown above.
