SIB 17 06 17

COOLANT LEAK FROM LOW TEMPERATURE COOLING CIRCUIT (N63R)

This Service Information Bulletin (Revision 5) replaces SI B17 06 17 **dated June 2019**.

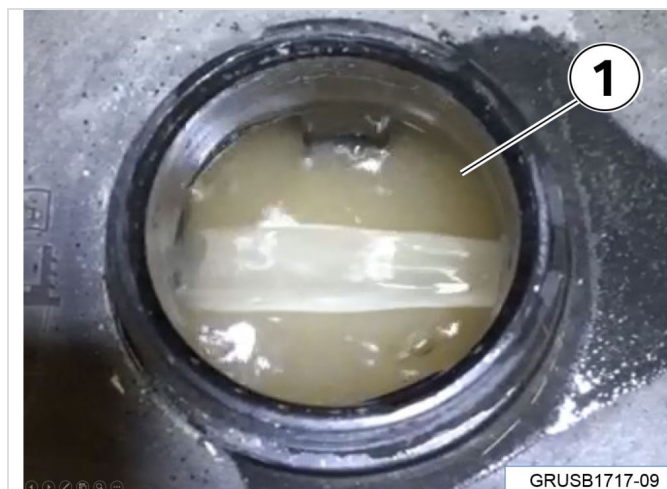
Coolant leaking from the engine compartment. Traces of coolant leaking from the expansion tank of the low temperature cooling system.

Coolant in the low temperature cooling circuit may also have an acrid smell and discoloration (1).

Aluminum corrosion in the charge air intercoolers, or in the radiator for the low temperature cooling is causing an unfavorable chemical reaction to the coolant.

Replace the radiator and both charge air coolers for the low temperature cooling circuit. Allow all the coolant in the system to drain during repairs (do not clamp off hoses).
