SIB 34 05 17

TICKING NOISE WHILE CORNERING WITHOUT THE BRAKES APPLIED

This Service Information Bulletin (Revision 3) replaces SI B34 05 17 **dated September 2017**.

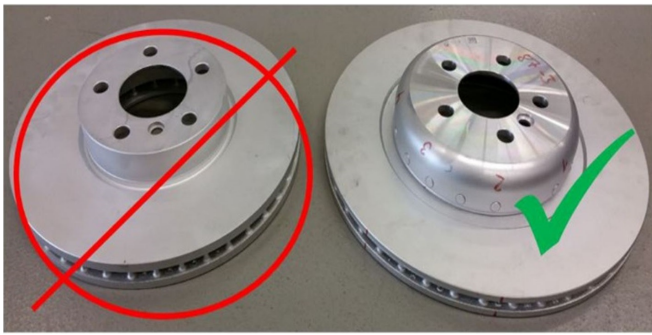
Microscopic movement of the contact interface between the inner brake disc and the wheel bearing flange on vehicles equipped with lightweight brake discs.

2. Check which type of brake discs are installed on the vehicle.

Are the lightweight discs (shown at right in the photo) installed on the vehicle?

Remove both front brake discs and install a friction ring between the brake disc and the wheel bearing flange.
