SIB 51 09 20
G01 WIND NOISE DIAGNOSIS

E-Series	Model Description	Production Date
G01	X3 Sports Activity Vehicle	September 1 st , 2017 to October 1 st , 2019.

G01 WIND NOISE DIAGNOSIS AND REPAIR INSTRUCTIONS

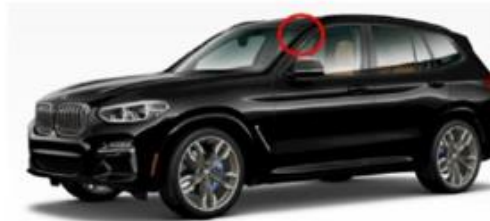
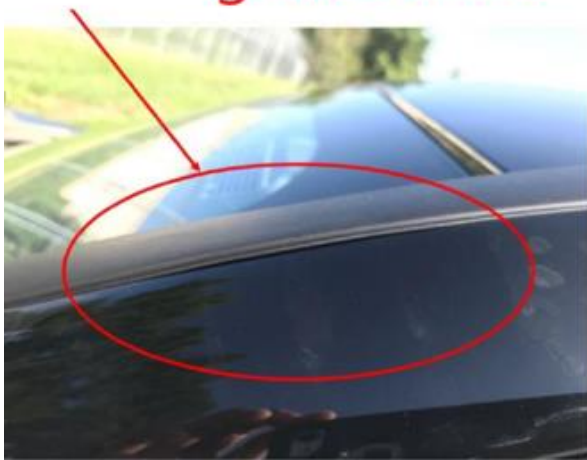
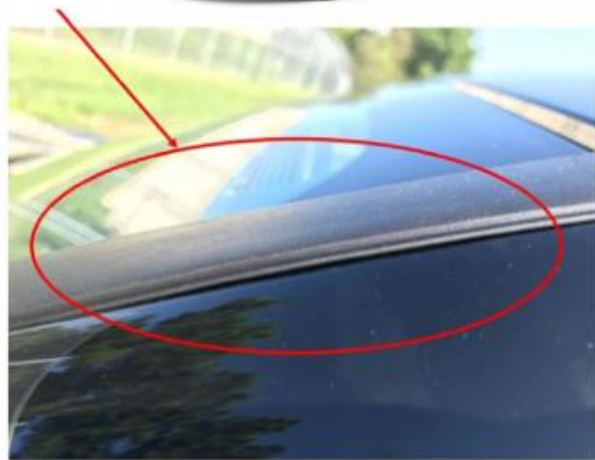
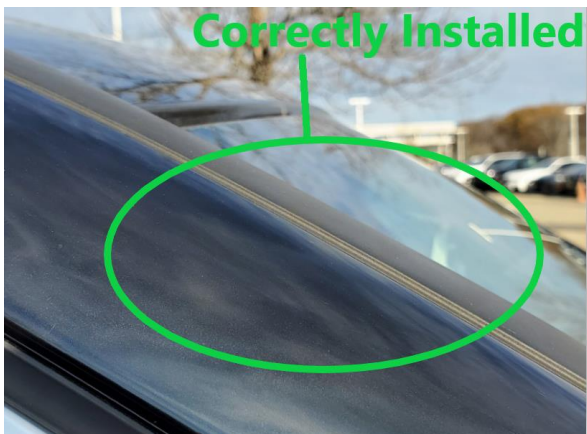
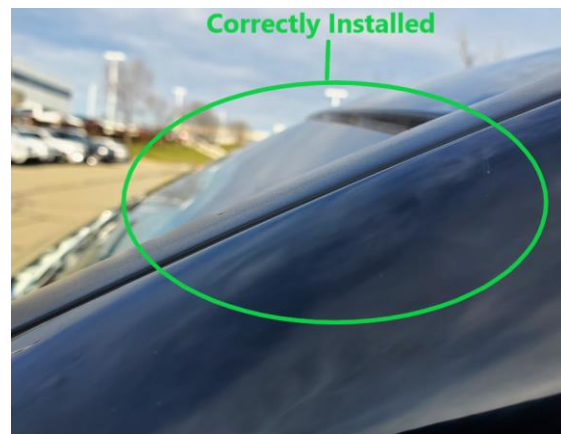
Incorrectly installed gutter trim.

1. Inspect the gutter trim for proper installation.
 - Re-install if necessary to be flush with the A pillar body. Refer to 51 31 030 removing and installing gutter strip.

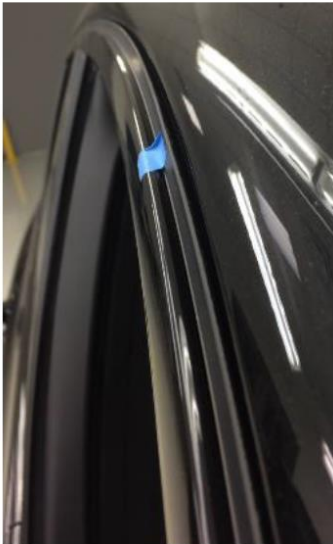
A

- Image “A” shows a incorrectly installed seal causing a gap between the seal and the body.
- Image “B” shows the the gap when the door is open.
- Image “C” shows a properly installed seal with no gap present.
- Properly install the seal.
- Reinstall or adjust as needed (refer to REP 51 71 115)

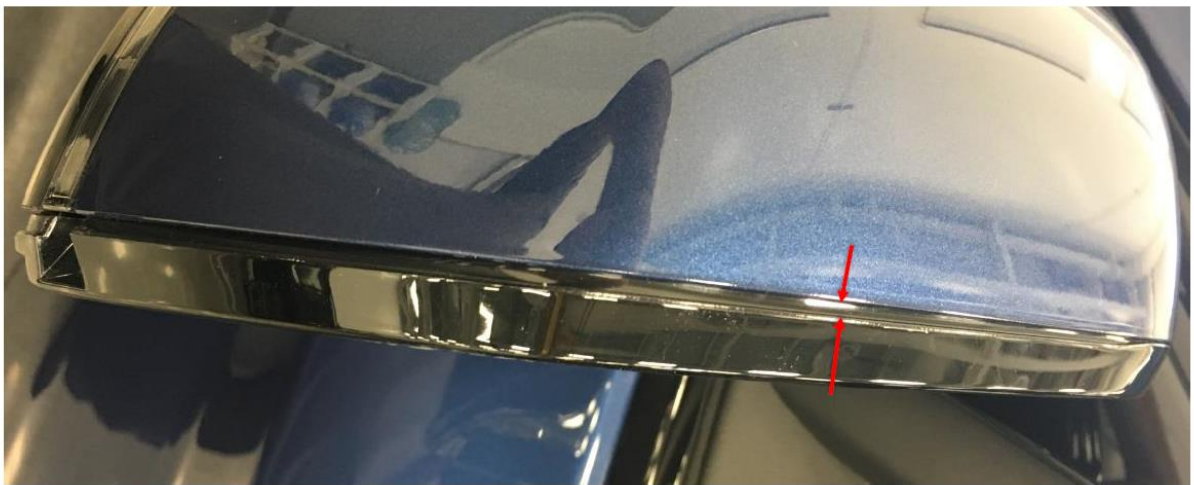
- Tape the mirror cap channel and test drive the vehicle.
- If the noise is eliminated, inspect the gap between the mirror cap and mirror panel must be even.
- The water channel gap should be 2 mm (plus / minus 0.4 mm). Larger gap may create whistling noises.
- If the gap is enlarged and the noise is eliminated when taping the mirror cap, the mirror cap must be exchanged.

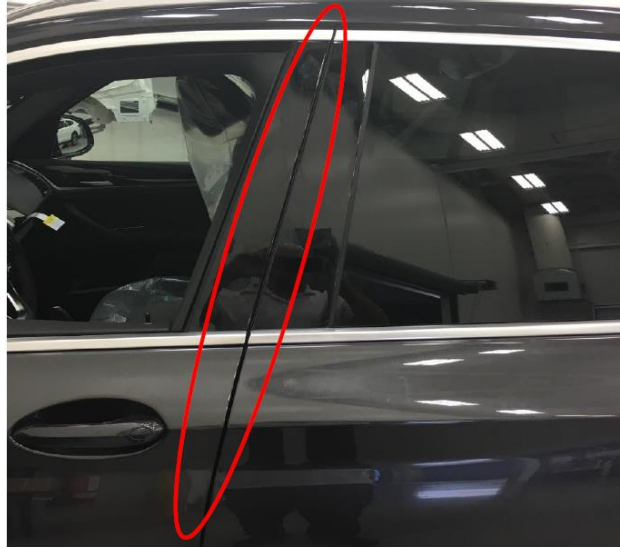
4. Inspect the door proper alignment and gaps.

- See repair instructions "41 51 004 Adjusting front left or right the door".
- Adjustment range 0 mm + 1.9 mm protrusion / 0.3 mm short length. Protrusion is recommended, short length should be avoided.

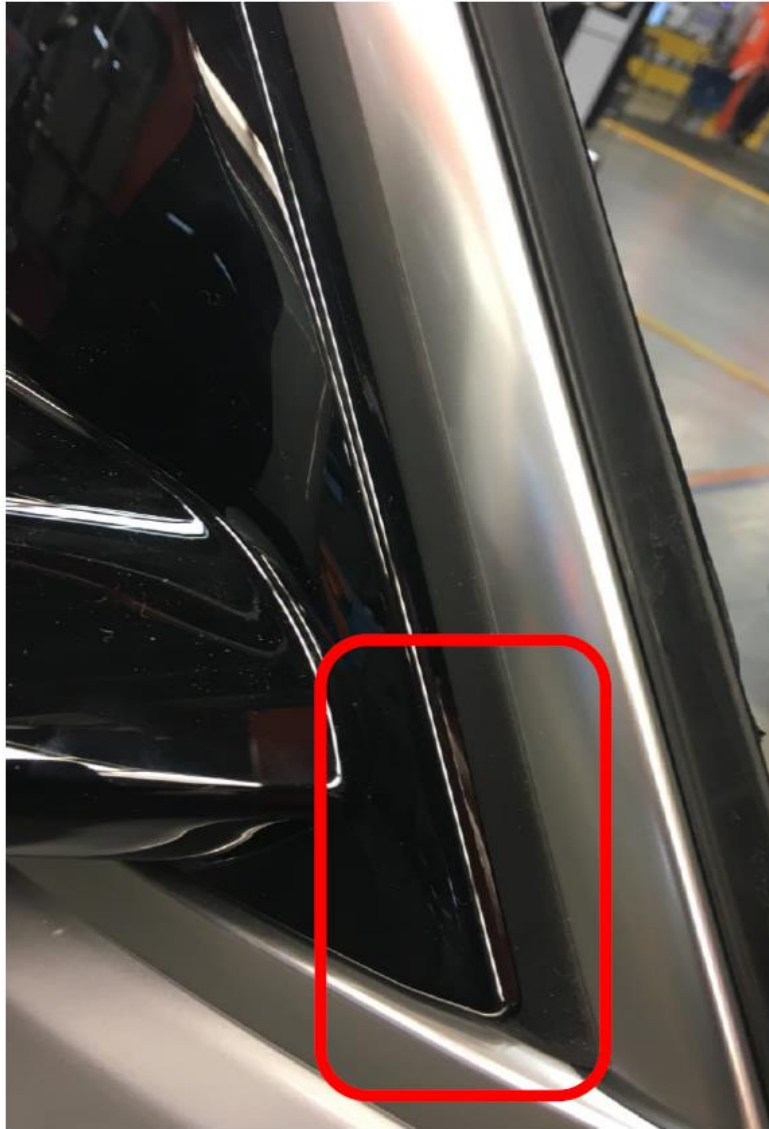
5. Inspect the side view mirror assembly to door for proper fitment.

- If the assembly is not properly aligned, remove the assembly and inspect proper installation and insulation foam.

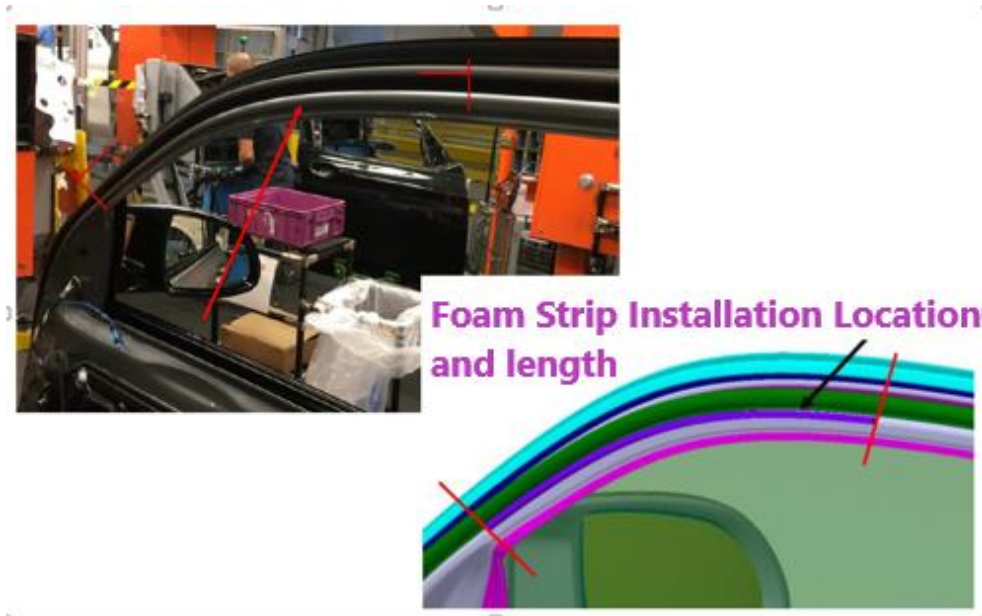
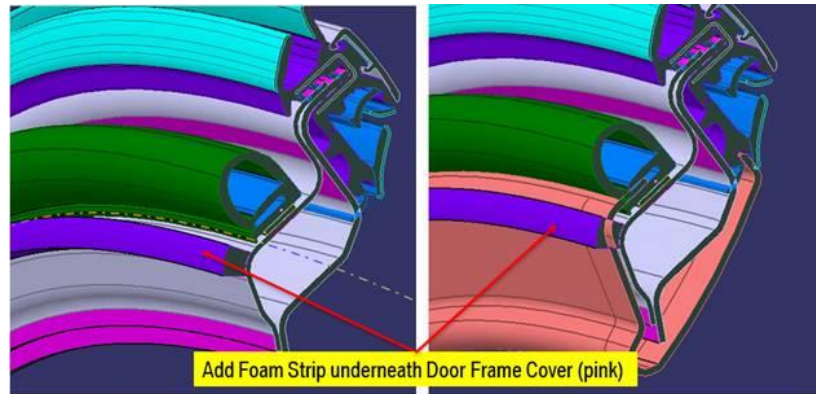
6. If noise is coming from the front doors without any of the above mention defects.

- Remove the window frame cover. Refer to repair instructions 51 32 420 remove and install window frame.
- Apply foam strips part number 9500543 on the door frame just below the door main seal as shown below.

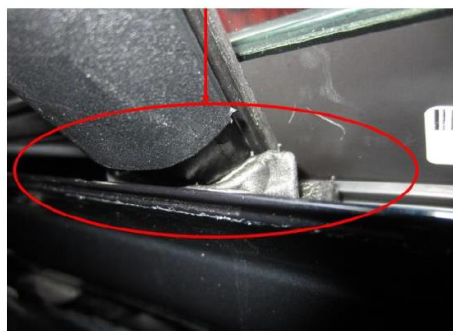
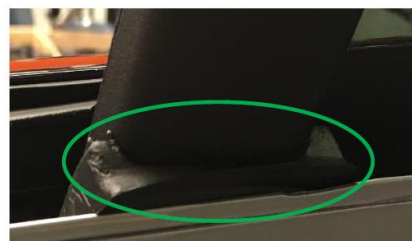
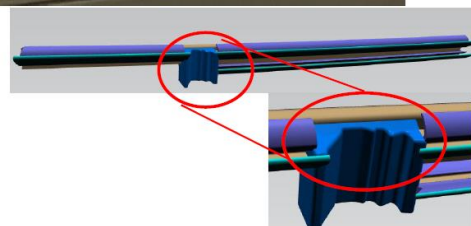
- Check the positioning of the window bar foam at the bottom of the rear door.
- Remove trim panel of the rear door.
- Check whether the foam is correctly positioned at the bottom of the window bar. Image “A” shows incorrect installation.
- Image “B” shows foam correctly installed. Must not sit below the capping line.
