SIB 51 10 20

2020-03-10

INTERFERENCE NOISE WHEN FOLDING THE OUTSIDE MIRRORS

E-Series	Model Description
G20	3 Series Sedan
G29	Z4 Roadster

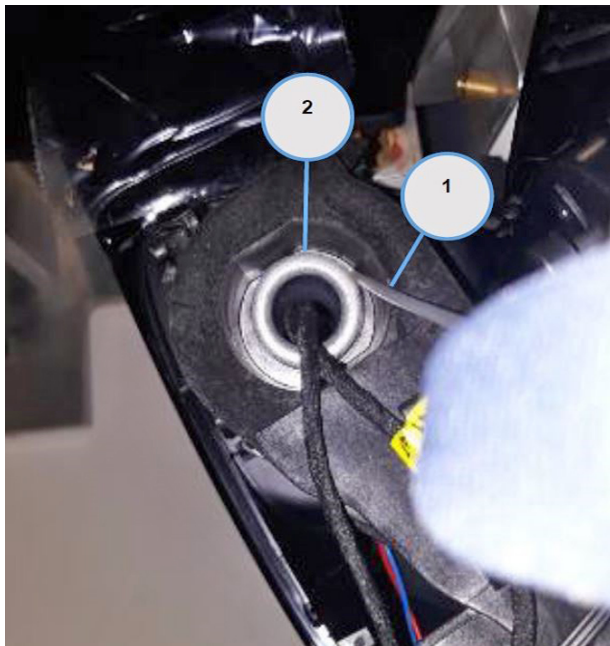
Interference noises (creaking, groaning, clicking) may be present when folding the side view mirrors in or out.

Excessive friction on the pivoting mechanism of the side view mirror hinge.

2. Using special lubricant, P/N 83 19 9 408 523 (1), apply lubricant to all visible surfaces of the sliding disc (2) as shown.

Complete this procedure on both sides of the vehicle.
