SIB 54 08 19

2020-03-19

**SUNROOF REVERSES WHEN CLOSING**

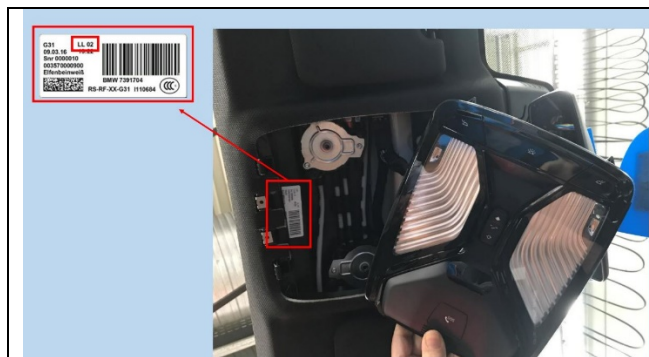
5. With the FZD removed, inspect the “LL” number on the ID tag on the bottom of the sunroof frame. Photo shows the location of the ID tag.

Utilize the tables below to identify the repair based on the “LL” number.

**LL42 or Lower:** Replace the glass/slide sunroof frame and wind deflector (not necessary if already replaced during step 2) following ISTA repair instructions **REP 54 13 556 “Replacing panorama glass roof frame”**.

**LL43 or LL44:** Replace only the sunroof wind deflector following repair instructions **REP 54 13 090 “Removing and installing/replacing wind deflector”** (not necessary if already replaced during step 2).
