SIB 61 02 20

KNOCKING NOISE FROM WASHER FLUID RESERVOIR

E-Series	Model Description	Production Date			
F97	X3 M Sports Activity Vehicle				
F98	X4 M Sports Activity Coupe	August 1 st , 2017 to December 31 st , 2021			
G01	X3 Sports Activity Vehicle	August 17, 2017 to December 317, 2021			
G02	X4 Sports Activity Coupe

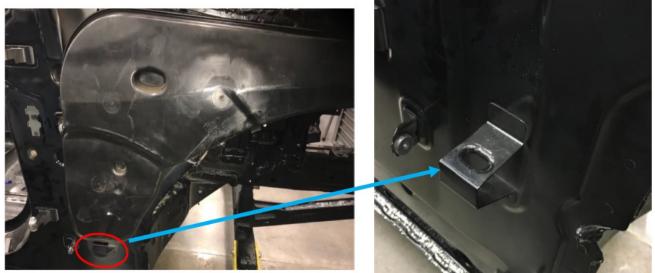
- 1. Remove the washer fluid reservoir as per repair instructions 61 71 063.
- 2. Access the lower mounting bracket.

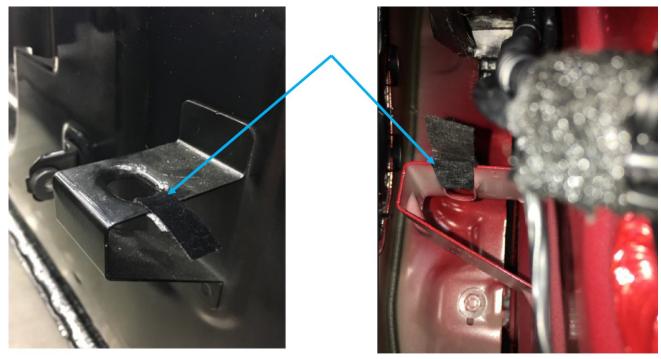
Washer fluid reservoir movement caused by mounting bracket clearance.

3. Wrap the lower mounting bracket with felt tape as shown.
