SIB 64 01 20

AIR CONDITIONING DOES NOT COOL

E-Series	Model Description	Production Date
I01	i3	ALL

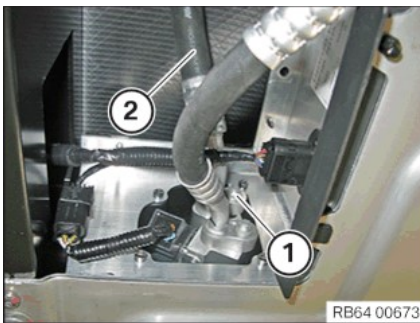
Release screw (1).

Tightening torque 64 53 6AZ.

Remove refrigerant line (2).

Renew sealing rings.

Use special tool 00 9 030 to mount sealing rings without damaging them.

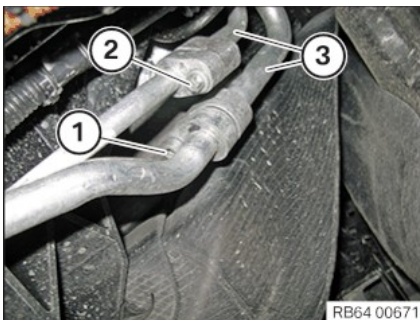
Release screw (1).

Tightening torque 64 53 12AZ.

Release screw (2).

Tightening torque 64 53 13AZ.

Remove refrigerant lines (3).

Renew sealing rings.

Use special tool 00 9 030 to mount sealing rings without damaging them.

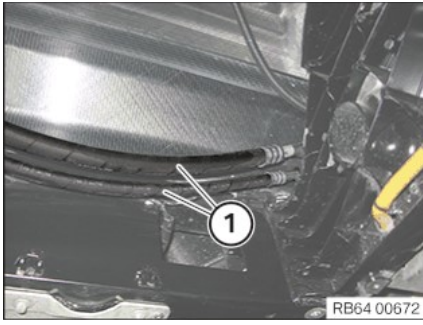
Feed out refrigerant lines (1).

- Evacuate and fill air conditioning system
