# Technical Service Bulletin

## 26 Droning, buzzing, or vibration from front of the vehicle

26 20 40 2054935/4 April 16, 2020. Supersedes Technical Service Bulletin Group 26 number 20-36 dated February 12, 2020 for reasons listed below.

Model(s)	Year	VIN Range	Vehicle-Specific Equipment
Q7	2017 - 2018	All	3.0TFSI
Q7	2019	000001 - 023479	3.0TFSI

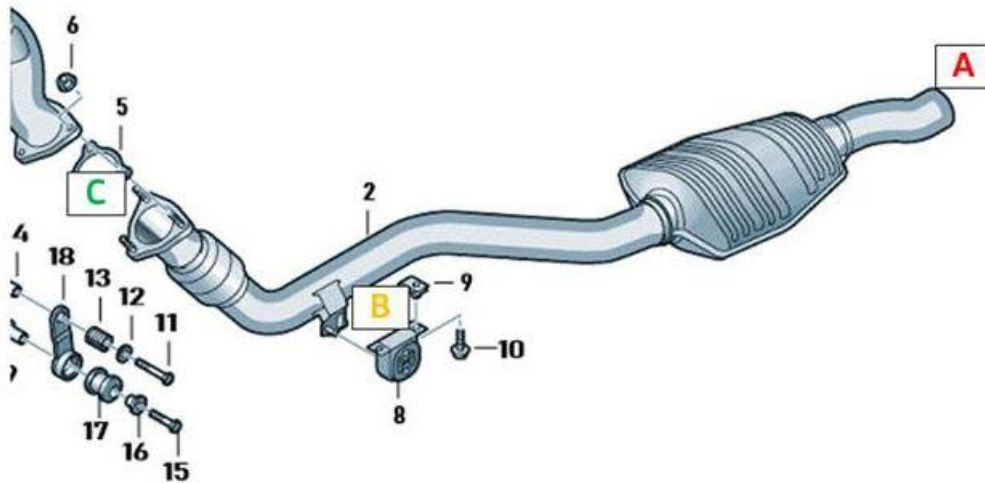
- Droning, buzzing, or vibration; especially between 1,000 – 1,400 rpm.

- The issue can be isolated to underside and front of the vehicle.

**Figure 1.** Example of locations to loosen and tighten.

1. Verify exhaust downpipes as the source of the customer concern. In most cases the replacement of the exhaust brackets (right/left side) in combination with the adjustment of the exhaust downpipes is only needed and the exhaust downpipes do not need to be replaced.
2. Replace the exhaust hangers on both right and left downpipes ("bracket for exhaust pipe") with the part numbers outlined below (or any future supersession thereof).
3. Proceed with the adjustment method below:
  - Loosen the exhaust clamp (A), exhaust bracket (B)
  - Then re-tighten beginning with clamp (A) and then bracket (B) (Figure 1).

4. Test drive vehicle to verify that the concern is no longer present. If the issue persists continue with the following steps (Figure 1):
  - Repeat and loosen the exhaust at (A), (B) and also the flange (C) to the catalytic converter.
  - Then tighten in the following sequence: First, the flange (C), second the exhaust clamp (A), and finally the exhaust bracket (B).
5. Test drive the vehicle to verify that the concern is no longer present.
6. If the noise still persists, replace the exhaust downpipe(s) which generate the noise.
