37 Vehicle electronics malfunction message, DTC B116229 is stored in the steering wheel or vehicle electronics module Q3

37 20 96 2058612/2 April 14, 2020. Supersedes Technical Service Bulletin Group 34 number 20-45 dated March 16, 2020 for reasons listed below.

Model(s)	Year	VIN Range	Vehicle-Specific Equipment
Q3	2019	All	With 0GC 7 speed S-tronic transmissions
Q3	2020	000001 - 008264	With 0GC 7 speed S-tronic transmissions

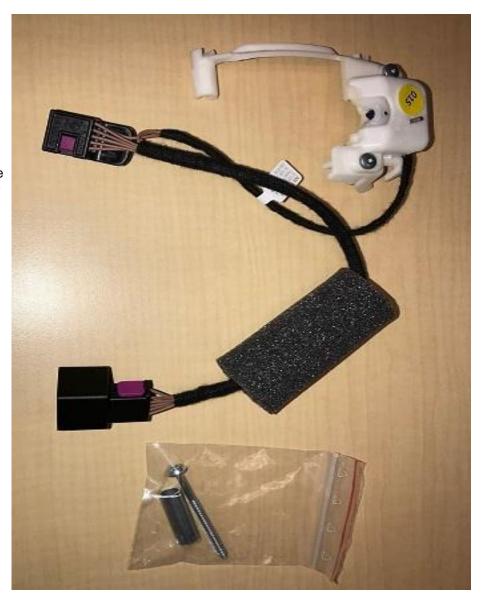
Figure 1. New microswitch module.

• DTC B116229 (Selector lever park position lock switch implausible signal).

Component-related deviation in microswitch of the selector lever.

If the customer has the above condition and the DTC B116229 is stored in the steering wheel electronics module, J527 (address word 0016) or the vehicle central electrical system module J519 (address word 0009), then install the new externally mounted microswitch module and selector lever handle sleeve per the instructions below (Figure 1).
